FACILITY COMPLIANCE AUDIT REPORT
Division of Waste Management
Solid Waste Section

Date of Audit: 3 May 2011

Carteret County/CRSWMA Transfer Facility
 800 Hibbs Road
 Newport, NC

16-04T, 050311

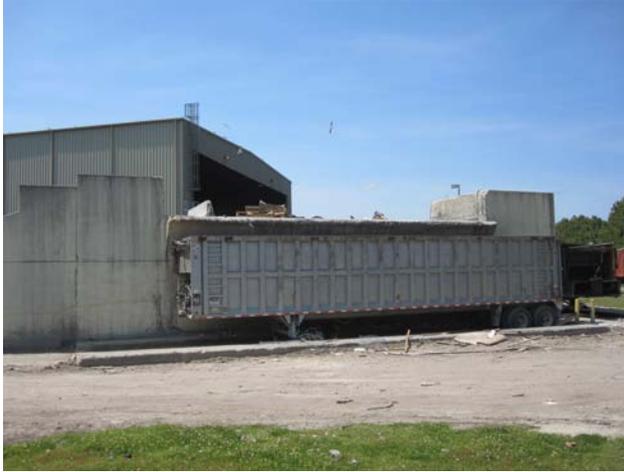
C&D loading area

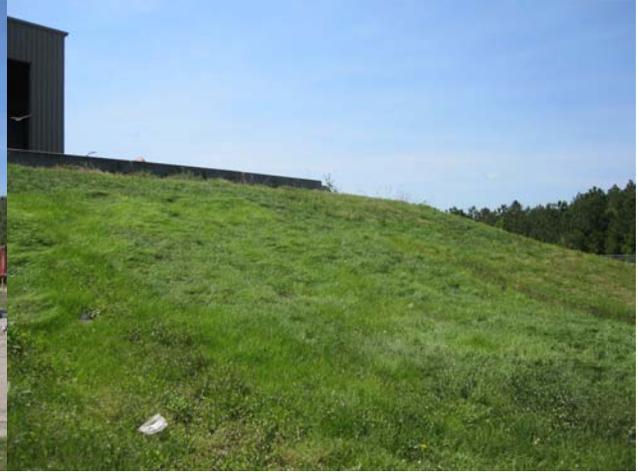
- 21) This facility maintains an adequate number of trailers on site to properly manage the volume of waste received during operating hours.
- 22) Access around the facility is stable. The areas of differential settlement and erosion noted in the previous audit have been filled and graded and have a groundcover established suitable to prevent erosion.

Northern sideslope filled and graded with cover crop established

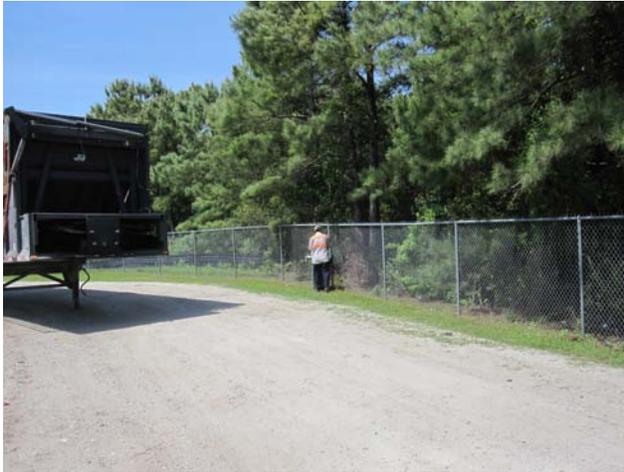
- 23) Windblown debris is collected and returned to the transfer station daily. An attendant was collecting windblown debris during this audit. No windblown debris was noted as leaving the facility.

Attendant collecting windblown debris

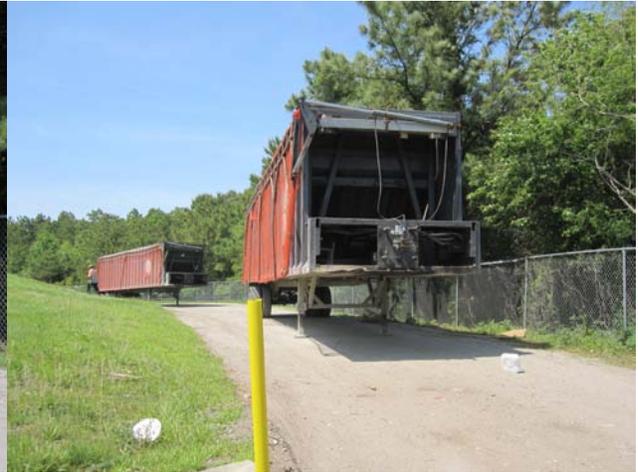
Trailers staged for waste loading and transport

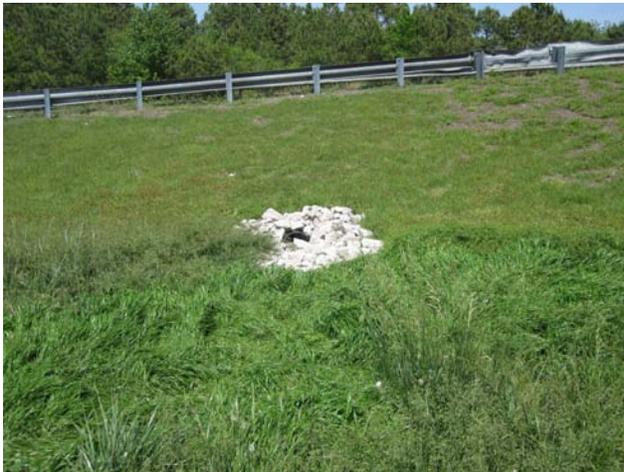
Surface waster drain repaired and stabilized with rip rap

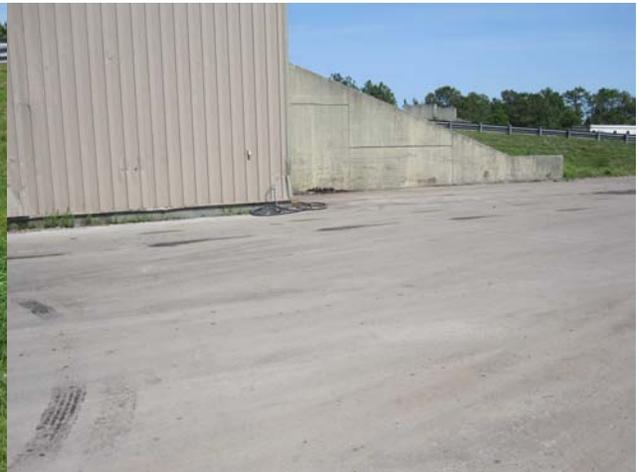
- 9) This facility had a fire occurrence in a partially loaded trailer earlier in the day. The load was smothered with soil then wet down. The trailer was then removed from the loading bay. Wetting of the load continued as the waste was unloaded from the trailer onto the paved area just outside the entrance to the loading bay. The fire was extinguished with no damage to the trailer or the facility and the waste was then reloaded for transport to the landfill.

Cleaned area used for offload and extinguishing of burning load
