**FACILITY COMPLIANCE INSPECTION REPORT**  
**Division of Waste Management**  
**Solid Waste Section**

**Date of Site Inspection:** September 29, 2011 **Date of Last Inspection:** October 29, 2008

Caswell County Municipal Solid Waste Landfill - Closed  
 162 County Landfill Road  
 Yanceyville, NC 27379

Post Closure Audit

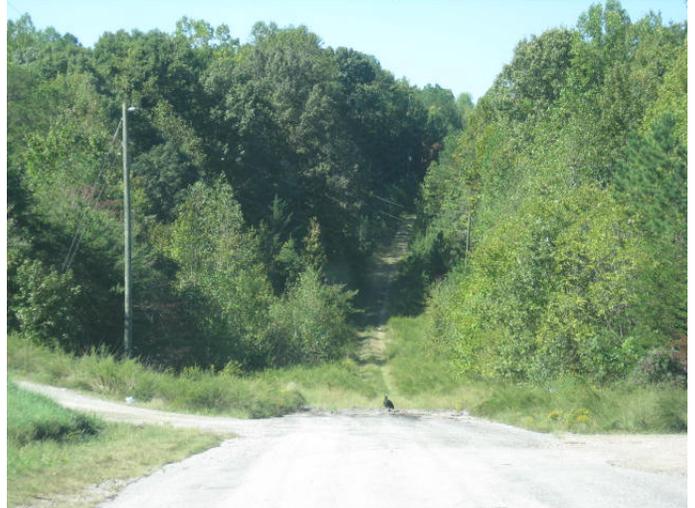
- 23. No erosion or runoff was observed.
- 24. The access road is of all-weather construction.
- 25. The facility is secured by a locked gate. A scale house operator is on site.
- 26. The facility has signage, although the closed landfill permit number should be included.

All-weather access road (leading to closed landfill area)

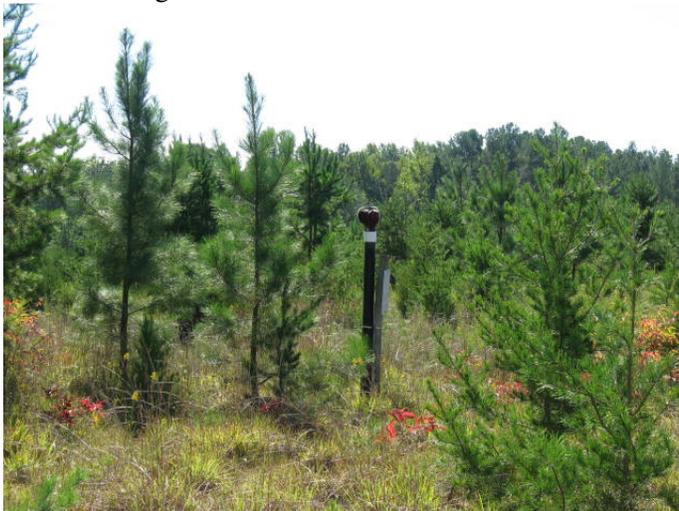
5. The landfill cap on Phase 2 is covered with native grasses and intermittent trees.
6. Ensure woody material is routinely removed from the landfill cap.

9. Methane gas vents were installed as a condition of landfill closure. Ensure that the vents are maintained and in good working order.
10. The facility shall monitor for landfill gas. Mr. Smith stated that methane monitoring will be conducted 4<sup>th</sup> quarter, 2011. Mr. Patrone asked that a copy of quarterly monitoring results be sent to the SWS – WSRO.

Woody vegetation atop Phase 2 (right side)  
and methane gas vent

7. Mr. Smith stated that the Phase 2 landfill cap will be mowed November 2011. And that the woody material atop Phase 2 will be removed by January 2012.

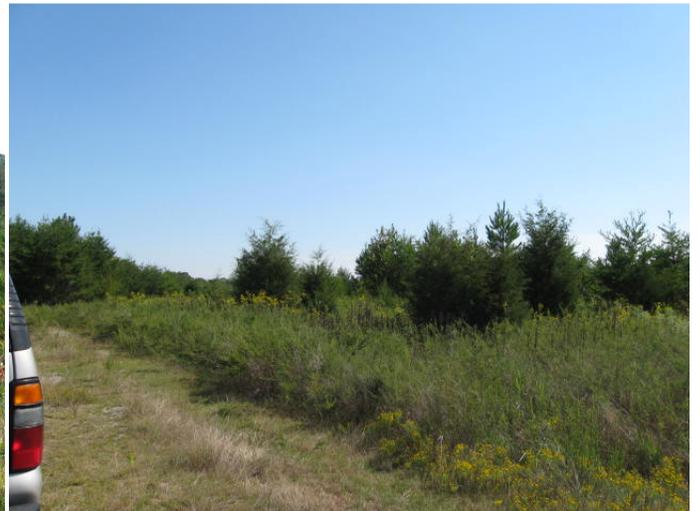
Woody vegetation atop Phase 2 (rear)

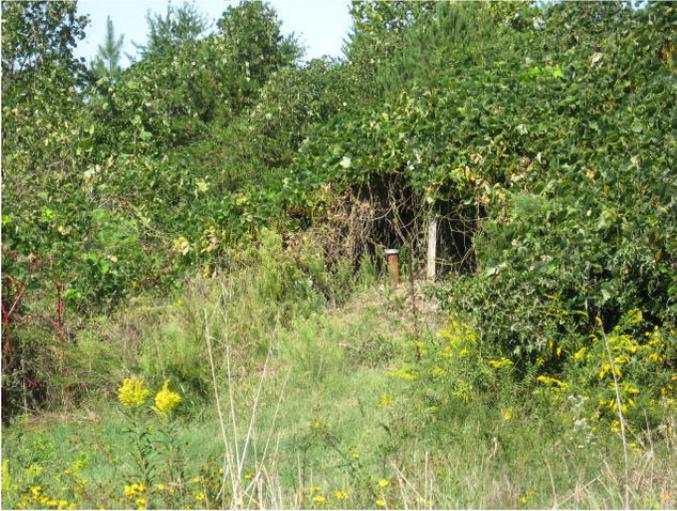
Upgradient well requiring tag and cement slab

11. Ensure that the upgradient monitoring well is properly labeled and contains a cement slab.
12. Ensure that all monitoring wells have functional locks.

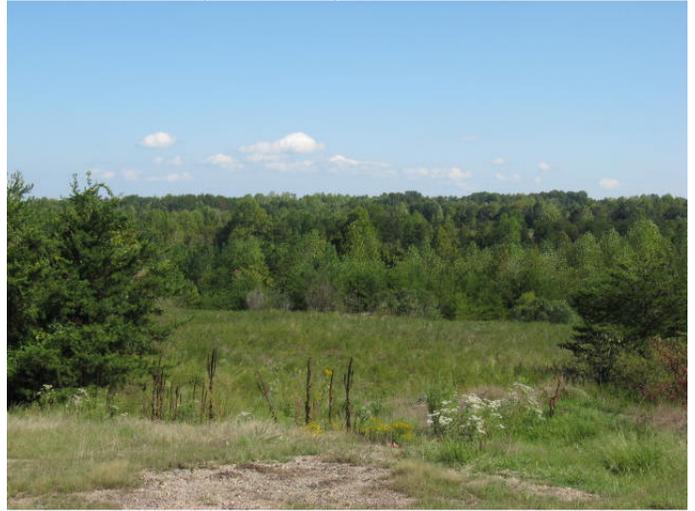
21. A temporary disaster debris staging site (TDDSS, No. DS17-001) has been approved for a tract of land adjacent to the rear of Phase 2, setback ~ 300 feet. Mr. Smith stated that the TDDSS is ~ 5 acres. And that he will ensure that ease of ingress and egress is maintained and that the area is routinely mowed. No debris was observed on the site.

TDDSS area adjacent to right rear of Phase 2

22. Ensure that the SWS is informed prior to operation of the TDDSS and that material is removed within 6 months.

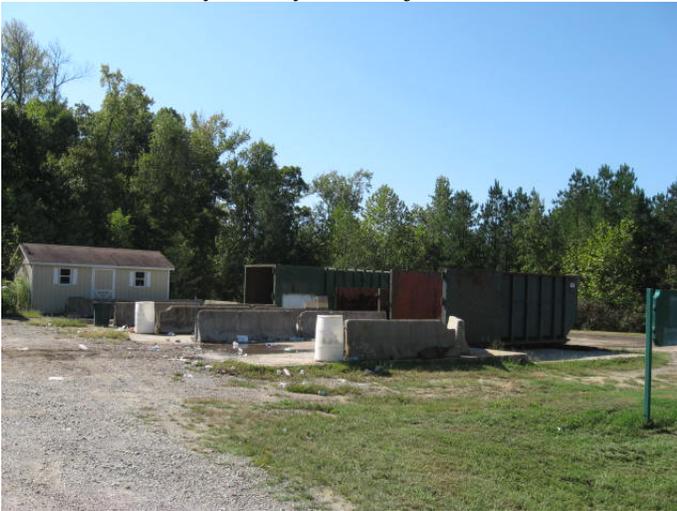
18. White goods and scrap metal are picked up by Hayes Iron and Metal Inc. in Providence.
19. A materials recovery facility (MRF)/area is located on site, prior to the landfill area, adjacent to the scale house. Convenience site containers containing recyclable material, collected throughout the county, are emptied and the material segregated into bays separated by concrete dividers. The facility collects newspaper, plastic, aluminum, and steel.

Materials recovery facility/area, adjacent to scale house

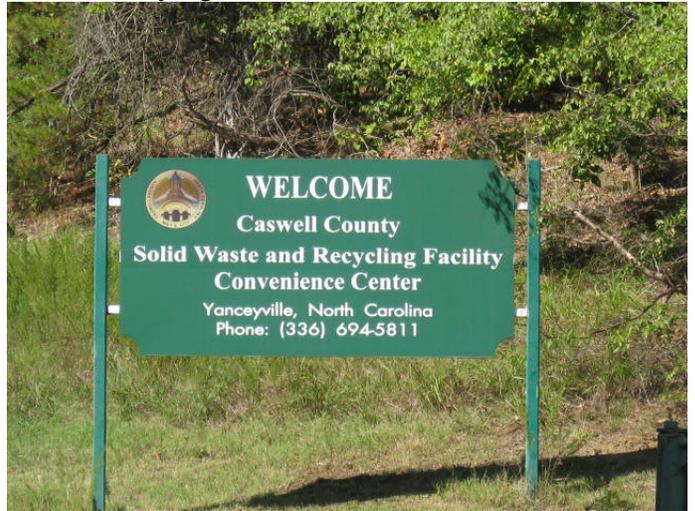
Main facility sign, at entrance
