FACILITY COMPLIANCE INSPECTION REPORT
Division of Waste Management
Solid Waste Section

Date of Site Inspection: October 11, 2011 **Date of Last Inspection:** February 28, 2011 (partial audits: 03/30/11, 06/08/11, and 07/26/11)

Waste Management of the Carolinas, Inc. – Chatham County Transfer Station
 361 Waste Treatment Plant Road
 Siler City, NC 27344

Comprehensive Audit

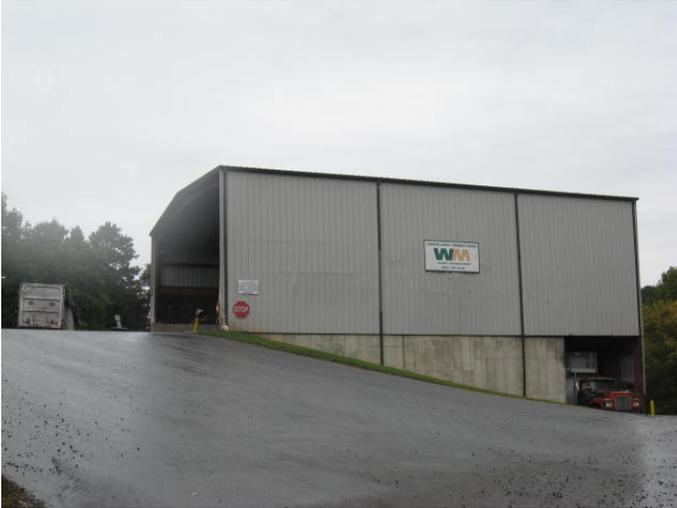
18. The transfer station (building) appeared to be in good repair.
19. There appeared to be no build-up of residue on the floor, walls, or ceiling of the transfer station. Mr. Dunn stated that the transfer station tipping floor is washed-down at the end of each workday.

Transfer station building

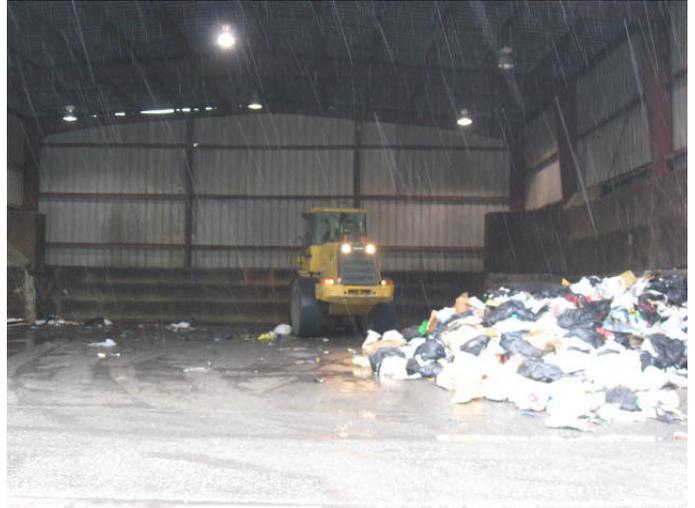
20. The leachate floor drain was functional and appeared to be free of debris buildup. Leachate is pumped to the local wastewater treatment plant (WWTP), located adjacent to the facility.

Transfer station tipping floor

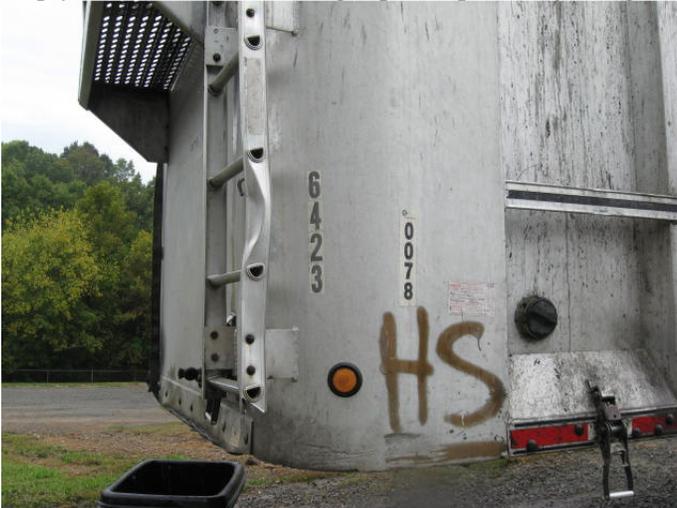
14. First Tee Transport, Inc. owns, moves, and hauls the load out trailers. Full load out trailers may be stored overnight occasionally.
15. The facility has troughs that are placed under load out trailers if the seal is leaking. During the inspection there was an empty trailer on site leaking from the right-front, possibly due to damage (trailer No. 6423/0078). A trough was in place collecting the liquid. Mr. Dunn stated that if the facility receives a transfer trailer that leaks, it is required to be repaired prior to being brought back on site.

Empty transfer trailer, leaking liquid captured by trough

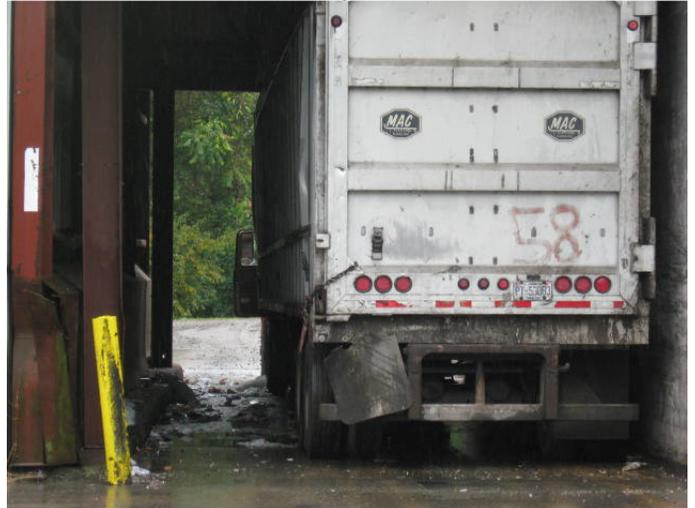
21. No windblown material was observed. Mr. Dunn stated that MSW that accumulates in the load out area is removed at the end of each workday.
22. The facility has fire extinguishers and a water hose (used to wash-down the tipping floor) available for fire suppression. In case of emergency, the facility will contact the local fire department.

Transfer station load out bay.
