FACILITY COMPLIANCE AUDIT REPORT

Division of Waste Management Solid Waste Section

Cherokee County Landfill
 10160 US 19/74/129
 Marble, NC 28905

Partial audit of MSW Landfill

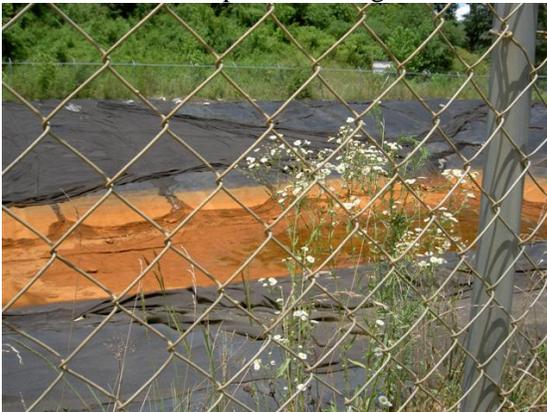
1. All photographs were taken by Troy Harrison on July 27, 2010.
2. This facility is a MSW landfill. The service area is Cherokee, Clay, Graham and Swain Counties.
3. The sky was lightly scattered and very hot at the time of audit.
4. The leachate pond was observed. There was a small amount of leachate in the basin. Leachate is pumped to the basin and then to a wastewater treatment plant. The leachate collection lines were maintained and scheduled to be inspected in August.

Leachate collection pond

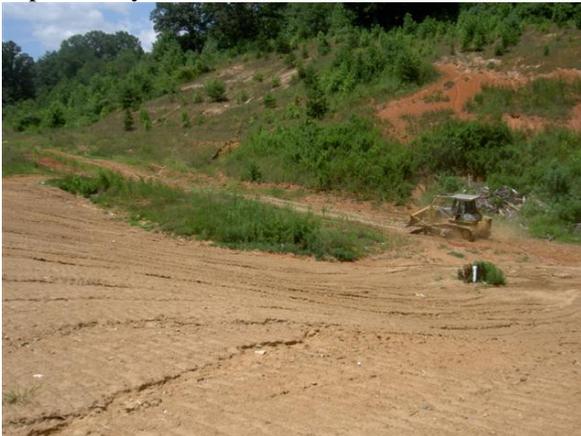
5. The cap of the landfill was observed. Portions of the landfill with intermediate cover have been seeded and have an established stand of grass while other portions have been graded and was waiting hydro-seeding. No standing water was observed on the landfill. The top of the landfill was graded to minimize low spots. There was one section where there was erosion from recent heavy storms. The erosion did not appear to have exposed any waste.

North slope of landfill showing moderate erosion

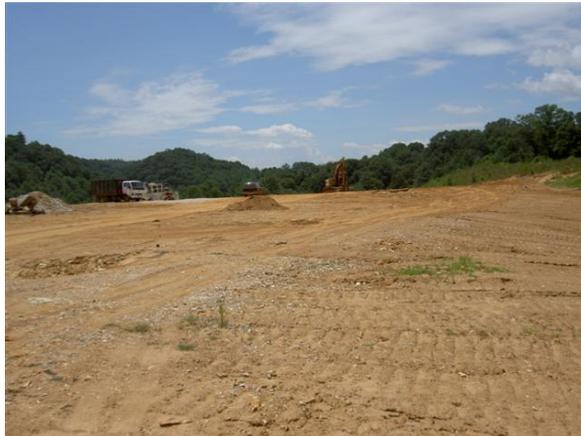
Top of landfill looking west showing grading work

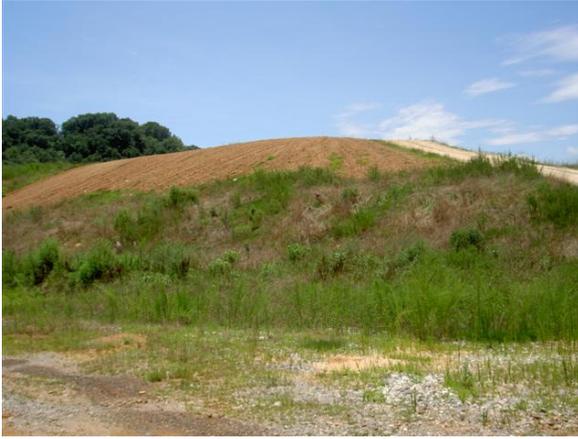
NW corner of landfill, entrance road is on the right.

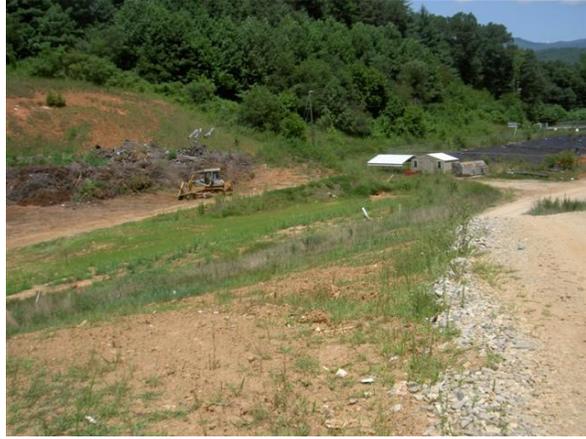
NW corner of landfill from top looking at sedimentation basin.

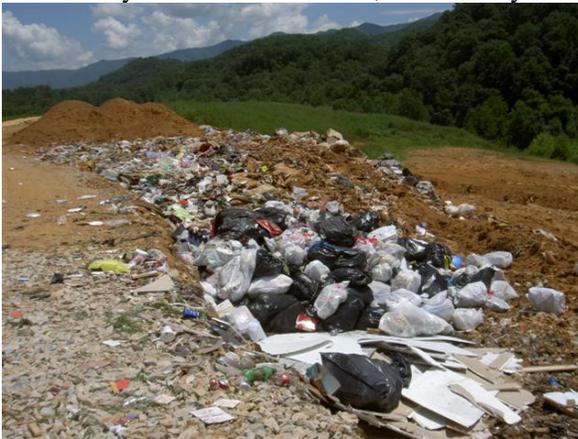
6. The working face was kept to a minimum footprint. Extra soil was placed at the edge of the working face for use as daily cover or fire control, if necessary.

Close-up view of working face

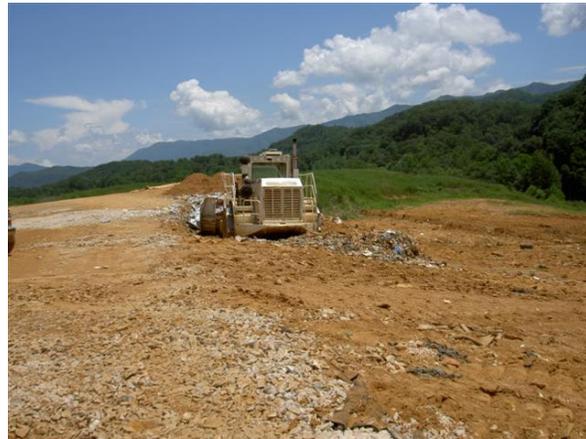
Working face and compactor

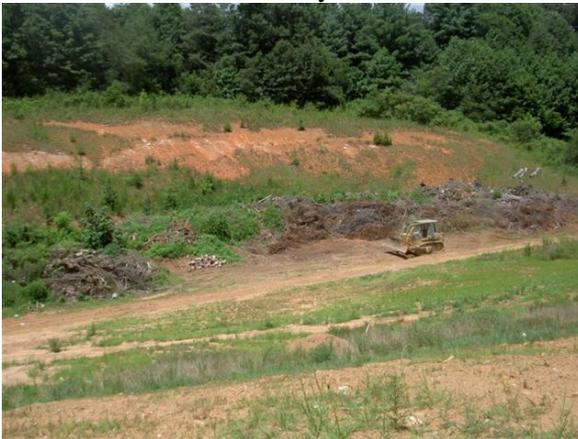
7. The entrance road was constructed with gravel placed on top of a fabric to make moving the road easier when necessary. The road was in good condition and appeared sufficient for all-weather use.
8. The Land Clearing & Inert Debris (LCID) Treatment & Processing (T & P) area was observed. Grinding has not occurred for over three years.

LCID T & P area

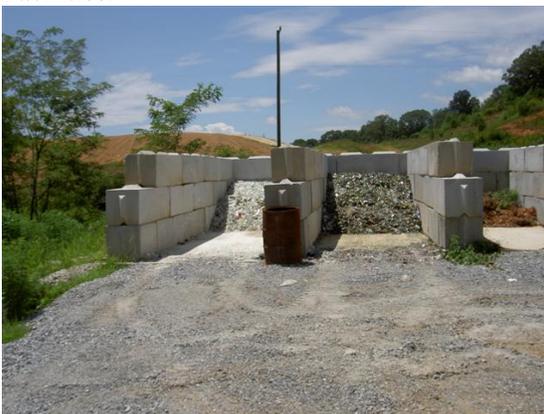
12. The battery collection area is located on a pallet. All batteries were observed upright.
13. The waste oil collection area is located within the recycling building on concrete. The used oil is removed by Holston Services, Inc.
14. The county recycles cardboard, newspaper, aluminum, and plastic. These are bailed and sold.
15. There is an area where doors, furniture or anything that can be reused are placed. This is a swap shop that is available to the general public.
16. A new area has been set up to receive glass and yard waste. If the yard waste is distributed to the public, then Cherokee County will be required to follow 15A NCAC 13B Section .1400 rules for Solid Waste Compost Facilities.

Glass and Yard Waste

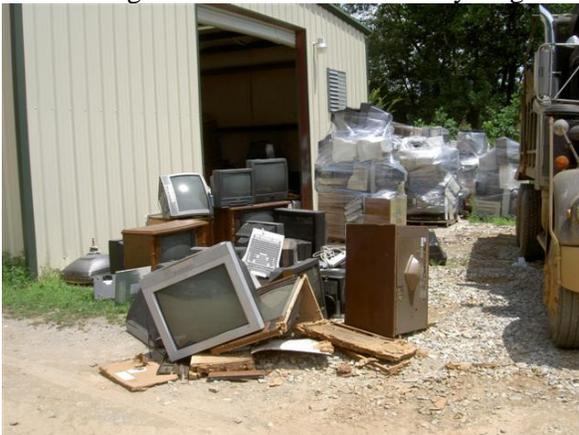
17. Electronic goods were collected for recycling along with pallets.

Electronic Goods

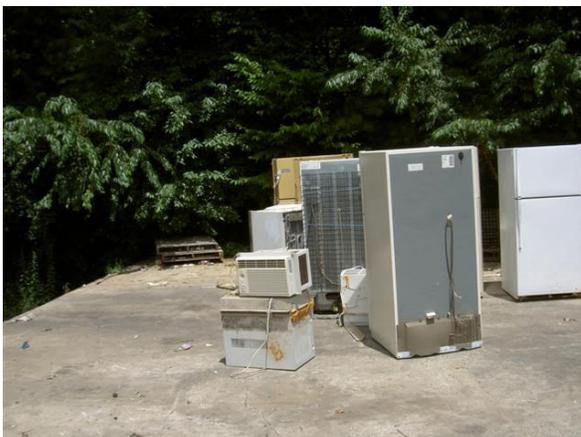
18. The metal area was observed. White goods were collected at a separate area where the Freon is removed them moved to the metal area.

White Goods Area

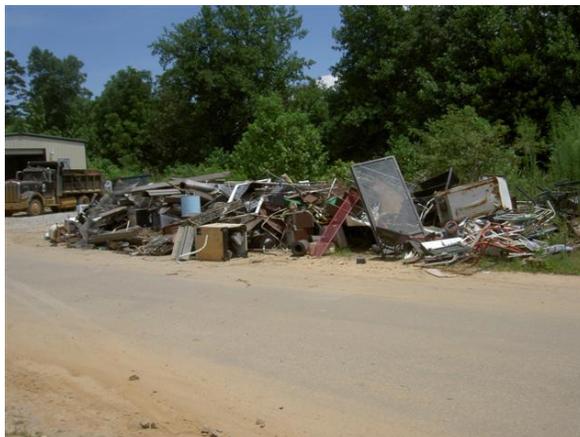
Metal Area
