# FACILITY COMPLIANCE AUDIT REPORT

## Division of Waste Management Solid Waste Section

**Date of Audit:** April 26, 2011**Date of Last Audit:** December 3, 2010**FACILITY NAME AND ADDRESS:**

Cherokee County Landfill  
 10160 US 19/74/129  
 Marble, NC 28905

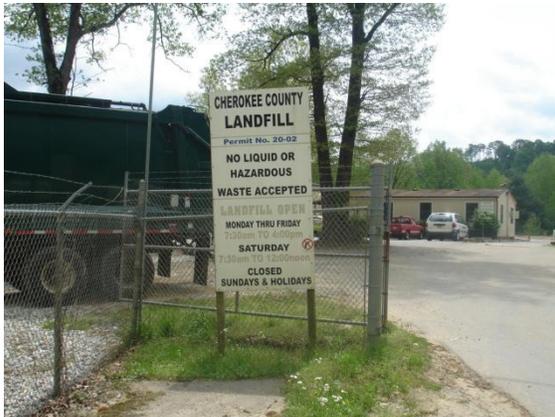
11. All public roads were well maintained. A sign was placed at the entrance to the facility which stated the hours/days of operation, "No liquid or hazardous waste" and the Solid Waste Permit Number.

Entrance Sign

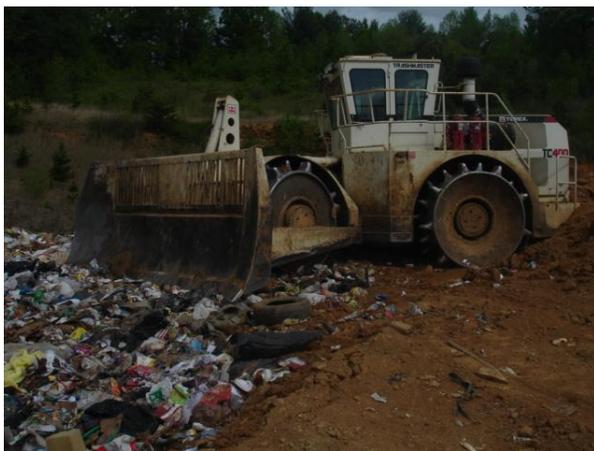
14. The landfill is currently in Phase 2. The facility is also approved for a Phase 3 vertical expansion. A quarterly fill plan was submitted on March 30, 2011, as required by the August 8, 2008 settlement agreement.
15. The working face was observed. Tires were being removed as needed by the compactor operator. A complaint was received about the landfill not covering the waste at the end of the day. Mr. Clark stated that he makes sure that all of the garbage is covered with either dirt or a tarp, as required. A pile of dirt was being kept near the working face in the event of a fire.

Compactor at working Face

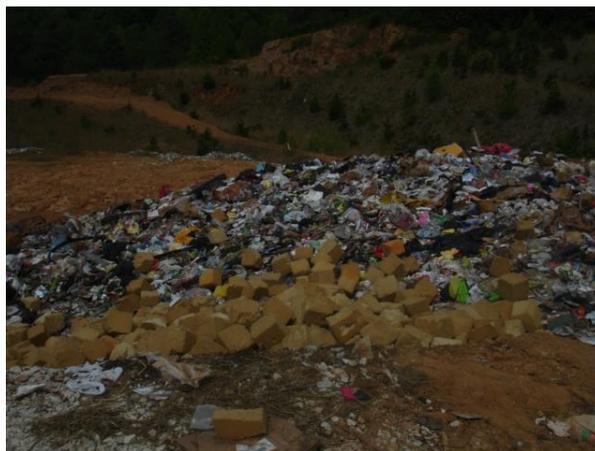
Working Face

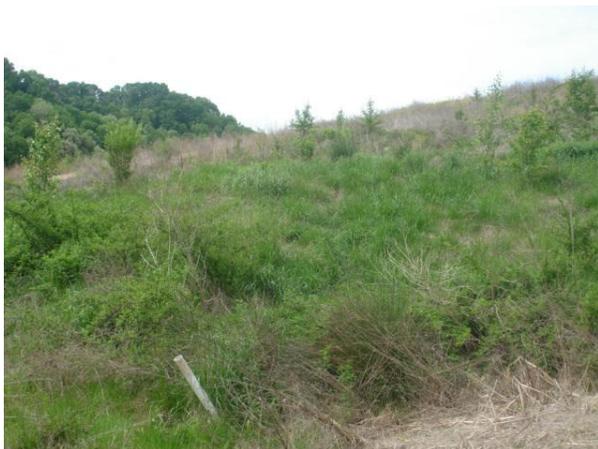
18. No ponding of water on the surface of the landfill was observed.
19. **Phase 1 of the landfill appears to have not been mowed for some time. In addition, woody vegetation saplings were observed growing on this section of the landfill. In order to maintain the cover, this area must be mowed and the woody vegetation removed.**

Close-up of Phase 1

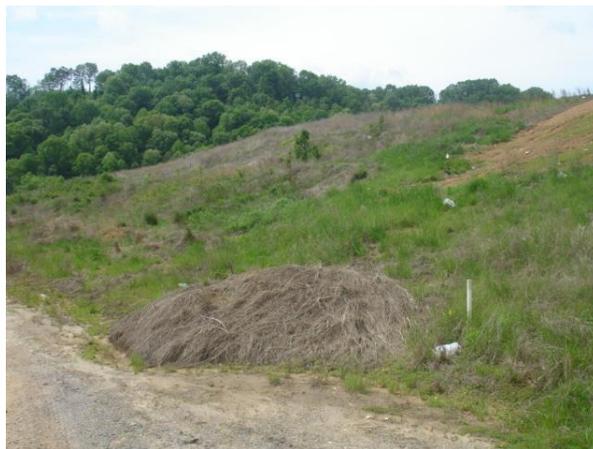
Phase 1

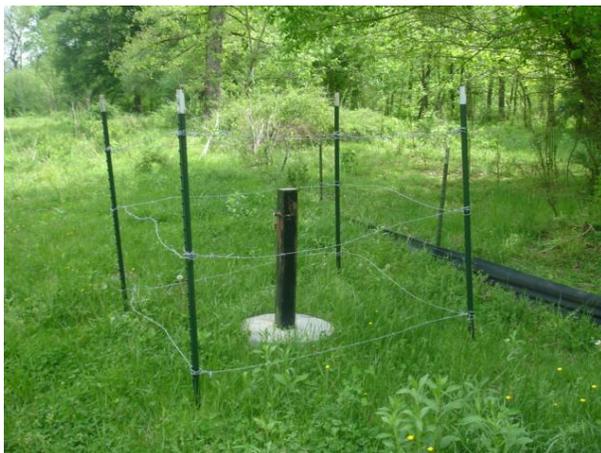
20. Methane and Groundwater wells were observed in good condition, with the exception of a missing cap on one. The wells located in the pasture area on the southern edge of the landfill had barbed wire around them to prevent damage from cattle. **The methane wells did not have any protection.** The grazing of cattle is an approved activity based on document No. 12192. **As a reminder, the wells must be labeled and access maintained.**

Groundwater Monitoring Well

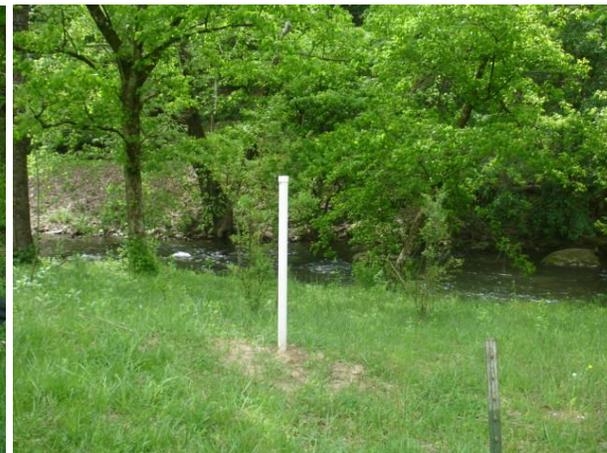
Methane Monitoring Well

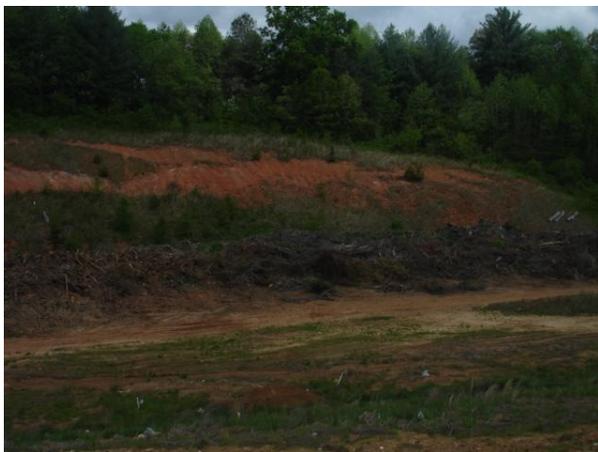
22. The facility has a wood grinding T&P area. No banned items were observed. The area consisted only of un-ground material.

Treatment & Processing Area

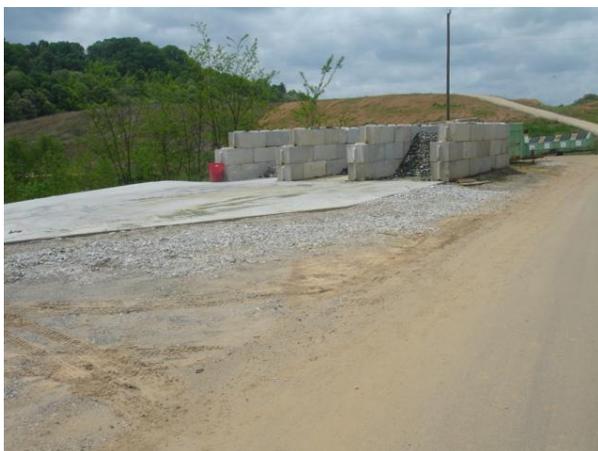
- 23. There were two tire trailers on site, one was full. No tires were observed outside of the trailers.
- 24. A new glass collection area was observed. Glass is separated into clear, brown and green and surrounded by concrete bunkers. The area was on a new concrete pad.

New Glass Recycling Area

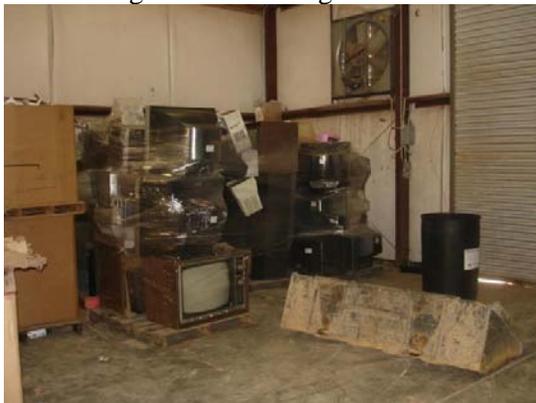
- 25. No gasoline or pressurized tanks were observed in the metal recycling area.
- 26. There was a very small yard waste collection area. Conditions for operating this area are contained in the permit and must be followed.
- 27. Electronic goods were being collected. An outside contractor picks up the material for recycling.

Electronic Waste Collection Area

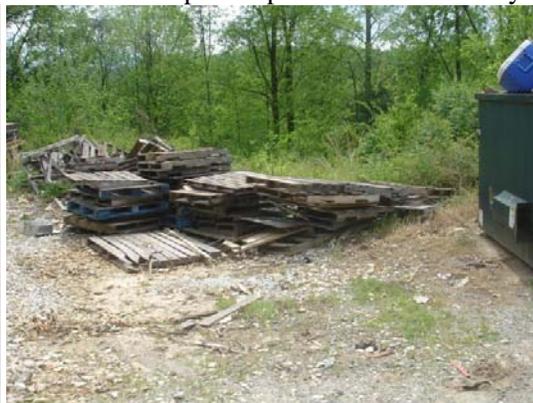
Used Pallets

- 28. Used pallets were being collected. There were being used for shipping of electronic goods.
- 29. The used oil collection area is located in a building with a concrete floor. The area was well maintained. An outside contractor picks up the used oil for recycling.
- 30. The white goods area was observed. All items were stored in an upright position. Freon is removed by an outside contractor, marked and then moved to the metal pile.

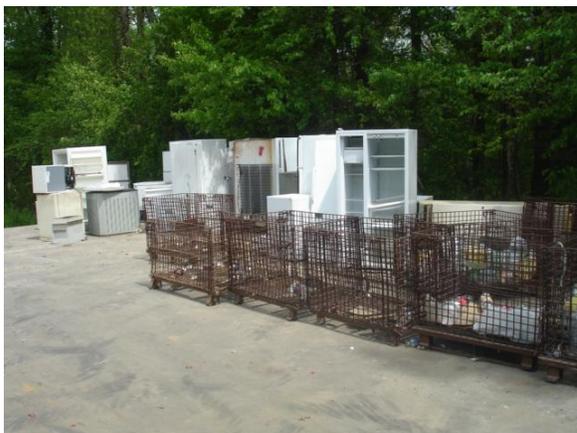
White Goods
