**FACILITY COMPLIANCE AUDIT REPORT**  
**Division of Waste Management**  
**Solid Waste Section**

**Date of Audit:** 22 March 2010

Town of Edenton Transfer Station  
 118 West Hicks Street  
 Edenton, NC 27932

Follow-up Audit

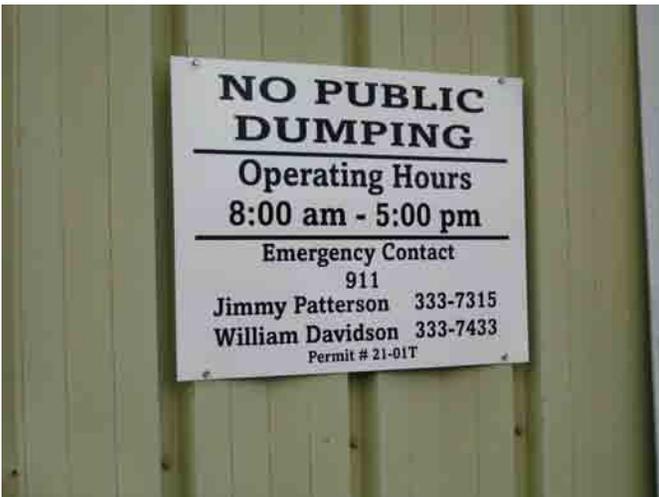
11. Signage has been installed, as required.
12. The area around the facility is stable and no soil erosion was noted.

Signage installed.

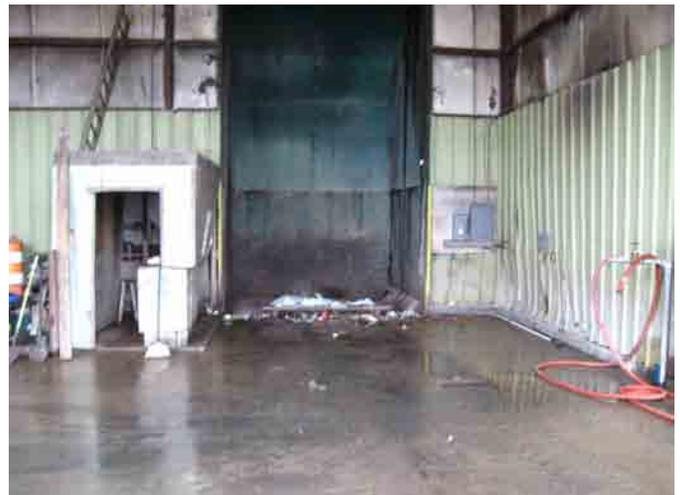
3. The service area for this facility is the Town of Edenton.
4. The tipping floor and transfer trailer loading area are cleaned daily per facility staff.

Tipping floor.

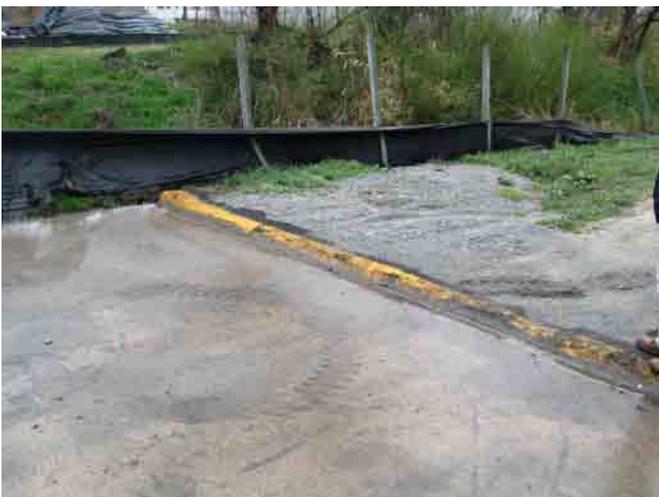
5. There was no wind blown litter. This facility utilizes a compactor that loads into the transfer truck.
6. Curbing has been installed to contain leachate and direct it into the Town's wastewater collection system.

Curbing installed to contain leachate/wash water.

The August 2009 leachate release (15A NCAC 13B .0402(3)) has been RESOLVED.

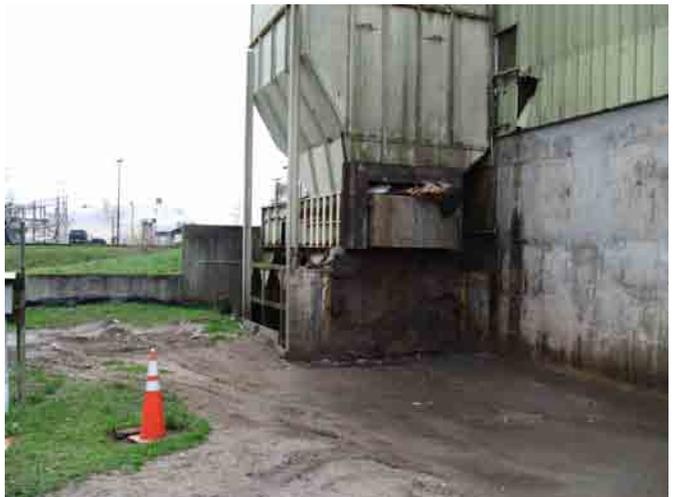
Compactor and sewer drain/pump; area is clean.
