**FACILITY COMPLIANCE AUDIT REPORT**  
**Division of Waste Management**  
**Solid Waste Section**

Date of Audit: September 25, 2009

Columbus County Closed MSWLF  
 Landfill Road  
 Whiteville, North Carolina 28472

NOV follow-up; Partial Audit

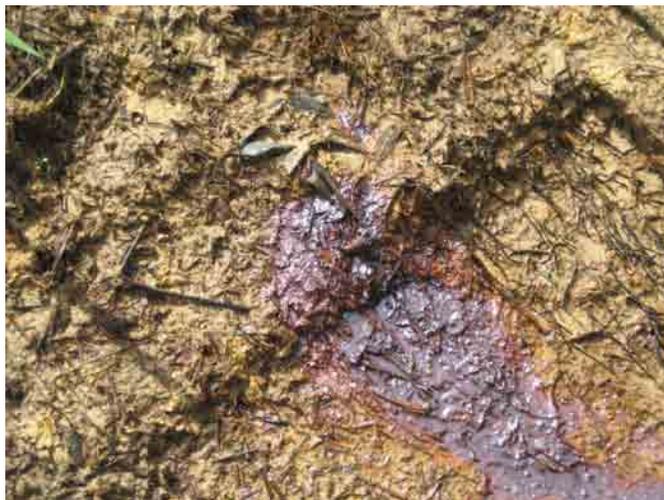
**1. NCAC 13B .1626 (8) (d) states** “Leachate shall be contained on site or properly treated prior to discharge. An NPDES permit may be required prior to the discharge of leachate to surface waters.” Leachate was exiting the cap where black plastic waste was protruding. It was flowing forty feet along the perimeter road to a culvert under the road. **Within ten (10) days of receipt of this audit, corrective measures must be in place to eliminate leachate drainage.**

3. The erosion and exposed waste on the northwest slope, as listed in the previous Notice, has been corrected; however, more erosion and subsequent exposed waste has occurred. Leachate was observed flowing from the toe of the northwest slope where waste was exposed, adjacent to the perimeter road. The leachate flowed forty feet along the edge of the road and entered a culvert. This area was Cell One and is near a monitoring well. Upon completion of the inspection, Vanessa Cartrett was notified. Ms. Cartrett called Kip McClary to address the issue. Per discussion 9/28/09, Mr. McClary had County staff block outlets with soil to prevent further flow offsite. The break-out shall be corrected and capped.

Leachate origination from waste through cap.

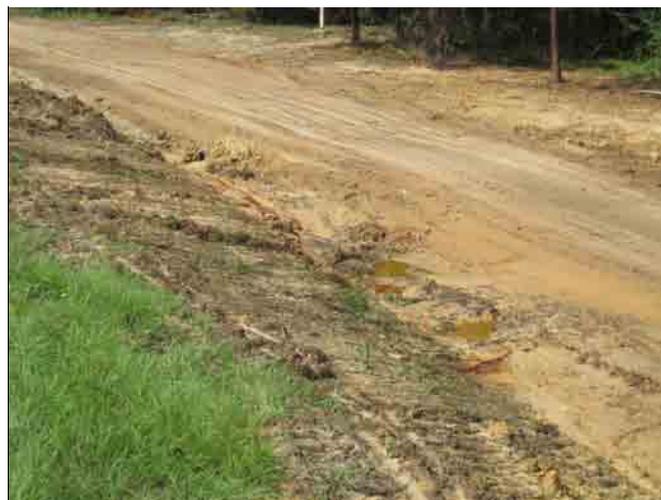
Leachate flowing forty feet to culvert.

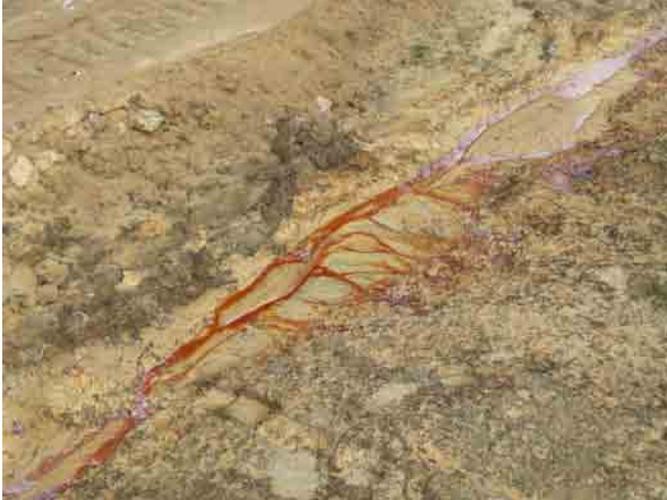
Leachate release along perimeter road near culvert.

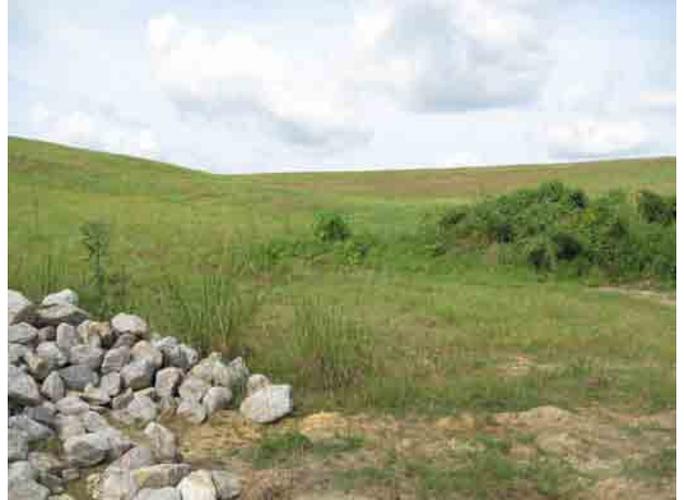
2. The erosion on the east side of the landfill noted in the previous report has been corrected. The rip-rap and silt fences have been removed and that area backfilled and vegetated.

Area with prior erosion has been corrected.

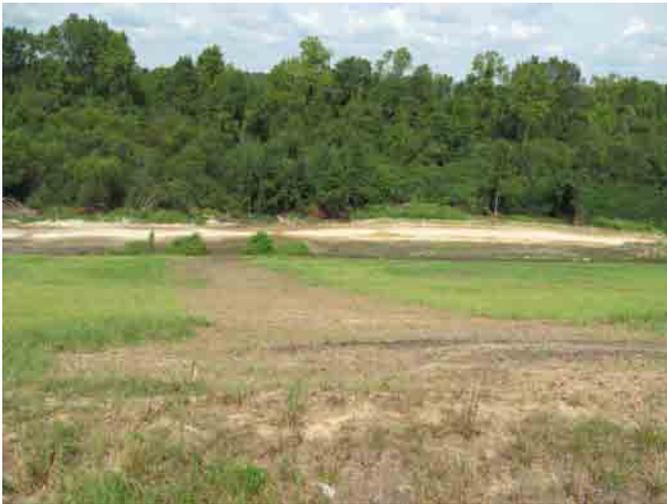
4. Seeding has occurred on the large bare areas of the southern slope and is ongoing.
5. The drain pipe on the northwest slope that was exposed and separated has been covered and vegetated.

Previously exposed/separated drains have been fixed.

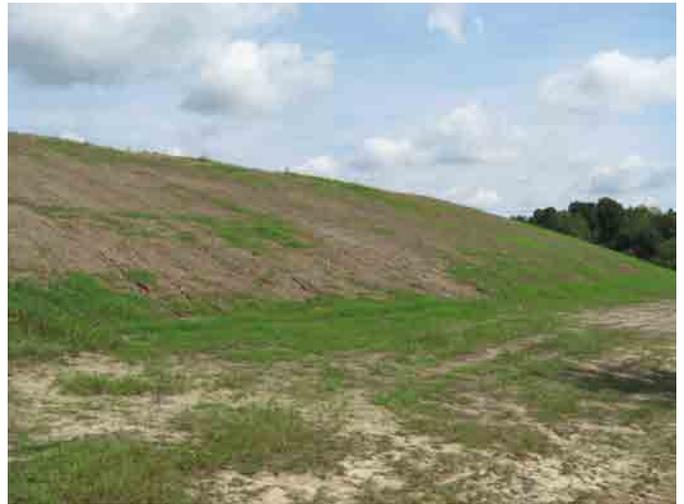
Bare south slope has been seeded.

6. All bare areas appear to have been seeded. These areas should be monitored and reseeded should germination not occur or erosion removes seed or topsoil.
