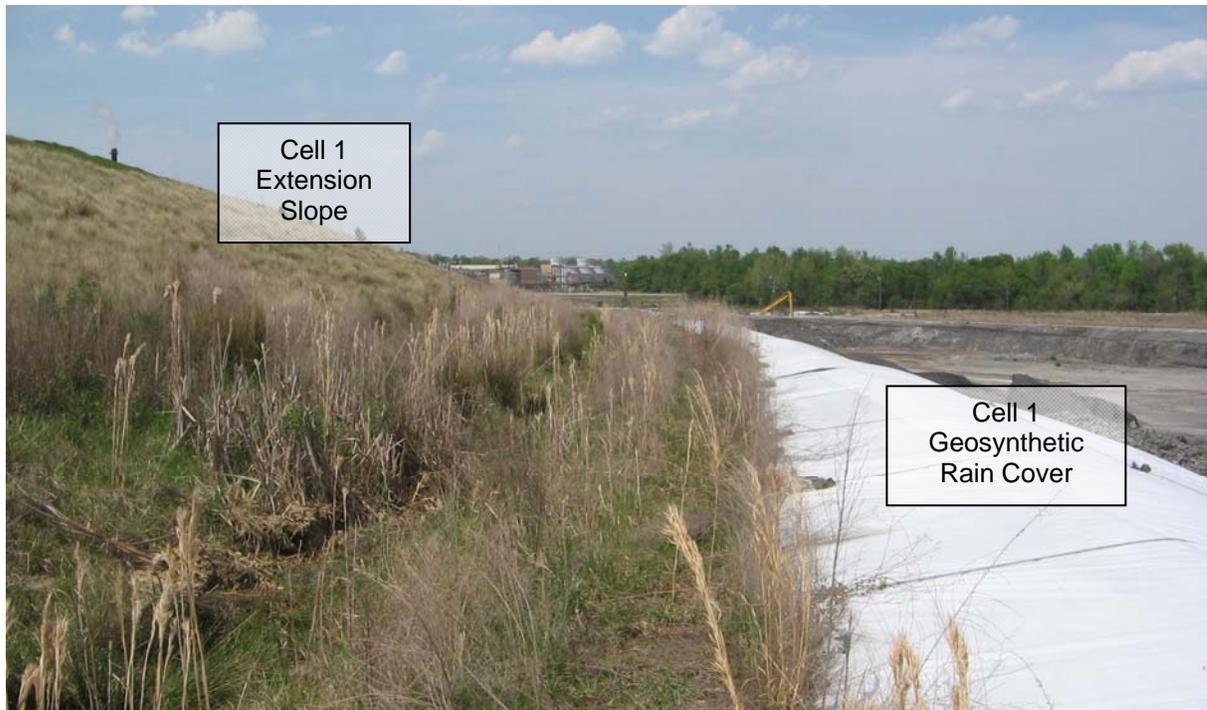
Photo 1. Vegetated slope of the Cell 1 Extension area (perimeter berm of the unlined landfill). The rain cover from Cell 1 is buried in the protective cover of Cell 1 (approximately 4/3/2007).

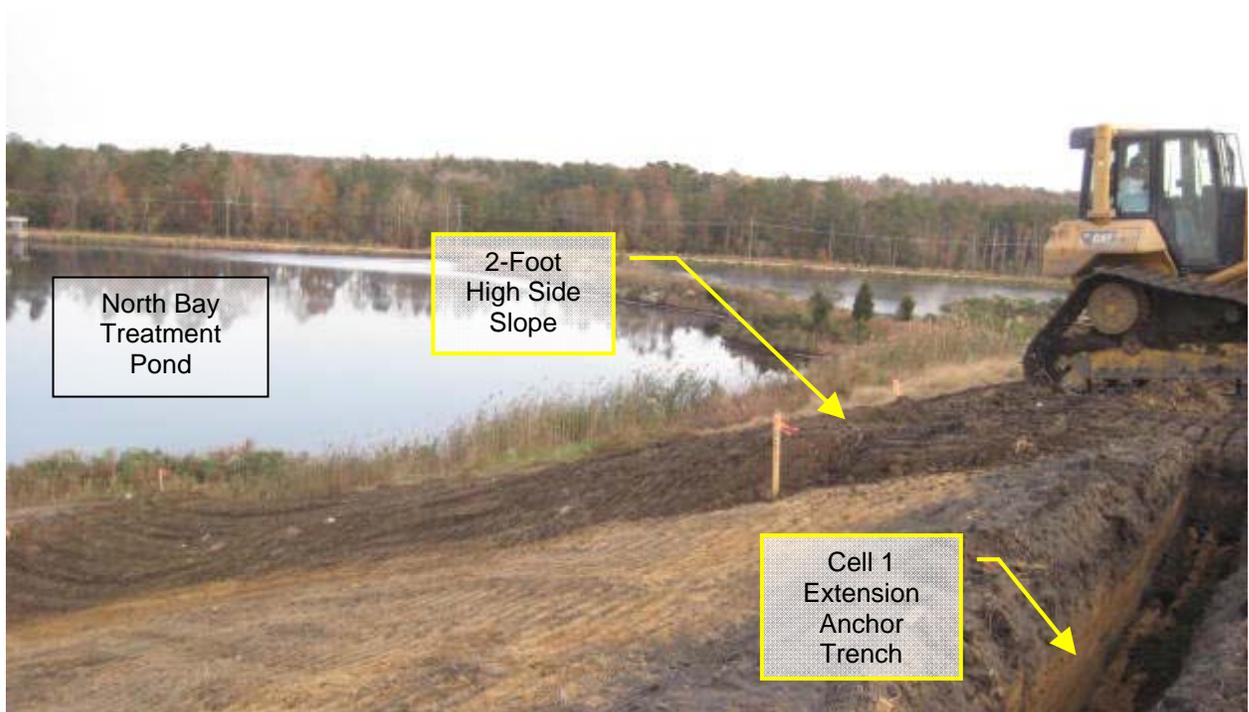
Photo 2. Anchor trench at the southeast end of the Cell 1 Extension during construction of the 2-foot high containment berm (12/1/2008).

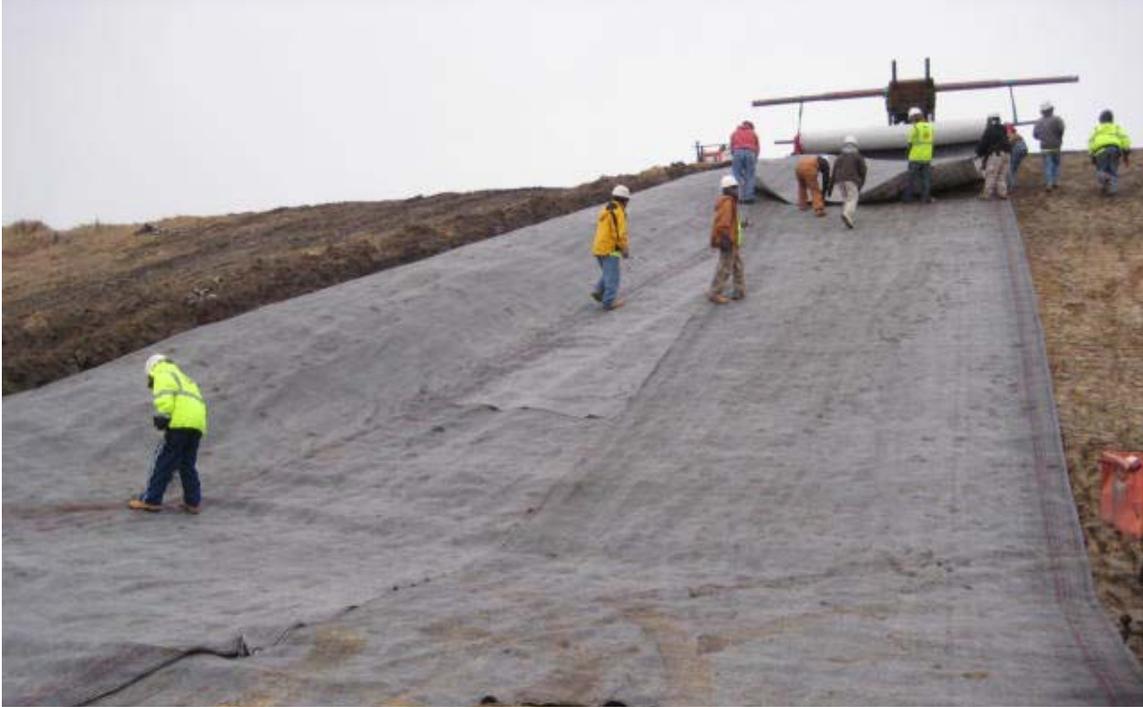
Photo 3. Deploying the GCL on the Cell 1 Extension (12/1/2008).

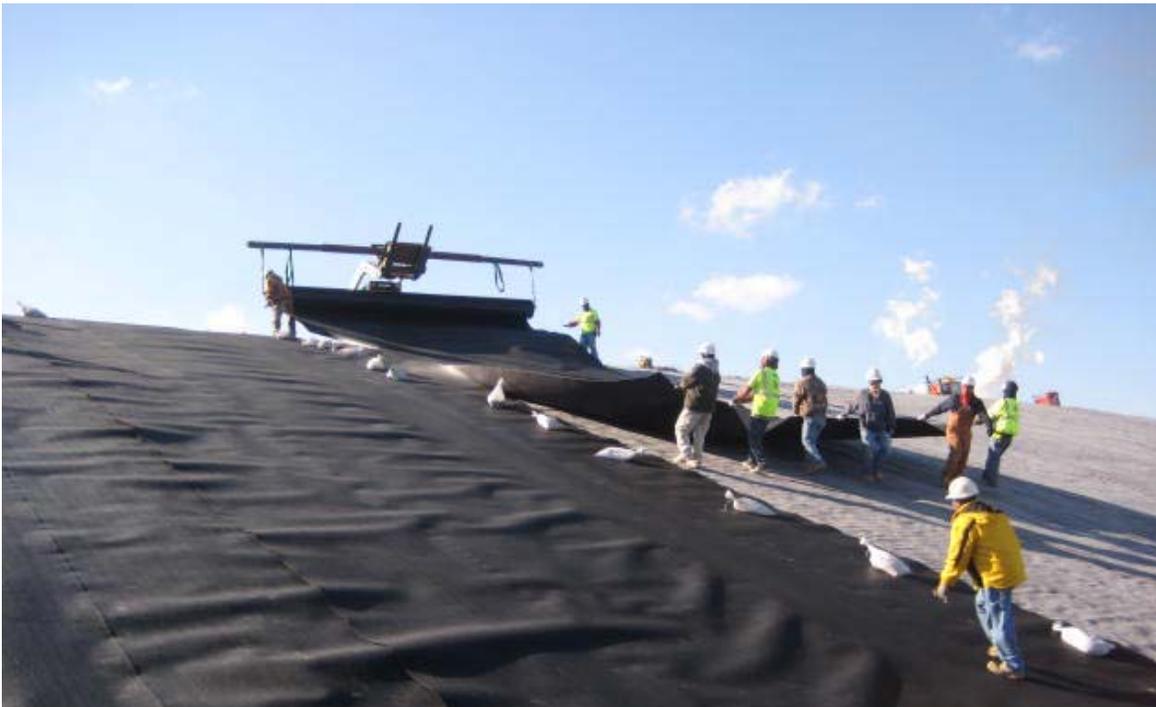
Photo 4. Deploying the 60-mil textured HDPE geomembrane over the GCL (12/1/2008). Each day, all GCL deployed was covered with geomembrane before leaving the site.

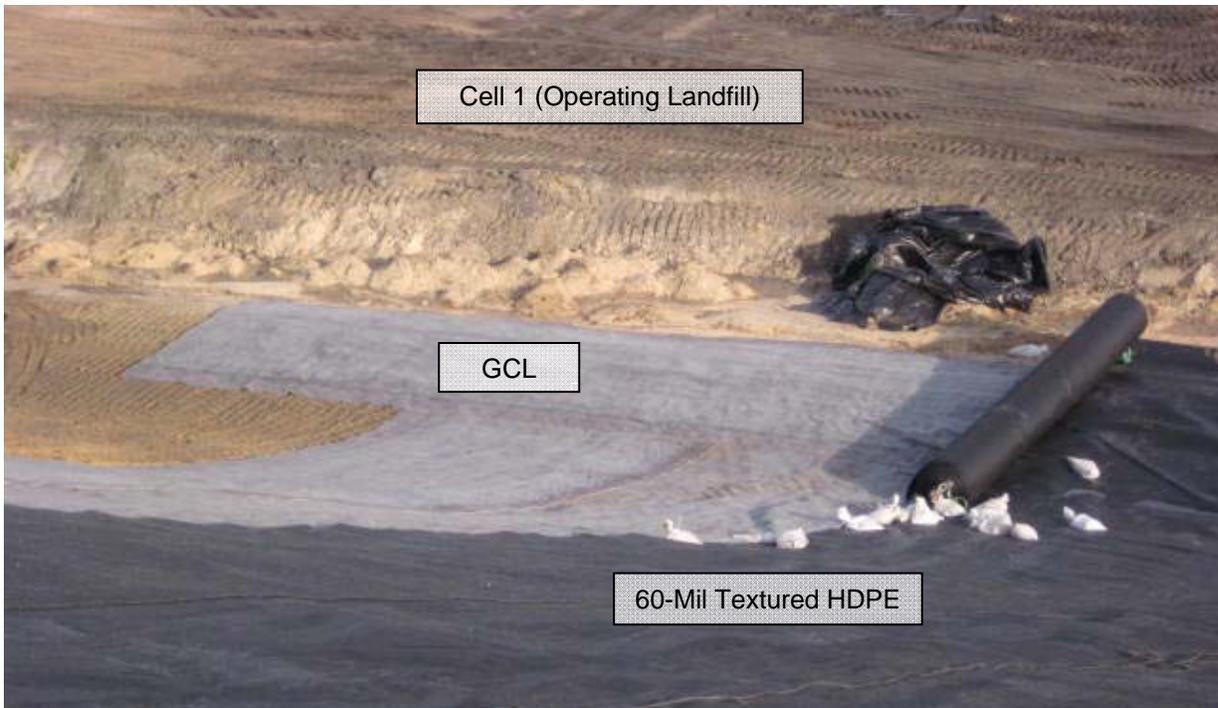
Photo 5. Deployed GCL and HDPE at the tie-in with Cell 1 (12/2/2008).

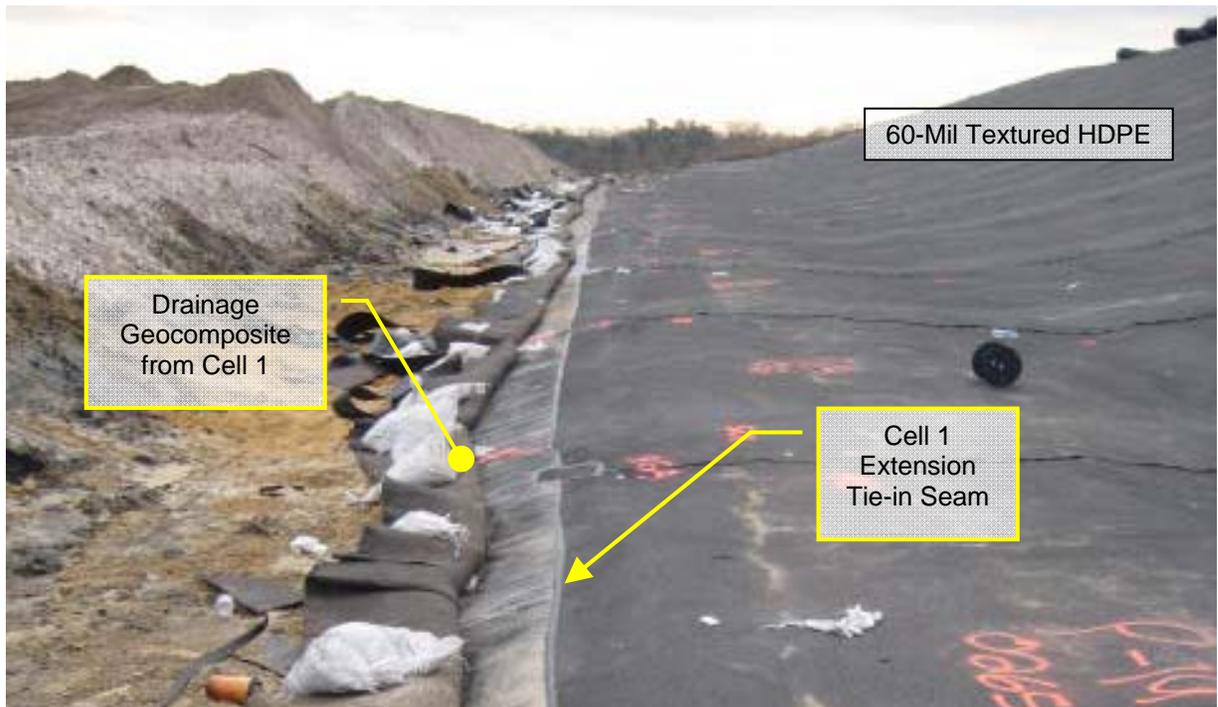
Photo 6. The extrusion welded tie-in seam with the Cell 1 primary liner (12/4/2008).

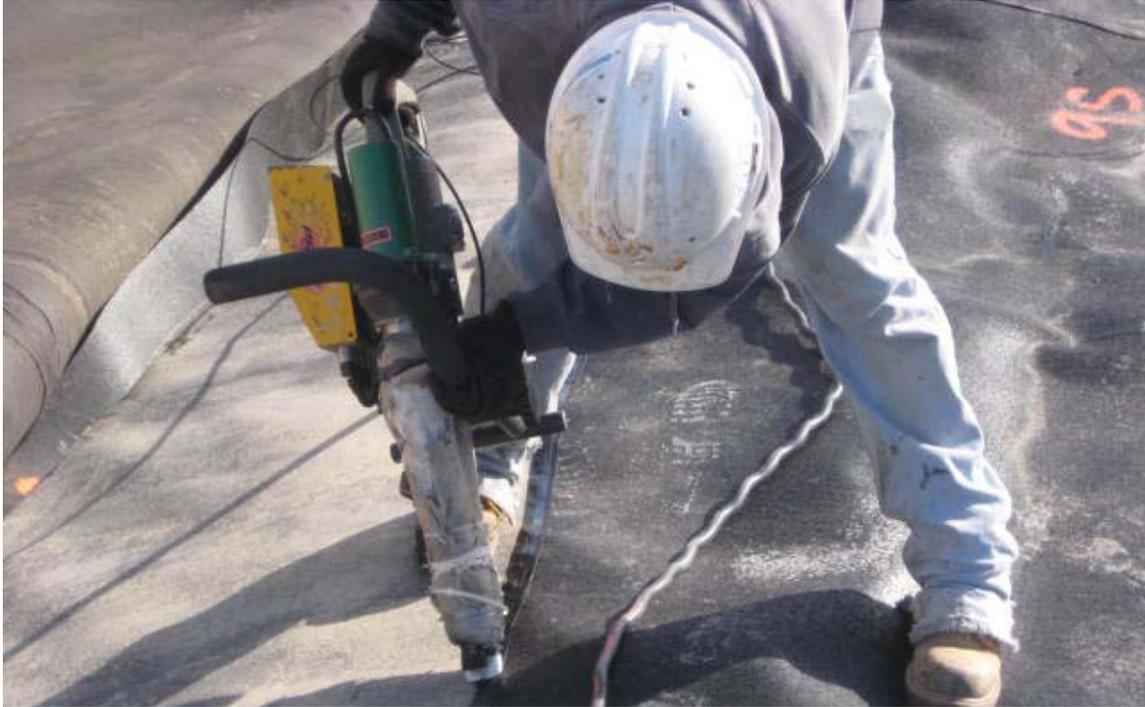
Photo 7. Extrusion welding the tie-in seam with Cell 1.

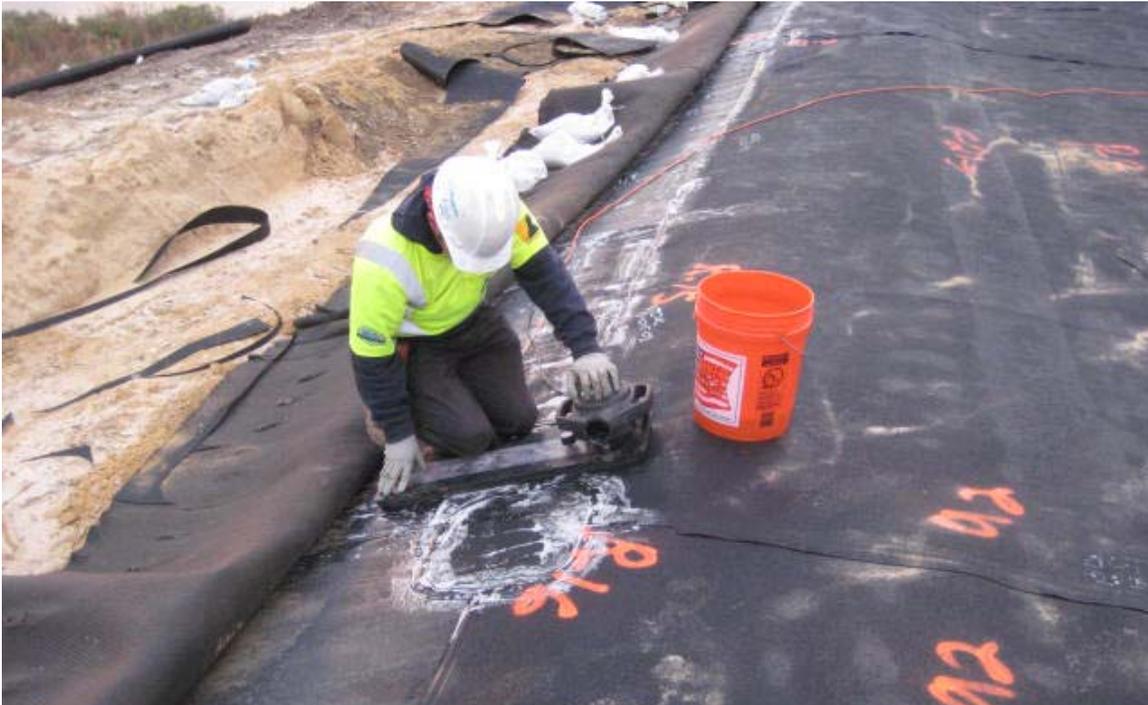
Photo 8. Vacuum box (non-destructive) testing of extrusion weld. The location is the tie-in with Cell 1, at the 3-panel intersection of P-15/P-16 and the Existing Cell 1.

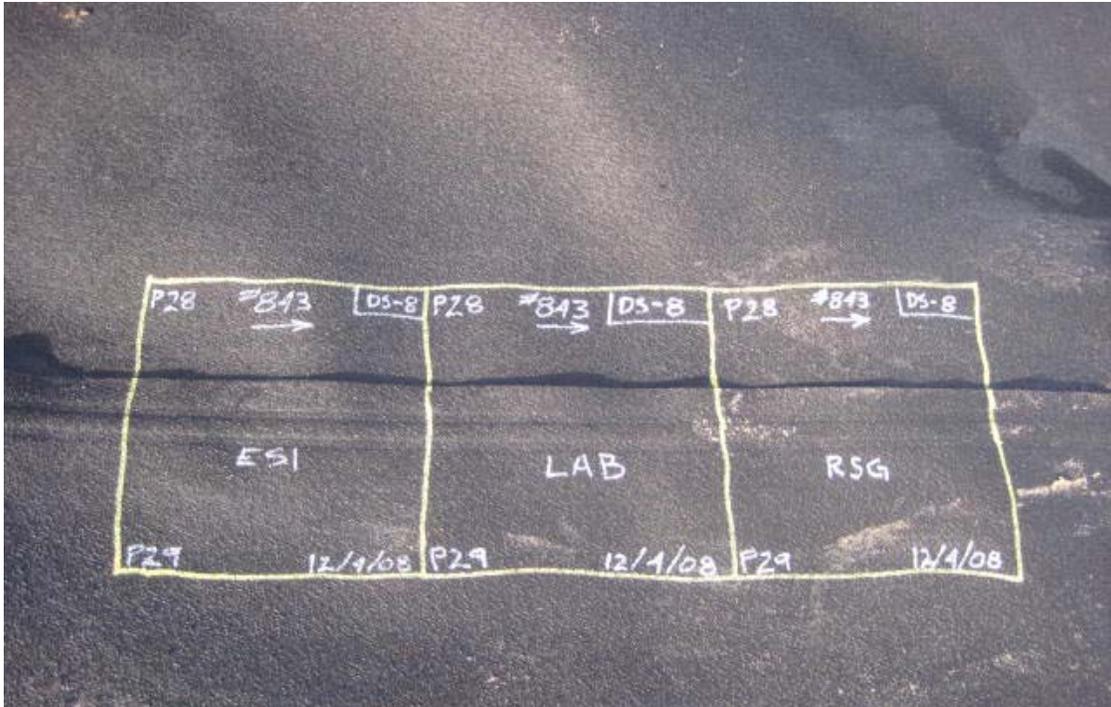
Photo 9. Layout of a typical destructive seam test location, showing samples for the installer, the laboratory and the engineer (12/3/2008).

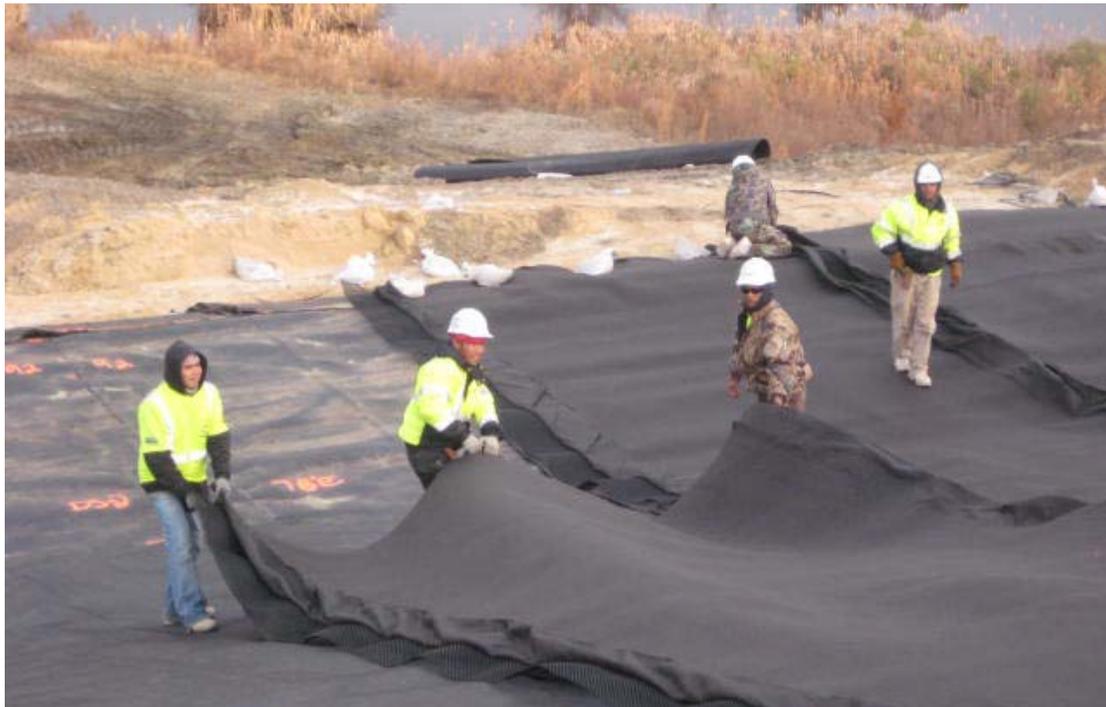
Photo 10. Deploying the drainage geocomposite (12/4/2008).

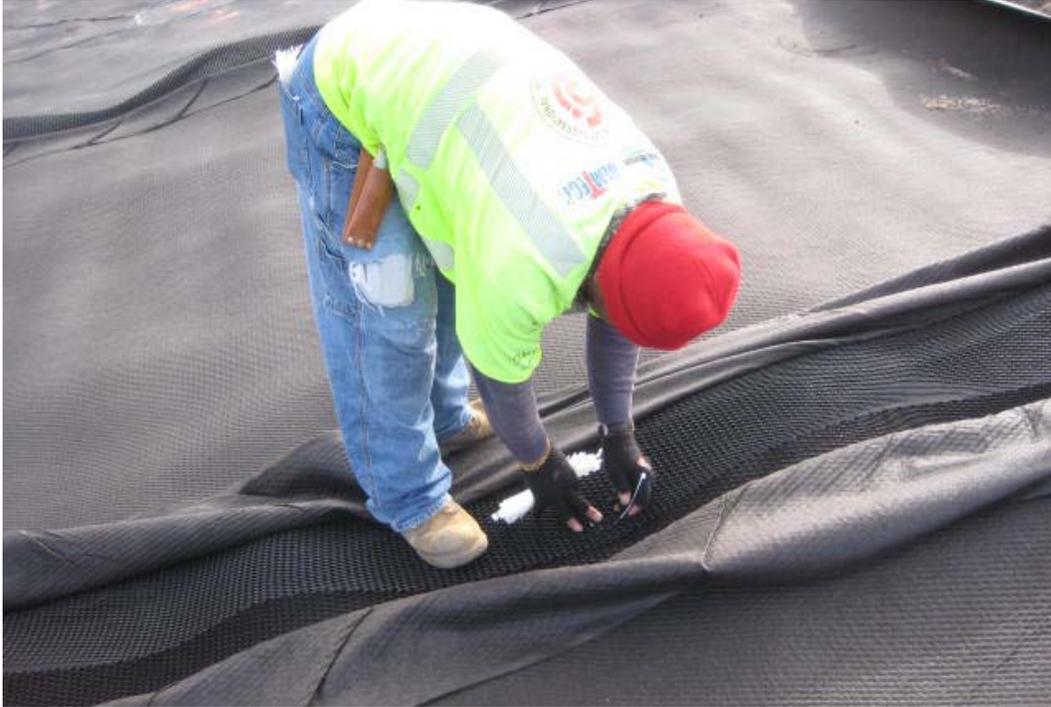
Photo 11. Nylon ties were used to fasten the core nets of adjacent drainage geocomposite panels every 5 feet along the seams (12/5/2008).

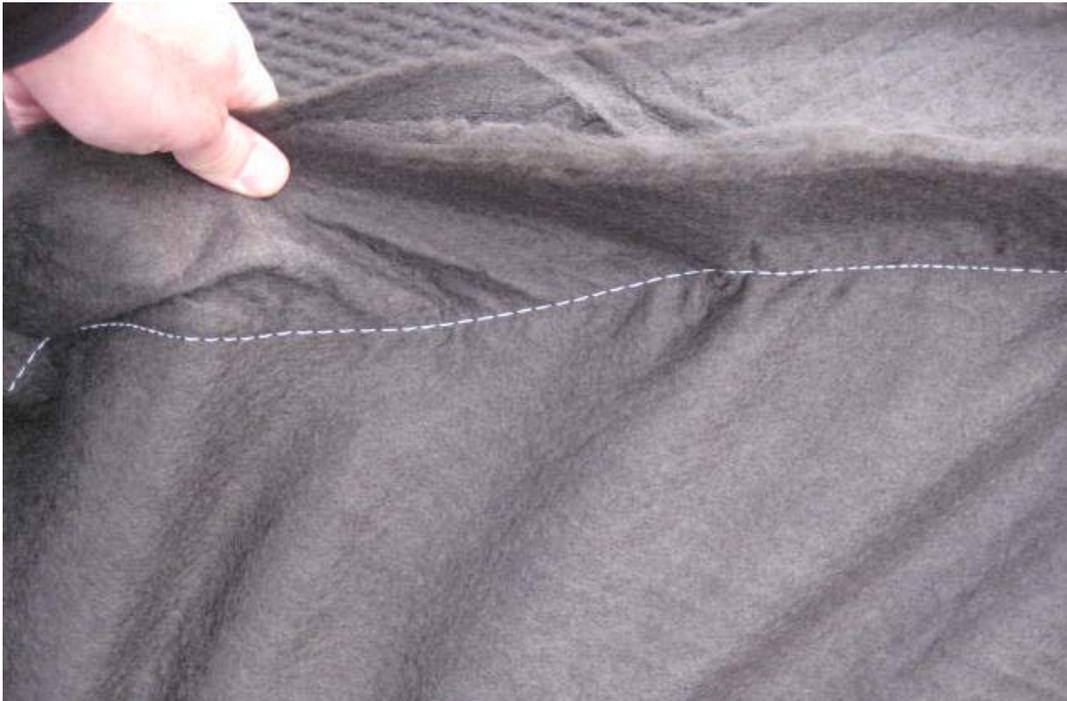
Photo 12. After the cores of the drainage were secured with nylon ties, the textiles were sewn together.

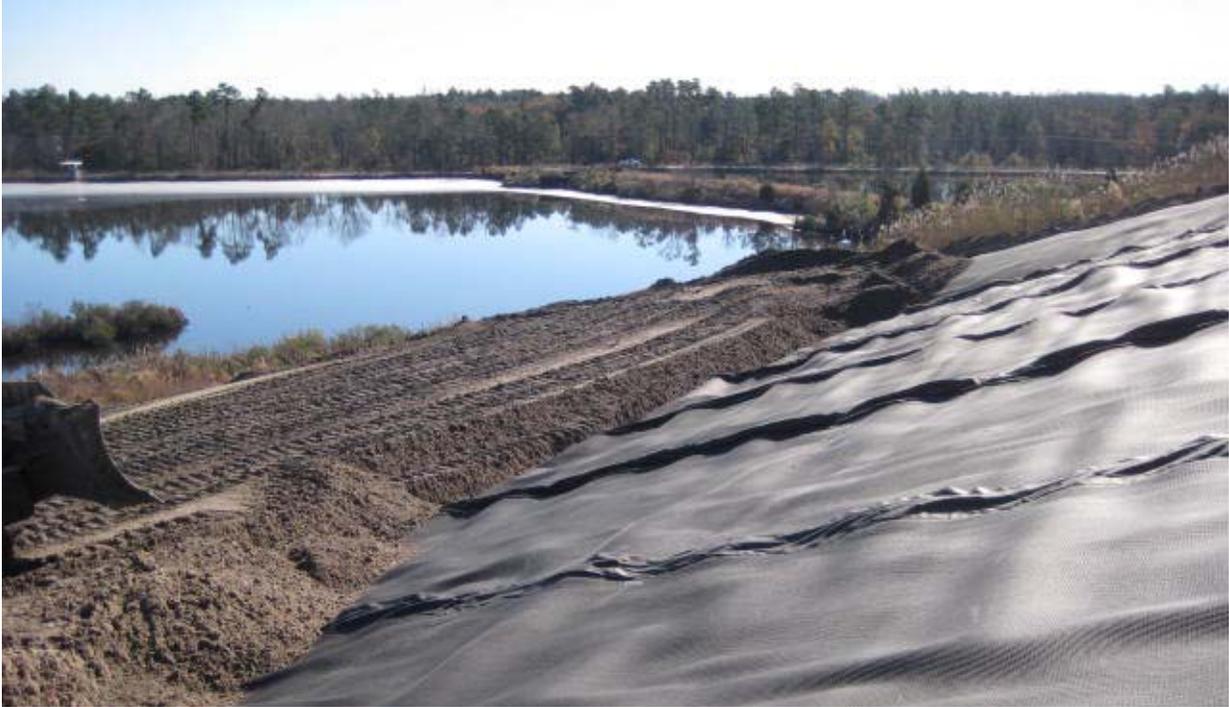
Photo 13. The protective cover sand was placed from the bottom up, from stockpiles placed adjacent to the work area (12/8/2008).

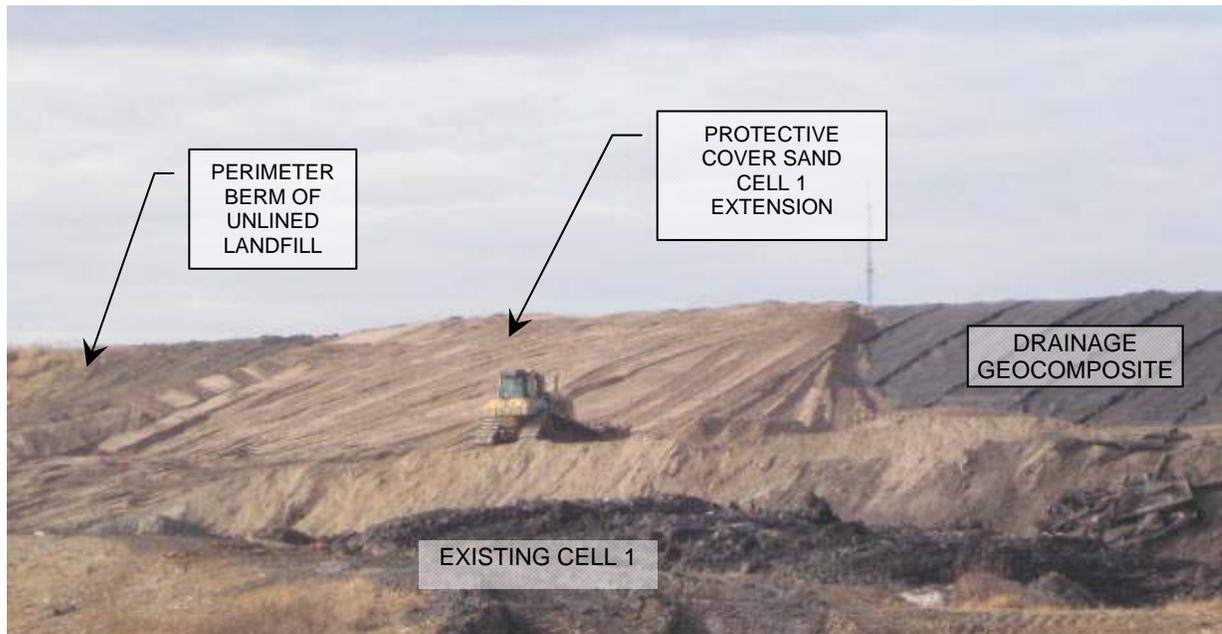
Photo 14. Initial placement of the protective cover sand over the drainage geocomposite (12/9/2008).

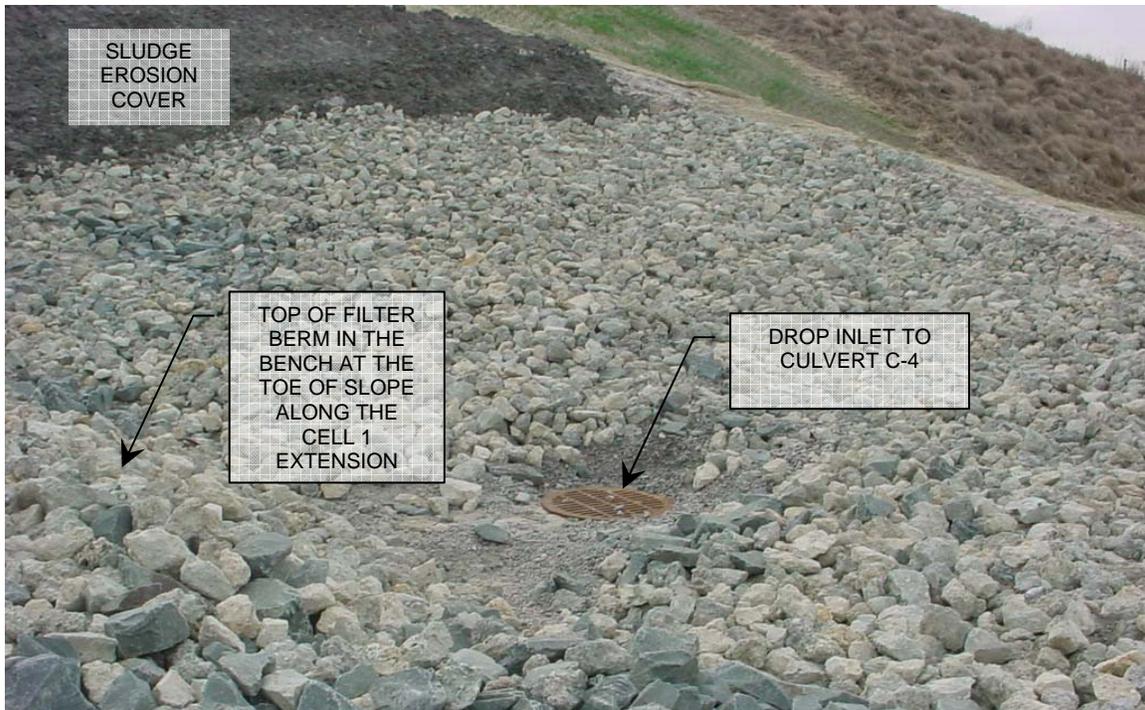
Photo 14. Drop inlet at the northwestern end of the Cell 1 Extension (3/12/2009).

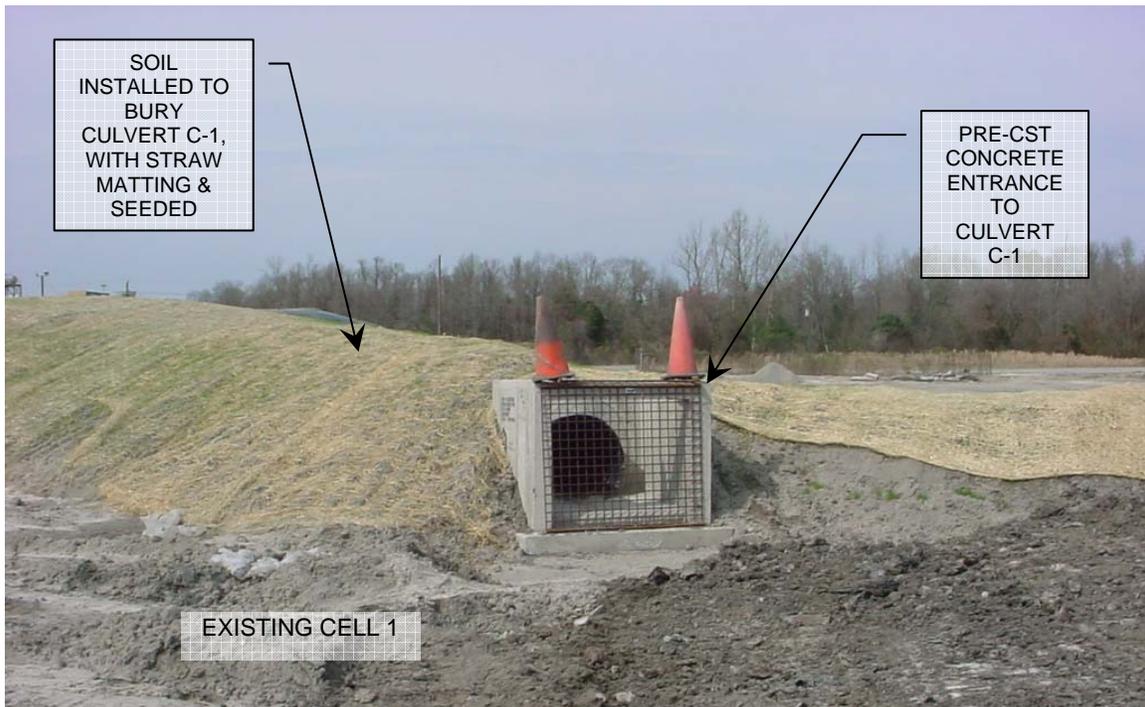
Photo 14. Culvert C-1 will allow storm water in Cell to gravity flow to the treatment system through to the waste water treatment system (3/12/2009).
