**FACILITY COMPLIANCE AUDIT REPORT**  
**Division of Waste Management**  
**Solid Waste Section**

**Date of Audit:** 13 January 2011

Weyerhaeuser Industrial Landfill  
 Washington Post Road  
 Vanceboro, NC

Closed: Unlined Industrial Landfill

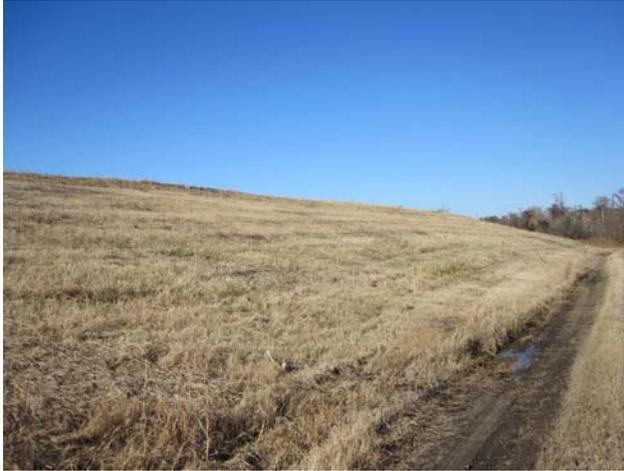
Landfill sideslopes, overall good cover crop and site stability    Monitoring well, well protected and properly labeled

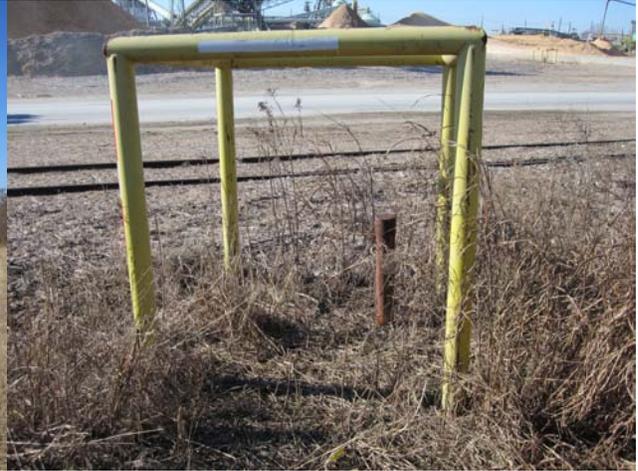
- 5) Permanent edge-of-waste markers have been installed and are being maintained to delineate the waste disposal boundary.
- 6) Facility monitoring wells were reviewed during this audit. All of the wells are easily accessible, secured by locks, properly labeled, and protected by highly visible steel bollards.

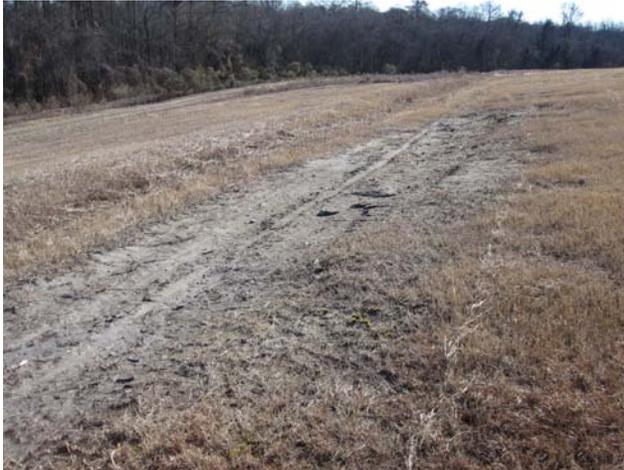
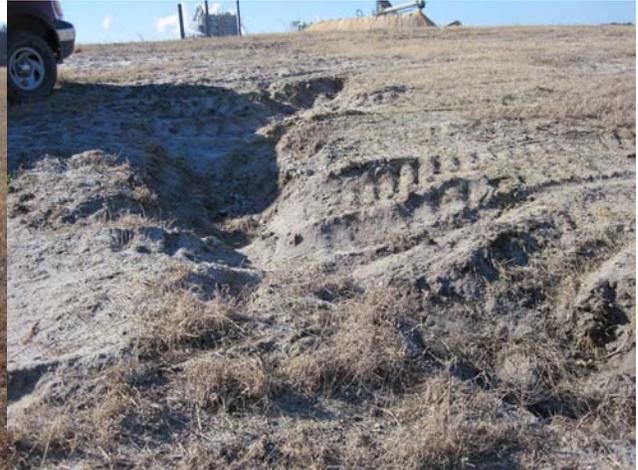
- 7) Overall the cover crop has been well established and maintained on the landfill sideslopes. However, several small areas along the northeastern and southern sideslopes were noted as having sparse cover with the potential of allowing erosion of the landfill cap system. Also, two areas of erosion were noted on the northeastern sideslope that need immediate attention. \*Please ensure that these areas are graded, seeded, and mulched to establish a cover crop suitable to prevent erosion and that the cover is maintained throughout the landfill to protect the integrity of your landfill cap system. These repair activities should be underway within thirty days of receipt of this report. Please see photographs attached below.

Area of sparse cover and eroded area in need of grading, seeding, and mulching

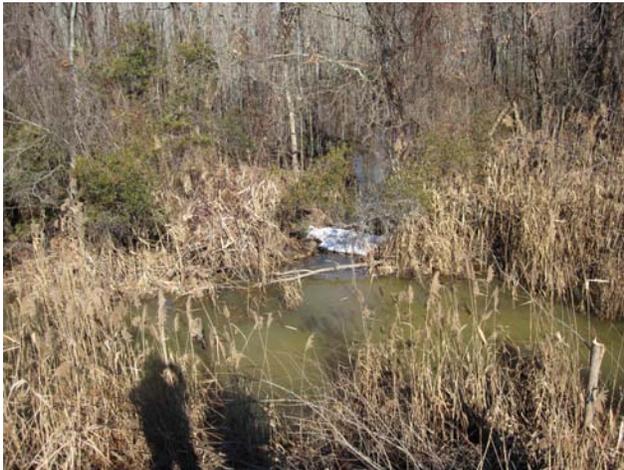
- 13) The leachate management canal dike is in need of repairs in two areas along the northern perimeter of the facility. A temporary repair has been made to the wall of the dike to prevent leachate from leaving the site. No leachate was noted as leaving the facility.

Temporary repair of leachate management canal

- 14) The site supervisor met with William Wescott of the US Army Corp of Engineers on the 12<sup>th</sup> of January 2011 and received approval to facilitate the necessary permanent repairs and to conduct needed maintenance such as brush and tree removal from the canal dike. The maintenance and repair activities are scheduled to begin during the week beginning 16 January 2011. This project expected to be completed by the end of January.

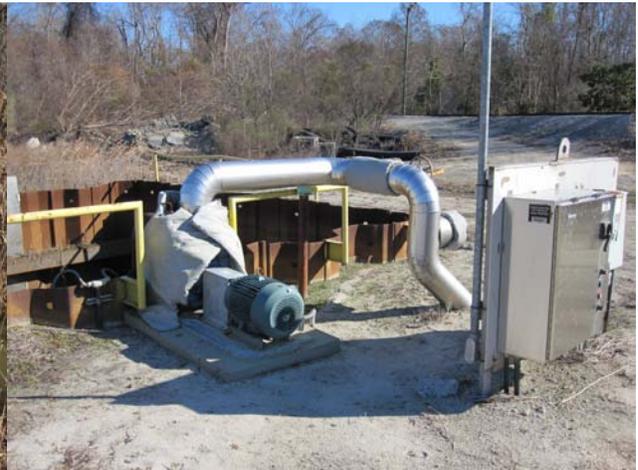
- 11) Surface water, groundwater, and leachate sampling was most recently conducted on 18 September 2010 by Environment One of Greenville, NC.
- 12) Leachate is transported via canal to the leachate canal pumping station and thence to the on-site Weyerhaeuser wastewater treatment plant.

Leachate canal pumping station
