FACILITY COMPLIANCE AUDIT REPORT
Division of Waste Management
Solid Waste Section

Date of Audit: 29 June 2010

Craven County Landfill
 7400 Old Highway 70
 New Bern, NC

Closed: Unlined MSW Landfill

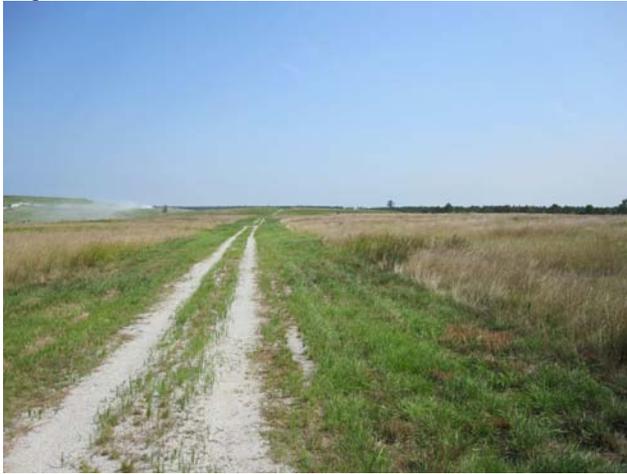
Landfill access road and cover

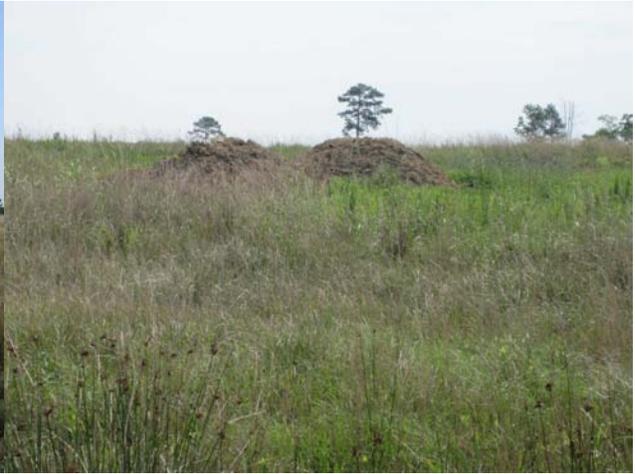
- 7) *There are areas of settlement throughout the landfill that will require continued maintenance to provide positive drainage of surface waters from the landfill surface.

- 8) Soil has been brought on-site and stockpiled at the landfill to use in grading operations.
- 9) The Facility Maintenance Log was complete, in order, and presented for review during this audit.

Soil stockpile for grading settlement

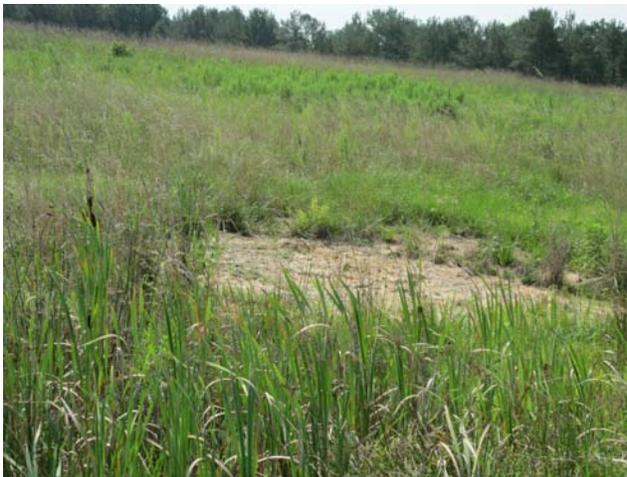
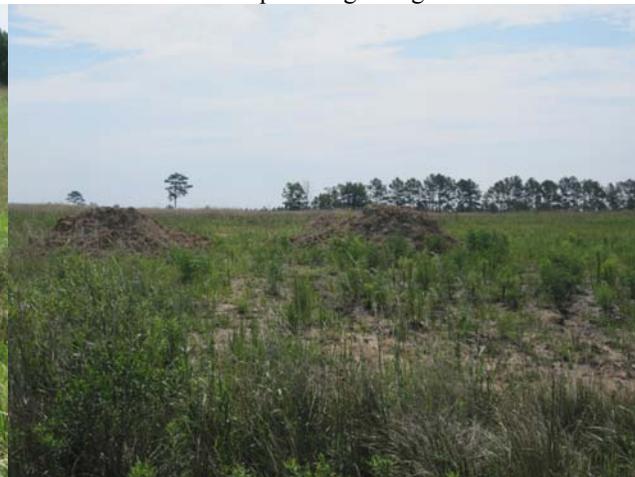
- 6) Overall the cover crop has been well established and maintained on the landfill sideslopes. However, several small areas along the western sideslope were noted as having sparse cover with the potential of allowing erosion of the landfill cap system. *Please ensure that these areas are graded, seeded, and mulched to establish a cover crop suitable to prevent erosion and that the cover is maintained to protect the integrity of your landfill cap system (see photographs attached below).

Areas of thin cover in need of grading, seeding, and mulching –soil stockpiled for grading

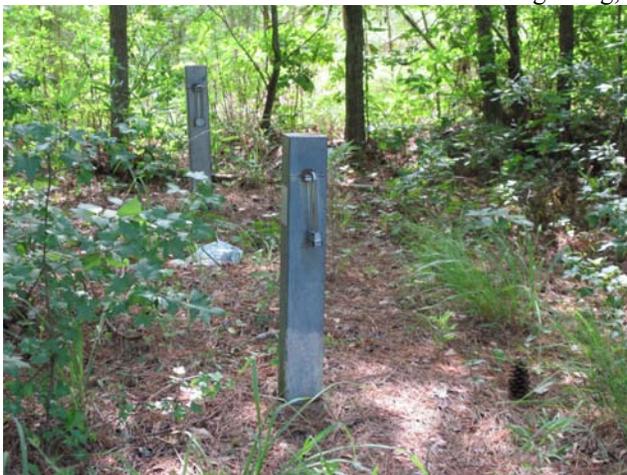
Monitoring wells locked and labeled

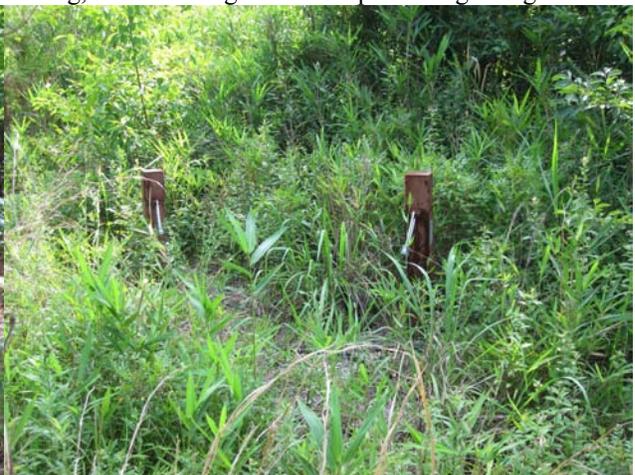
- 1) This facility is a closed MSW Landfill.
- 2) The facility is mowed annually; the next mowing event is scheduled for September 2010.
- 3) The site is secured by a locked gate at the facility entrance.
- 4) The facility access road is of all weather construction and is being well maintained.
- 5) Facility monitoring wells were reviewed during this audit. All of the wells are accessible and secured by locks.
 *Brush and undergrowth should be removed from around all of the wells for improved accessibility and safety (see photographs attached below).

Monitoring wells needing excess brush removed
