FACILITY COMPLIANCE AUDIT REPORT
Division of Waste Management
Solid Waste Section

Date of Audit: 8 February 2011

MCAS Cherry Point Transfer Facility
 Mockingbird Road
 MCAS Cherry Point, NC 28533

25-10T, 020811

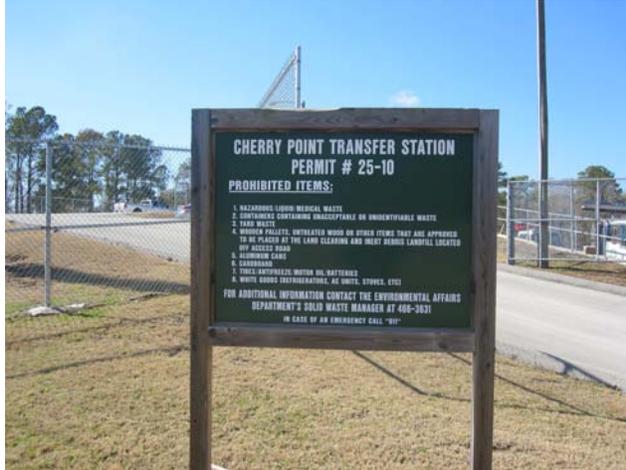
- 4) Proper signage is posted at the entrance to the transfer station stating the facility permit number, list of banned materials, and the emergency contact number.

Signage posted at the facility entrance

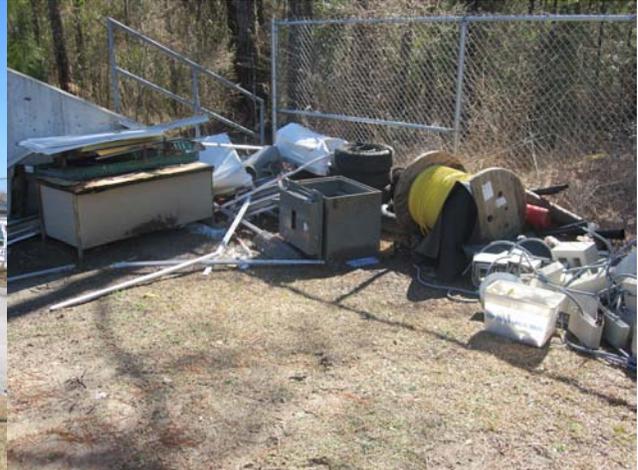
Scavenged materials needing proper management

- 17) A large amount of scavenged materials was present next to the perimeter fence behind the transfer facility. *Scavenging is not allowed at permitted solid waste management facilities. Any recyclable materials removed from the waste stream should be placed in an appropriate receptacle and taken to a facility managed for the recycling of such materials.

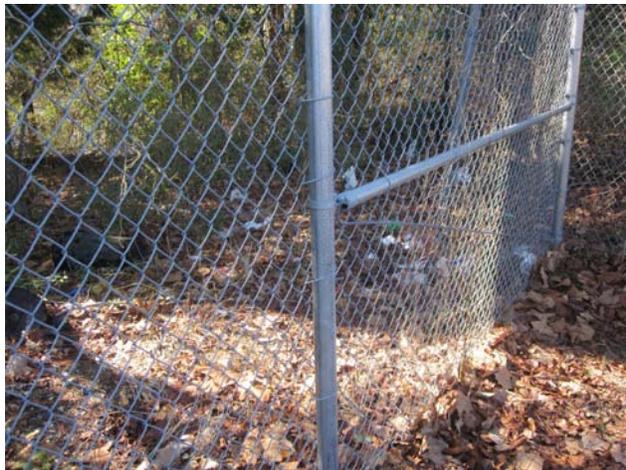
Wind-blown debris outside of perimeter fence

- 16) Overall, the trailer loading area and windblown debris are being well maintained at this time; however windblown debris was noted on the outside of the perimeter security fence. *Please ensure that all windblown debris both inside and outside the perimeter fence is collected and disposed in the MSW trailer at the end of each workday.

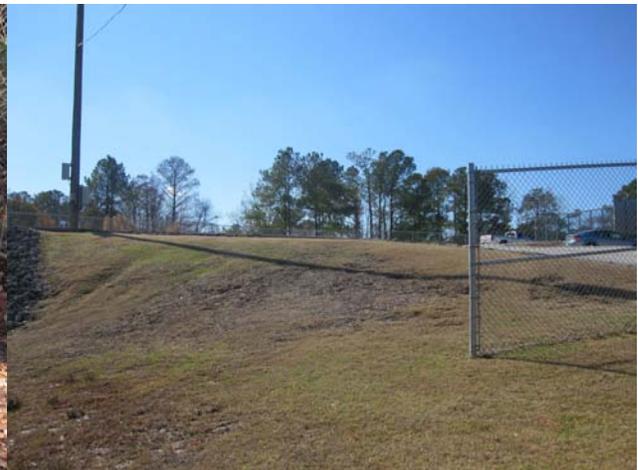
Area on east slope with sparse cover and slight erosion

- 23) Access around the facility is generally stable; however, an area of sparse cover and minor erosion was noted near the center of the eastern slope. *To maintain site stability; please grade, seed, and mulch this area to establish a groundcover suitable to prevent erosion.

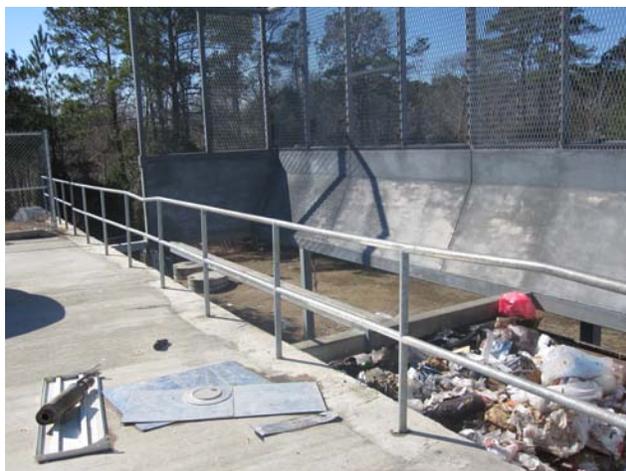
- 8) All wastes managed at this facility are dumped directly into transfer trailers; MSW is dumped into a hopper, which directs the waste into the MSW trailer, wood waste is loaded directly into a separate roll-off container.

MSW Hopper above MSW transfer trailer loading area and wood waste container
