**FACILITY COMPLIANCE AUDIT REPORT**  
**Division of Waste Management**  
**Solid Waste Section**

<b>UNIT TYPE:</b>										
Lined MSWLF		LCID	X	YW		Transfer		Compost	SLAS	<b>COUNTY:</b> Craven <b>PERMIT NO.:</b> 25-I <b>FILE TYPE:</b> COMPLIANCE
Closed MSWLF		HHW		White goods		Incin		T&P	FIRM	
CDLF		Tire T&P / Collection		Tire Monofill		Industrial Landfill		DEMO	SDTF

Date of Audit: 12 April 2011

Cieszko Construction Company LCID Landfill  
 NC Hwy 101 Havelock, NC

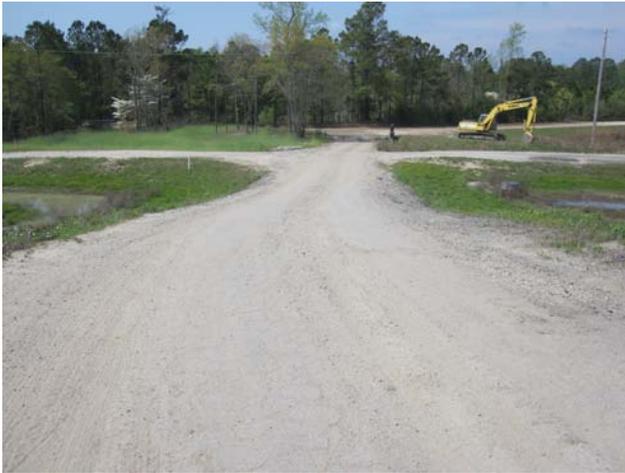
Well maintained facility access road

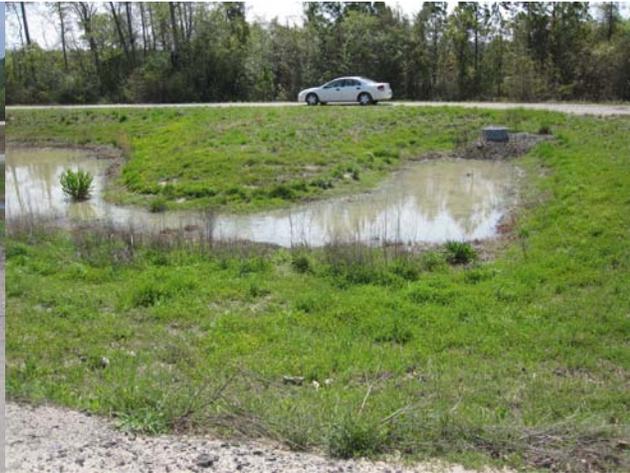
- 5) The soil sedimentation and erosion control measures were reviewed and no off-site erosion was noted at this time.
- 6) The sideslopes have a well established cover crop of native warm season grasses and are being maintained at a slope not greater than 3:1. No areas of erosion were noted during this audit.

Well maintained stormwater/sedimentation control basin

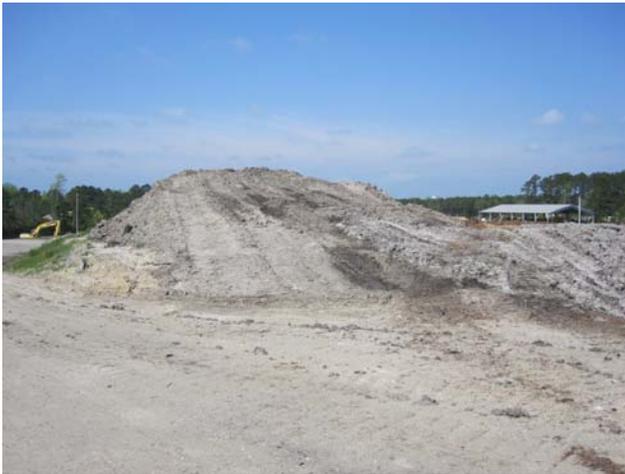
- 9) The active working area is compact and well managed.
- 10) Soil is being stockpiled in an area adjacent to the active working face for use as cover.

Soil stockpiled adjacent to the working face

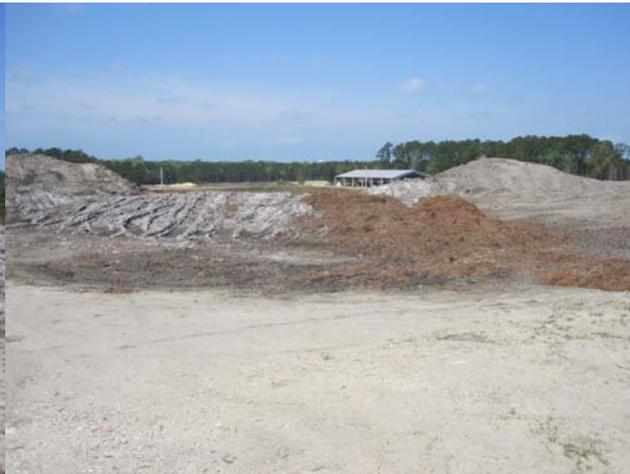
Compact working face

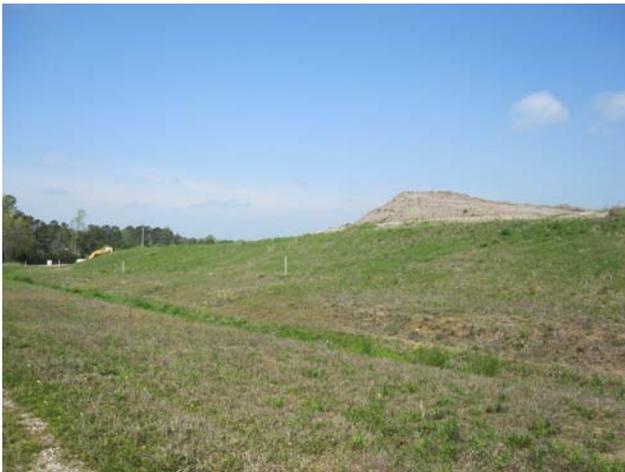
- 7) The waste type being disposed is LCID waste only. There were no unacceptable waste streams noted during this Audit.
- 8) This facility has highly visible, permanent, edge-of-waste markers in place delineating the landfill waste disposal footprint.

Sideslope with well established cover crop and boundary markers

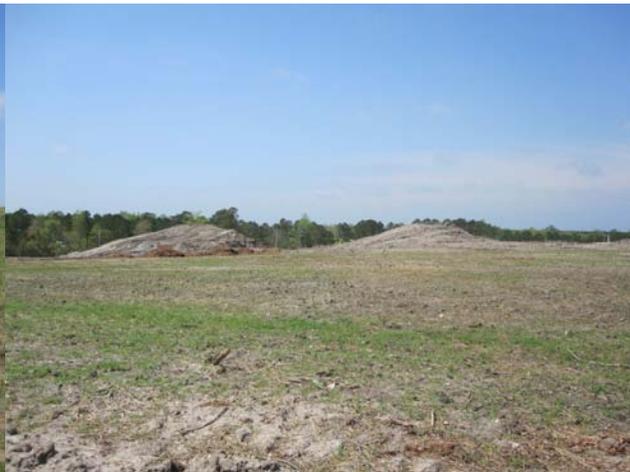
Seeded cover crop germinating on upper lift
