FACILITY COMPLIANCE AUDIT REPORT
Division of Waste Management
Solid Waste Section

Date of Audit: November 19, 2010 Date of Last Audit: March 9, 2005

Andrews Land Clearing and Inert Debris Landfill
 Doc Bennett Road
 Fayetteville, NC

Comprehensive Audit

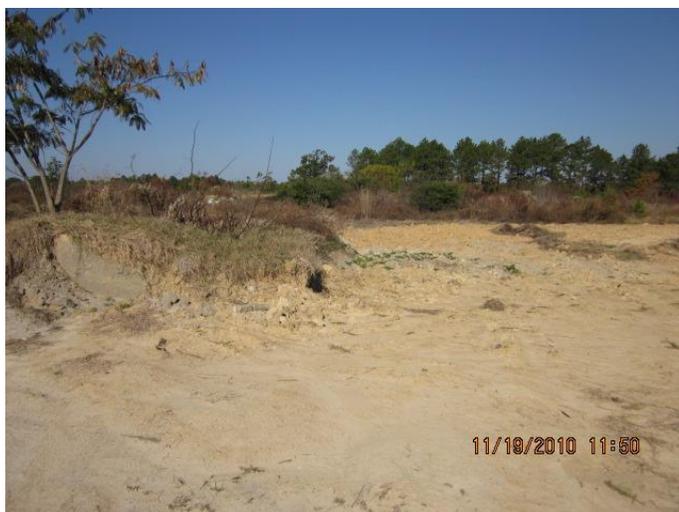
4. There were trees and thick vegetation growing on the western side of the landfill making it difficult to thoroughly inspect this area.
5. There was a denuded area near the center of the site where soil has been removed.

Central area of LF, soil being removed.

8. Provisions for a ground cover sufficient to restrain erosion must be accomplished within 30 working days or 120 calendar days upon completion of any phase of landfill development.

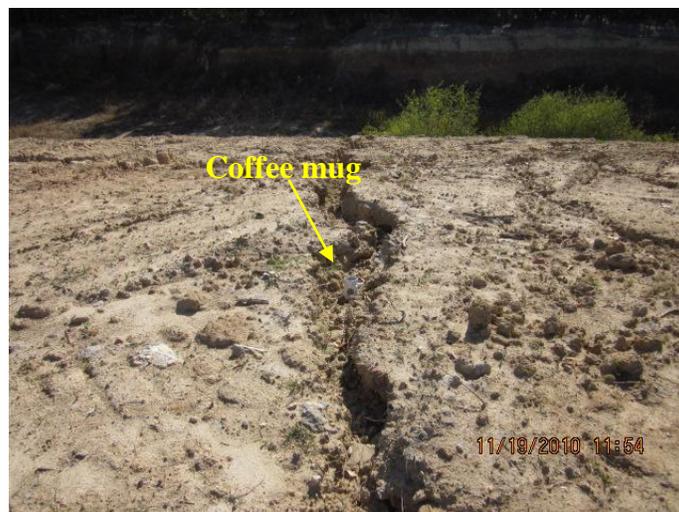
6. Eroded areas were observed on the sparsely vegetated southeastern and south side slopes.
7. 120 calendar days after completion of any phase of disposal operations, or upon revocation of a permit, the disposal area shall be covered with a minimum of one foot of suitable soil cover sloped to allow surface water runoff in a controlled manner.

Erosion along upper portion of side slope facing E.

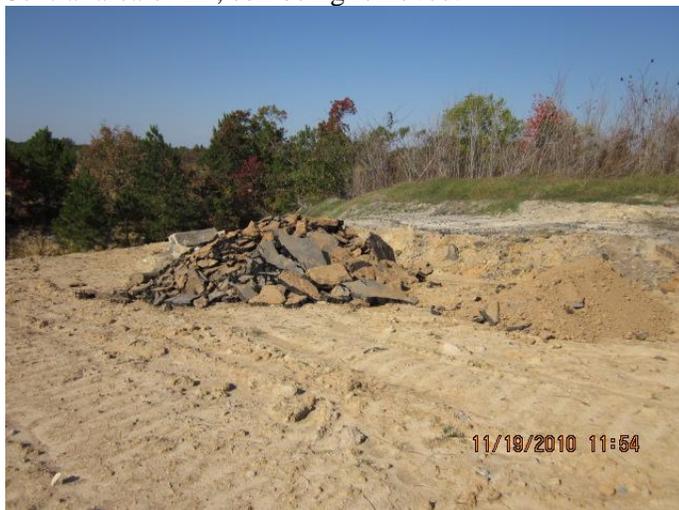
1. The permit for this site has expired.
2. Waste is still being dumped at the site even though the owner stated that the site has been closed for several years.
3. Uncovered waste to include asphalt, plastic pipe, metal, clay pipe, and lumber, concrete, and tree debris was

Recently dumped waste near the S end of LF.

9. Uncovered, exposed waste must be covered and a vegetative cover established to prevent erosion.
10. Cease hauling waste to this site. Close the site in accordance with the Solid Waste Rules 15A NCAC 13B .0510 and 15A NCAC 13B .0566(5) or submit an application for a Land Clearing and Inert Debris landfill.

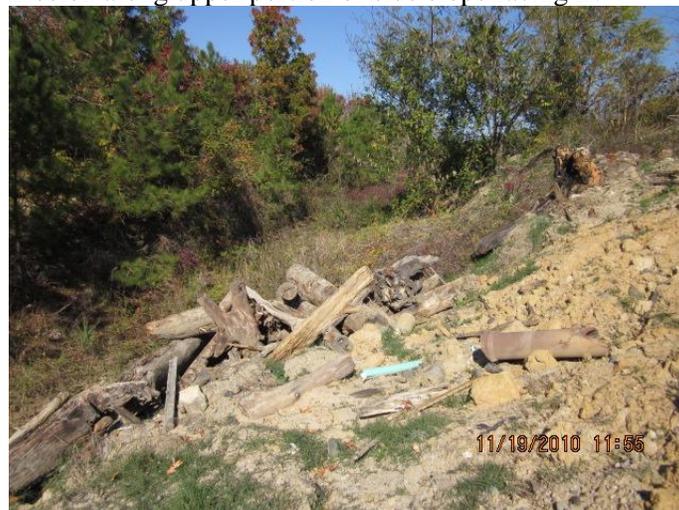
observed during the inspection in several areas of the LF. Waste was visible along the toe of the slope on the south and southwest sides of the LF.

Uncovered waste along SW side slope toe facing W.

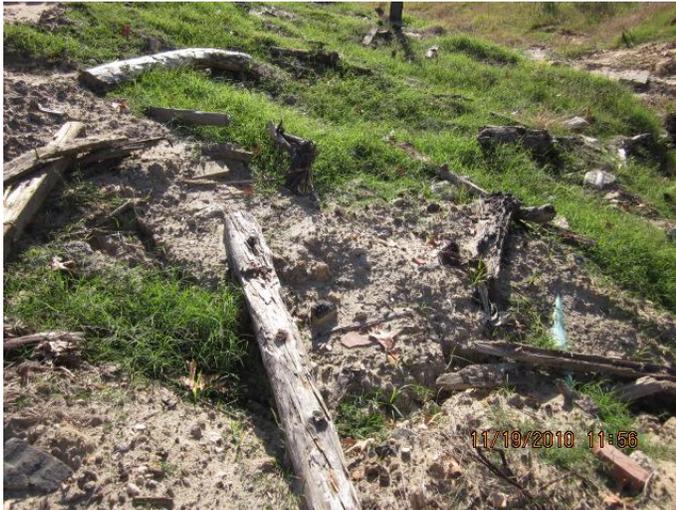
Charred uncovered waste S slope toe.

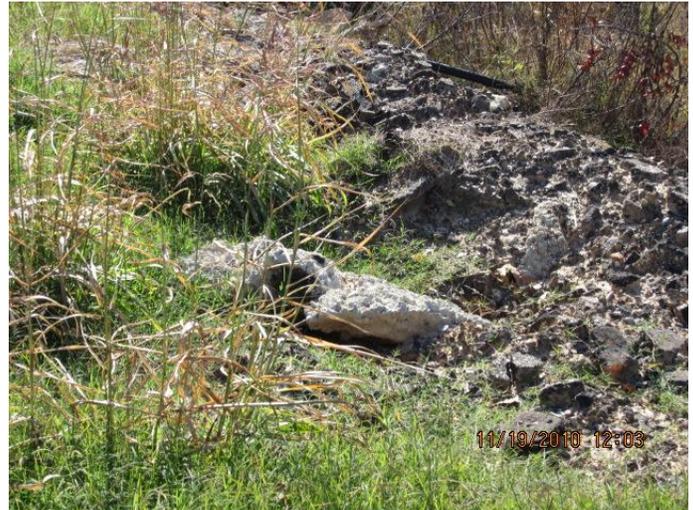
Uncovered waste W side of LF.

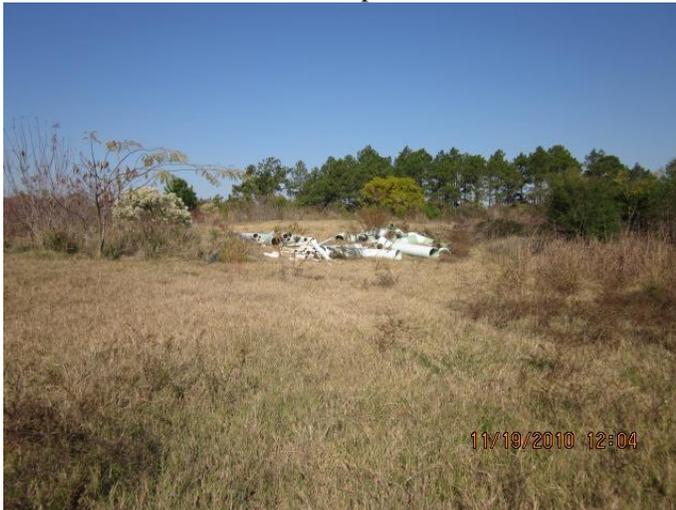
Waste plastic pipe dumped W side of LF.

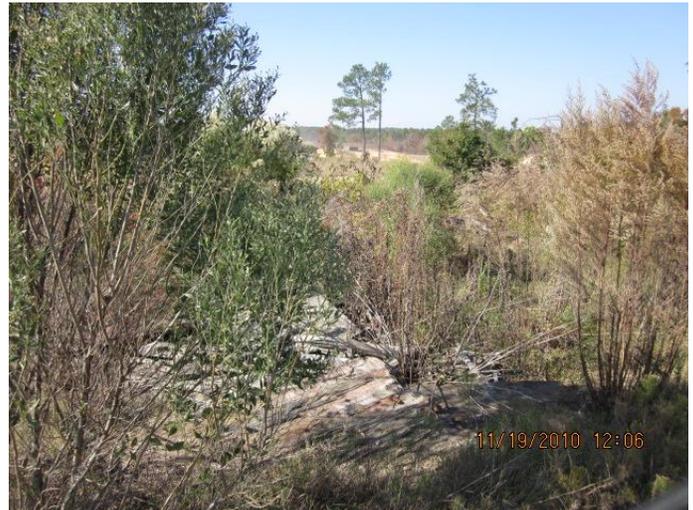
Wood waste uncovered near W side of LF.
