FACILITY COMPLIANCE AUDIT REPORT
Division of Waste Management
Solid Waste Section

Date of Audit: 8 October 2009

Dare County C & D Landfill
 1603 Cub Road
 Manns Harbor, NC 27953

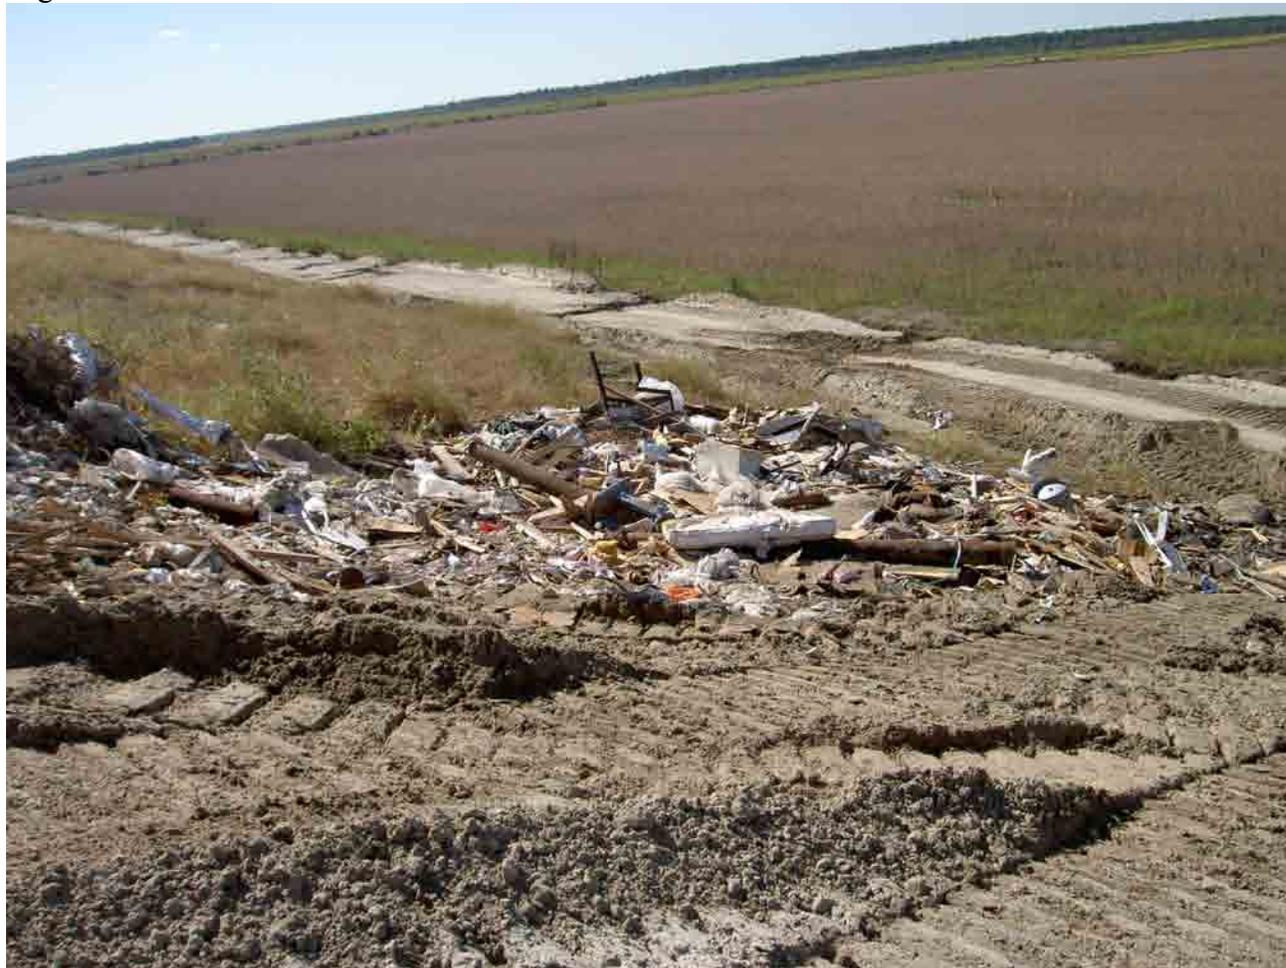
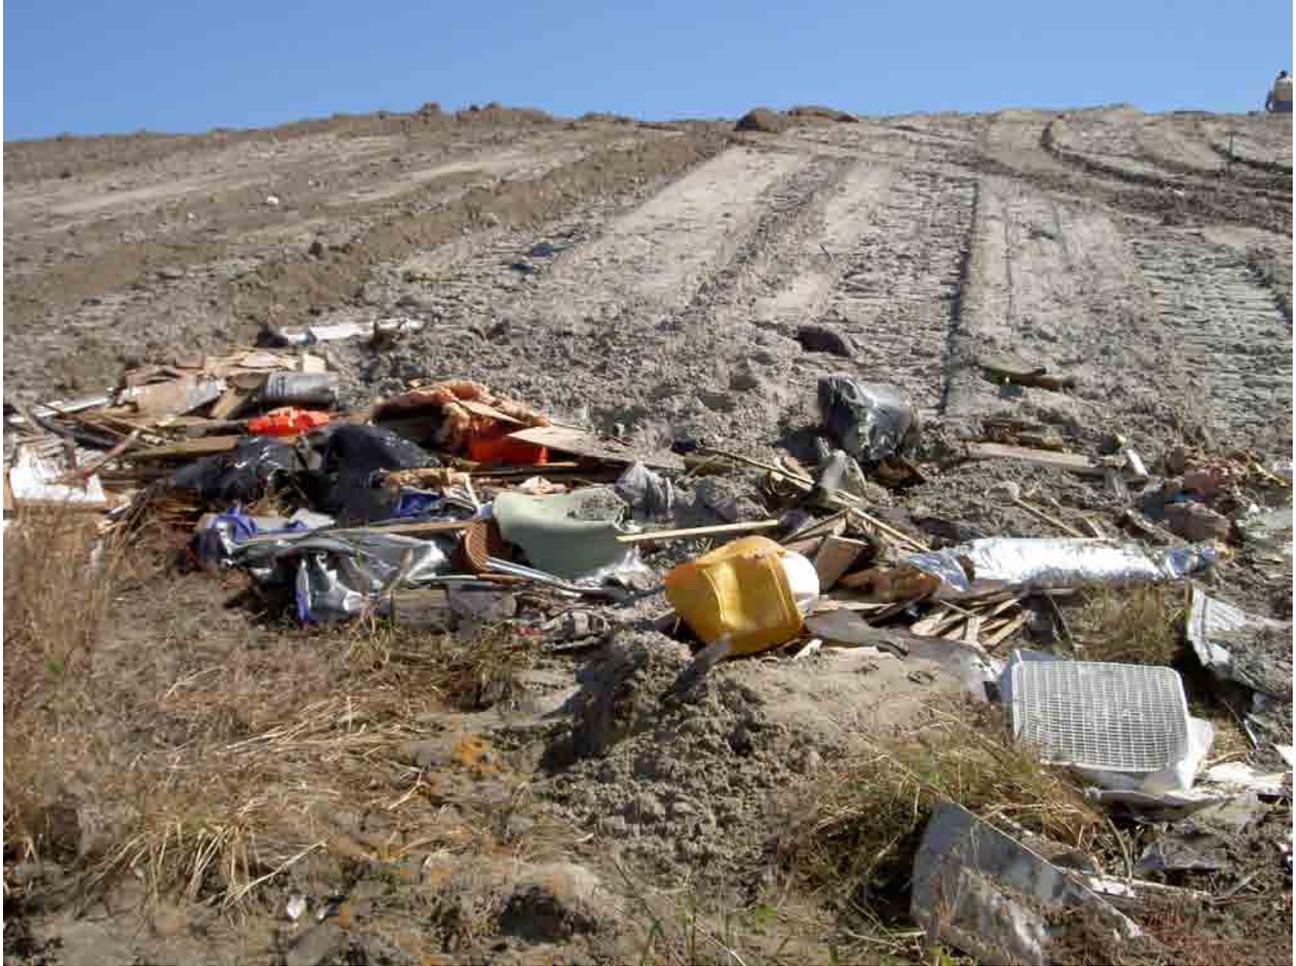
Exposed waste noted at the toe of the western sideslope

- 19) Exposed waste was noted on the side slopes of the active cell. Care should be taken to ensure that all waste is covered with a minimum of six inches of soil at least once per week. *Any area that will not be receiving additional waste for twelve months or more but where final termination of operations has not occurred needs to be covered with a minimum of twelve inches of soil and stabilized with vegetative cover suitable to prevent erosion. Seeding operations need to be underway within 30 days after the cover and grading activities are completed.

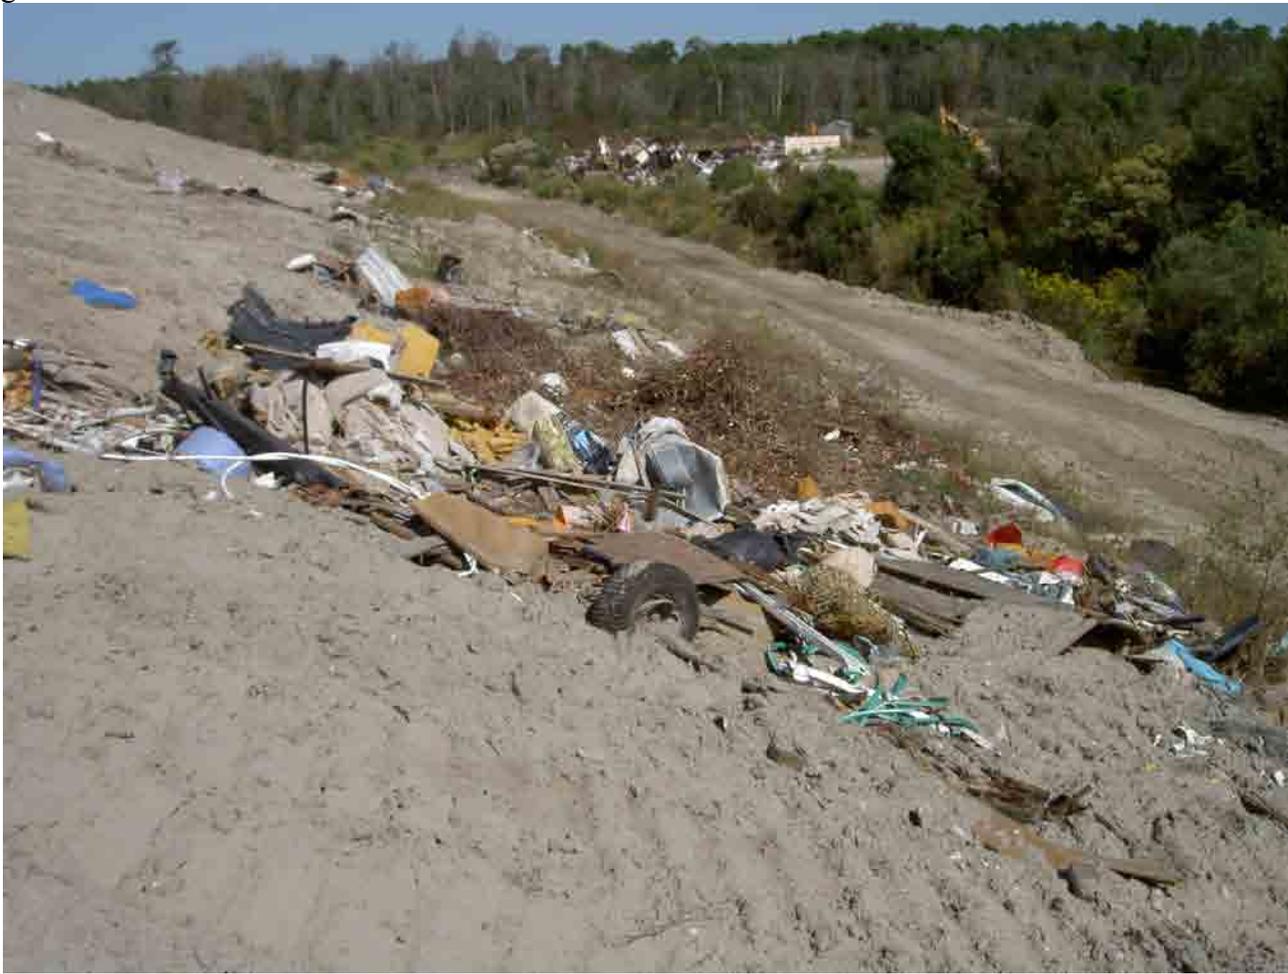
Exposed waste noted on the eastern sideslope

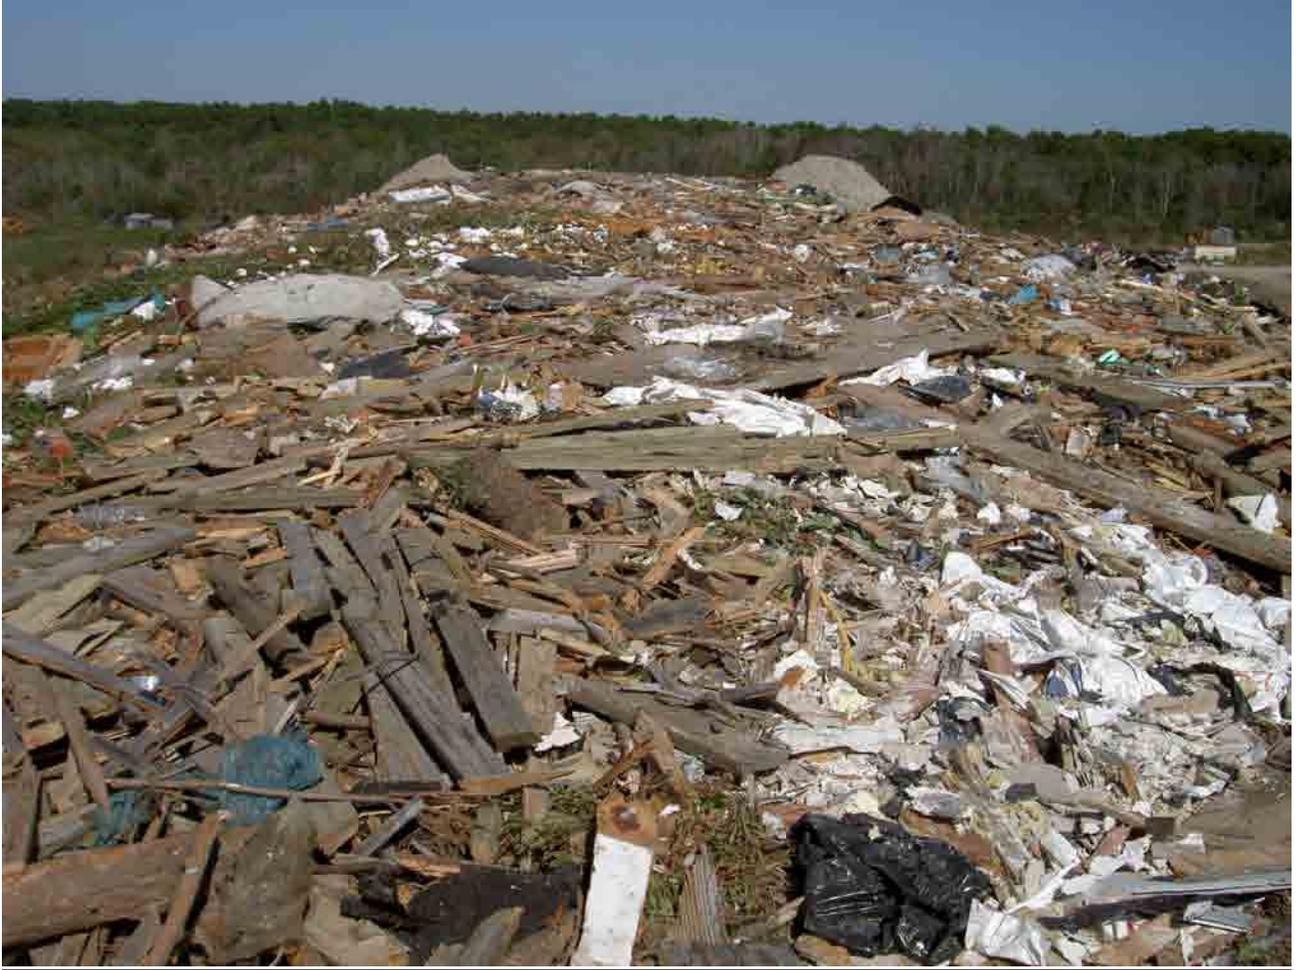
Working face; needs cover when reaching ½ acre in size

- 20) The facility was noted as having approximately ½ acre of exposed waste. *Care should be taken to ensure that all waste is covered with a minimum of six inches of soil when the active disposal area reaches ½ acre in size.

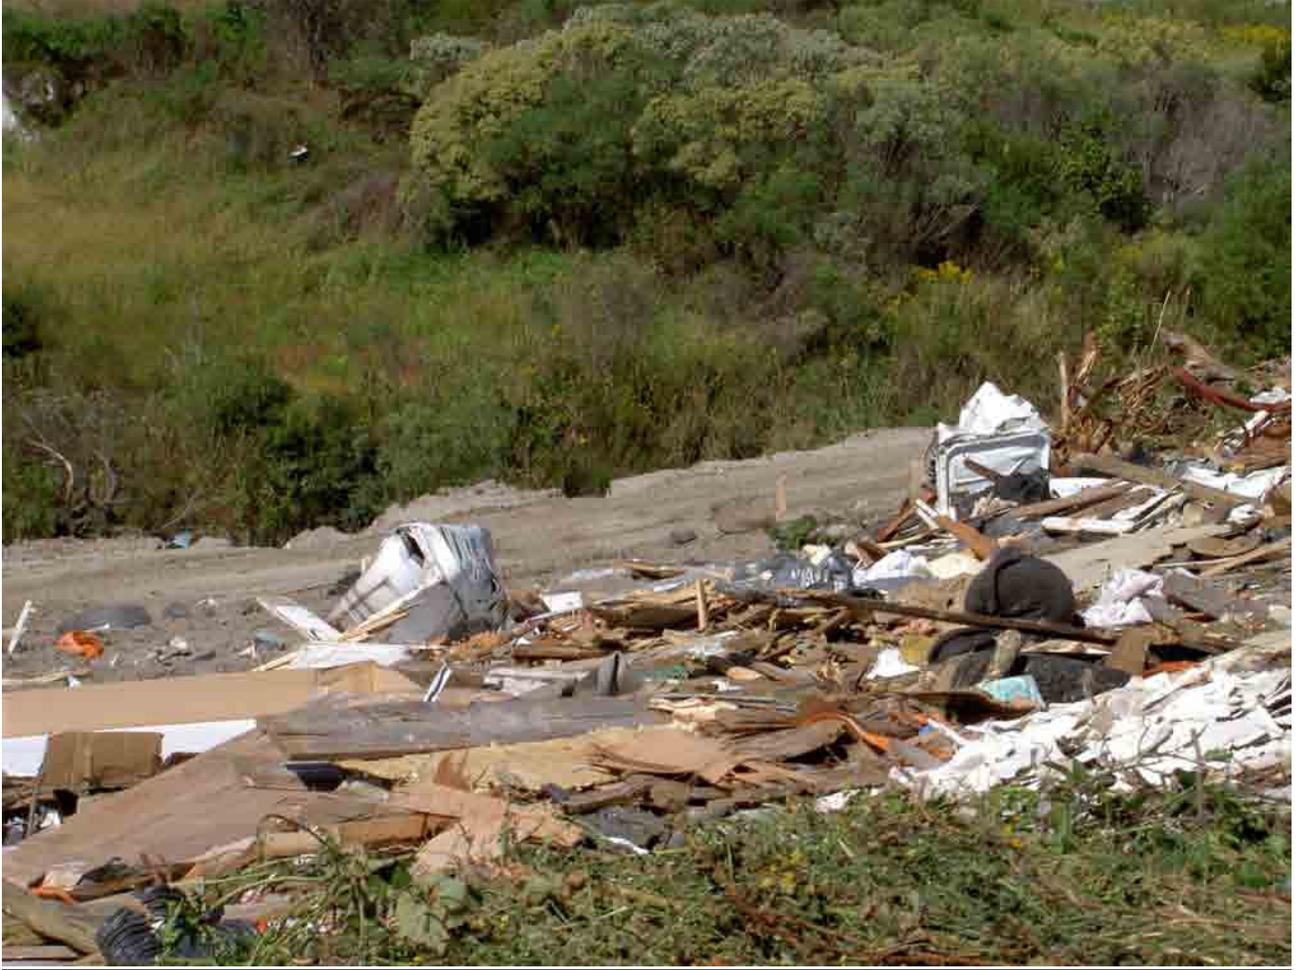
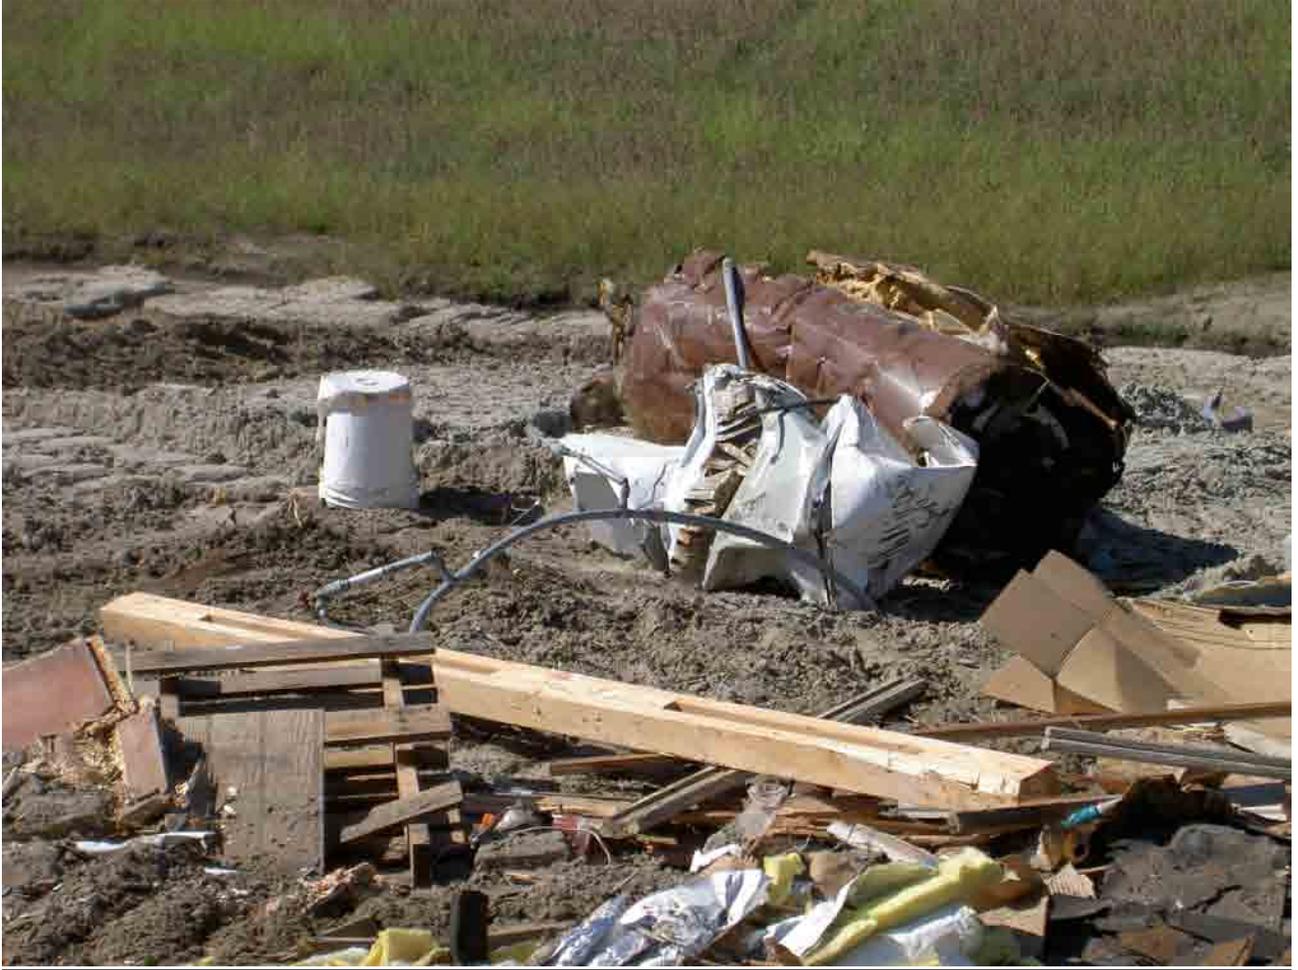
White goods disposed at the working face

- 21) Several articles classified as white goods were noted in the waste on the active working face. *Care should be taken to ensure that all unpermitted wastes are screened from the disposal area as they are discovered. All white goods should be managed at the White Goods Management Area of the landfill facility and properly managed until the Freon is removed.
