FACILITY COMPLIANCE AUDIT REPORT
Division of Waste Management
Solid Waste Section

Date of Audit: 3 November 2009

Dare County C & D Landfill
 1603 Cub Road
 Manns Harbor, NC 27953

Comprehensive Audit

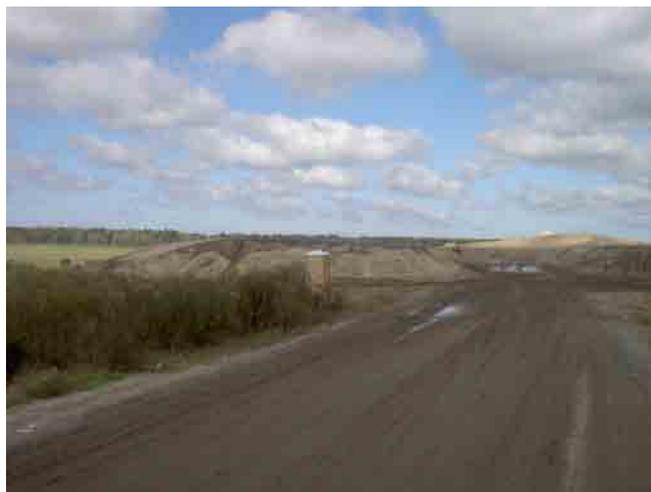
Entrance to Cell 3

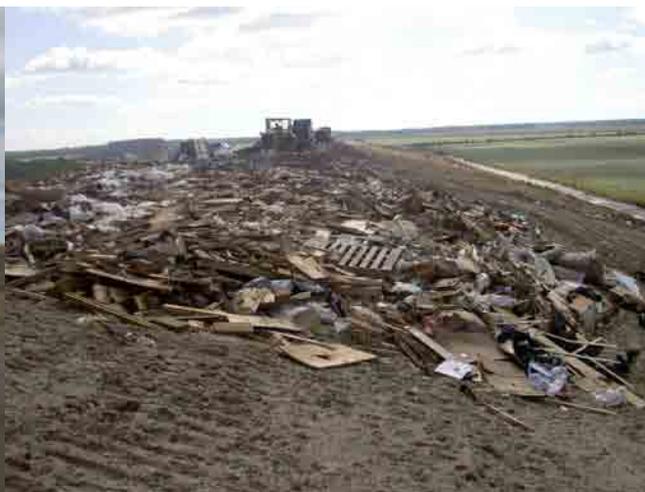
- 20) The working face looks much better and is being kept as compact as practicable. The waste is being covered when the active disposal area reaches ½ acre in size.

Cell 3 Working Face

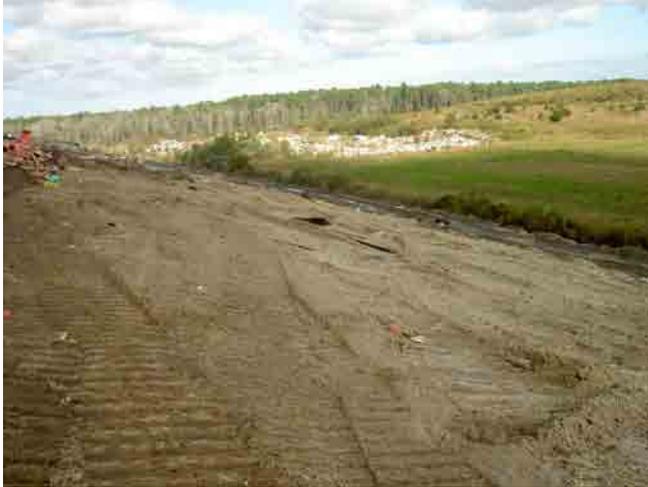
- 19) The side slopes of the active cell look much better. Care should be taken to continue to cover all waste with a minimum of six inches of soil at least once per week. *Any area that will not be receiving additional waste for twelve months or more but where final termination of operations has not occurred needs to be covered with a minimum of twelve inches of soil and stabilized with vegetative cover suitable to prevent erosion. Seeding operations need to be underway within 30 days after the cover and grading activities are completed.

Improved cover on sideslopes of Cell 3

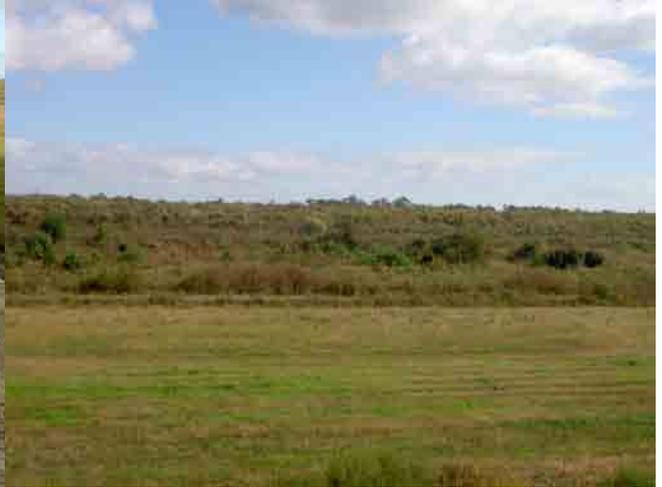
Vegetation on sideslope of Cell 2

- 17) The top of cells one and two have been mowed. *The sideslopes need to be mowed as soon as practicable to remove the woody vegetation that has been allowed to grow in the cap. For proper maintenance of the facility cap, a regular maintenance schedule which includes mowing the facility on at least an annual needs to be established.

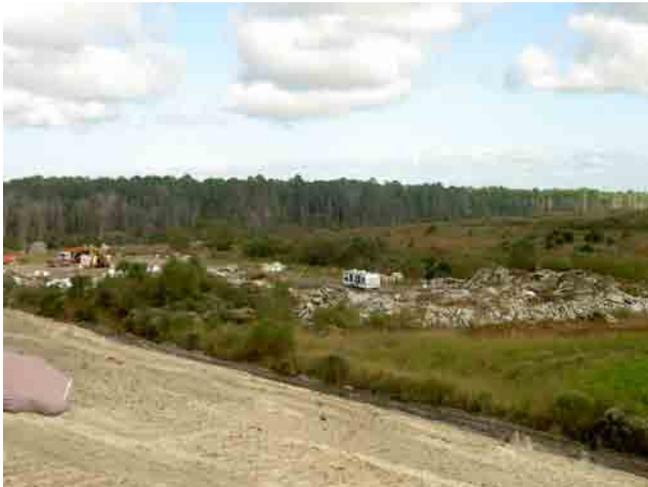
Concrete staged at white goods area

- All metal should be removed from your concrete recycling pile.
 - *This element of your operation needs to be improved. The installation of a concrete pad should be

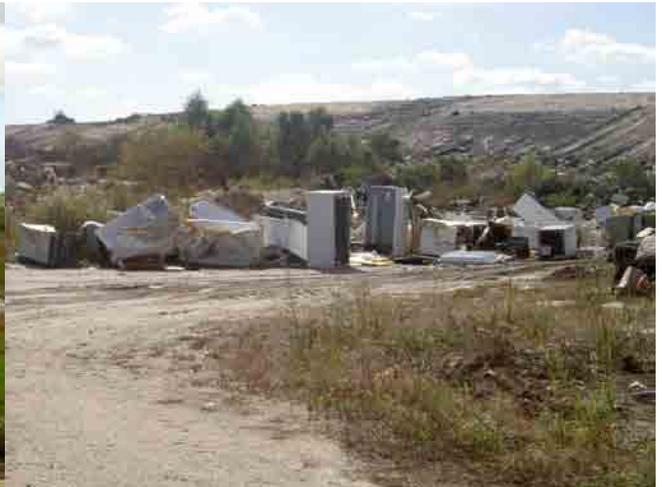
- 23) The white goods/metal recycling area is in need of continued attention.
 - *Please ensure that:
 - All Freon containing white goods are placed and maintained in an upright condition until the Freon is properly collected or until the appliance is removed from the facility.

White goods collection area

- All materials collected for recycling are deposited on-site and maintained in an orderly fashion.
 - All waste contaminated materials, i.e. painted concrete, concrete with tile or mastic, C&D waste contaminated loads of brick or concrete, etc. are disposed of in the C&D landfill.
