FACILITY COMPLIANCE AUDIT REPORT
Division of Waste Management
Solid Waste Section

Date of Audit: 6 January 2011

Dare County C & D Landfill
 1603 Cub Road
 Manns Harbor, NC 27953

28-03, 010611RES

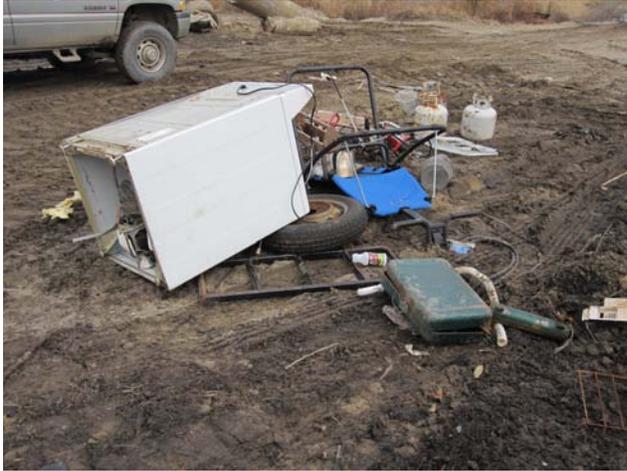
- 23) No unpermitted wastes were noted in the disposal area.
- 24) All recyclable metals and white goods are screened from incoming waste, removed from the working face, and transported to the white goods/metal recycling area daily.

Recyclable metals screened from waste stream

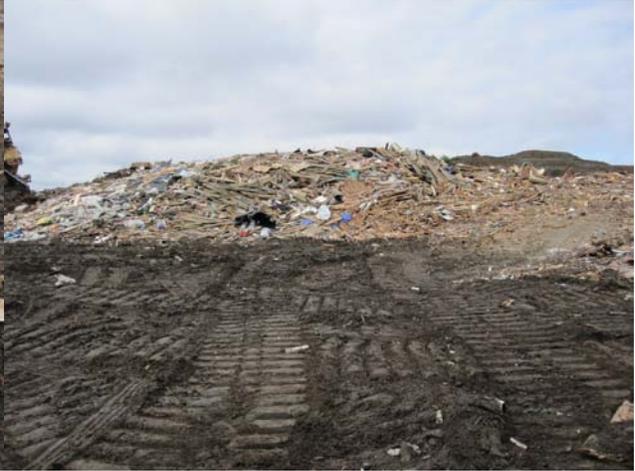
- 21) The working face was compact and is being covered with six inches of soil when it reaches ½ acre in size.
- 22) The landfill cover log was presented for review and in order.

Compact working face

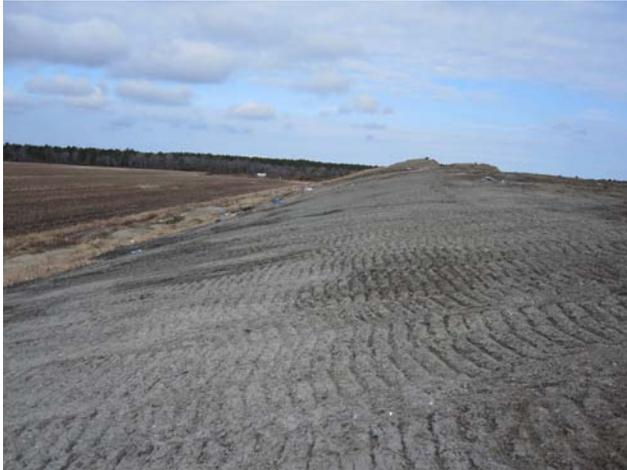
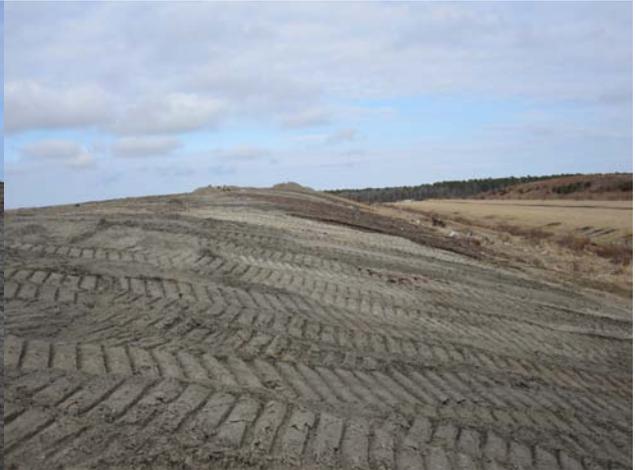
Recently covered and graded sideslopes

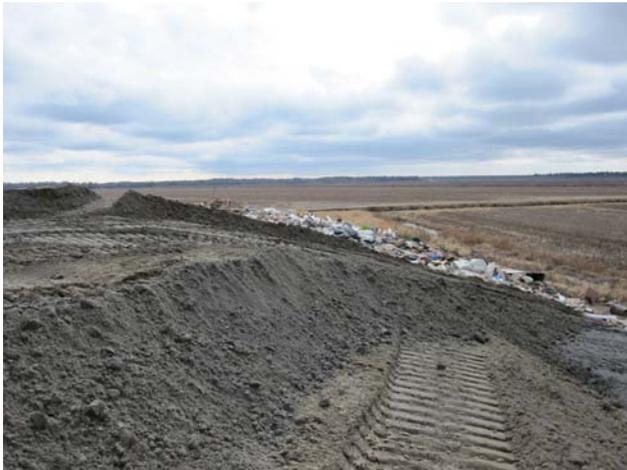
Soil stockpile for cover on backside of working face

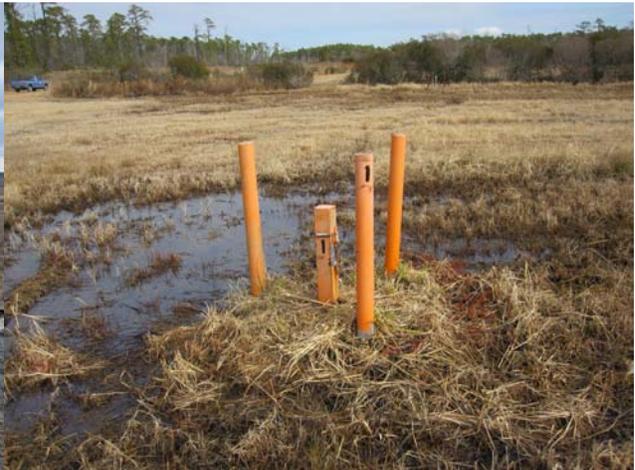
- 18) The facility groundwater monitoring wells were observed during this audit. All wells were marked and secured with functional locks with the exceptions of well #1 which was missing its lock, and well #2 which needs to have its cap repaired. *Please ensure that all wells have functional lids with locks installed for security.

Groundwater monitoring well #1 needing lock installed
