FACILITY COMPLIANCE AUDIT REPORT
Division of Waste Management
Solid Waste Section

UNIT TYPE:											
Lined MSWLF		LCID		YW		Transfer		Compost		SLAS	COUNTY: Dare PERMIT NO.: 28-03 FILE TYPE: COMPLIANCE
Closed MSWLF		HHW		White goods	X	Incin		T&P		FIRM	
CDFL	X	Tire T&P / Collection	X	Tire Monofill		Industrial Landfill		DEMO		SDTF

Date of Audit: 6 April 2011

Dare County C & D Landfill
 1603 Cub Road
 Manns Harbor, NC 27953

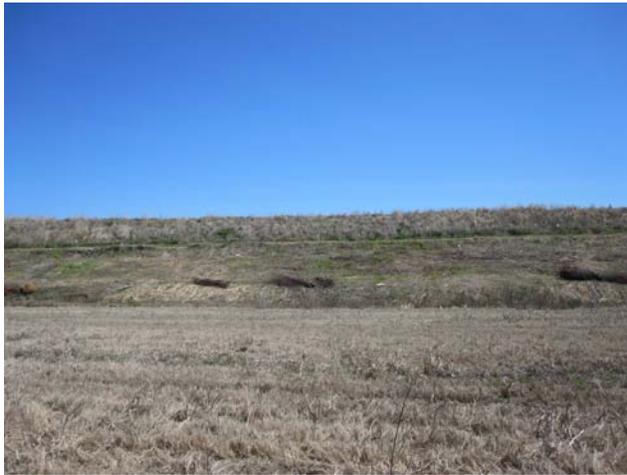
- 21) Permanent Edge of Waste Markers are in place and are being maintained as required.
- 22) Cells one and two have been mowed and all woody vegetation has been cut and piled at the tow of each cell. These piles will be removed and properly disposed when the weather allows.

Cell #2, note cleared brush and woody vegetation

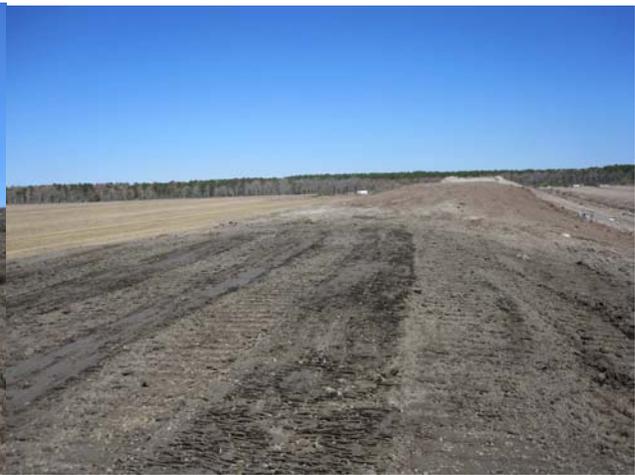
Soil cover in recently closed disposal area

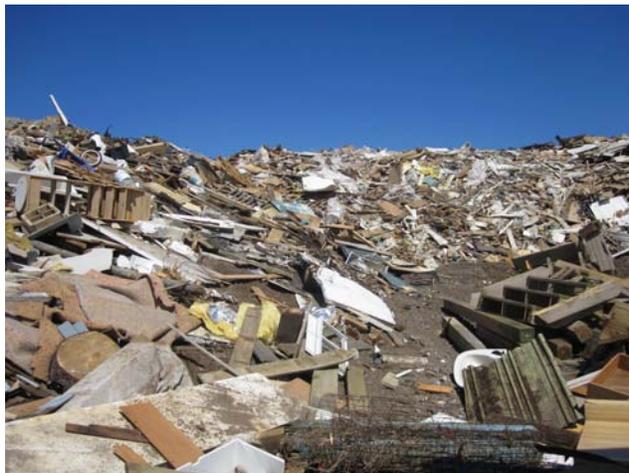
- 23) The working face was compact and is being covered with six inches of soil when it reaches ½ acre in size.
- 24) The landfill cover log was presented for review and in order.

Compact working face, no unpermitted waste types noted

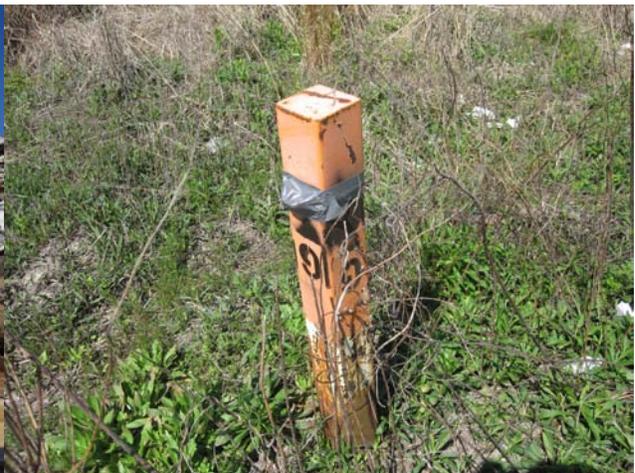
- 20) The facility groundwater monitoring wells were observed during this audit. All wells were marked and secured with functional locks with the exceptions of wells #1 and #9 which were missing their locks. Well #2 could not be inspected due to standing water from a recent rain event. *Please ensure that all wells have functional lids with locks installed for security.

GW monitoring well #9 needing lock
