FACILITY COMPLIANCE AUDIT REPORT
Division of Waste Management
Solid Waste Section

Date of Audit: 9 February 2010

Dare County Transfer Station
 1603 Cub Road
 Manns Harbor, NC 27953

Comprehensive Audit

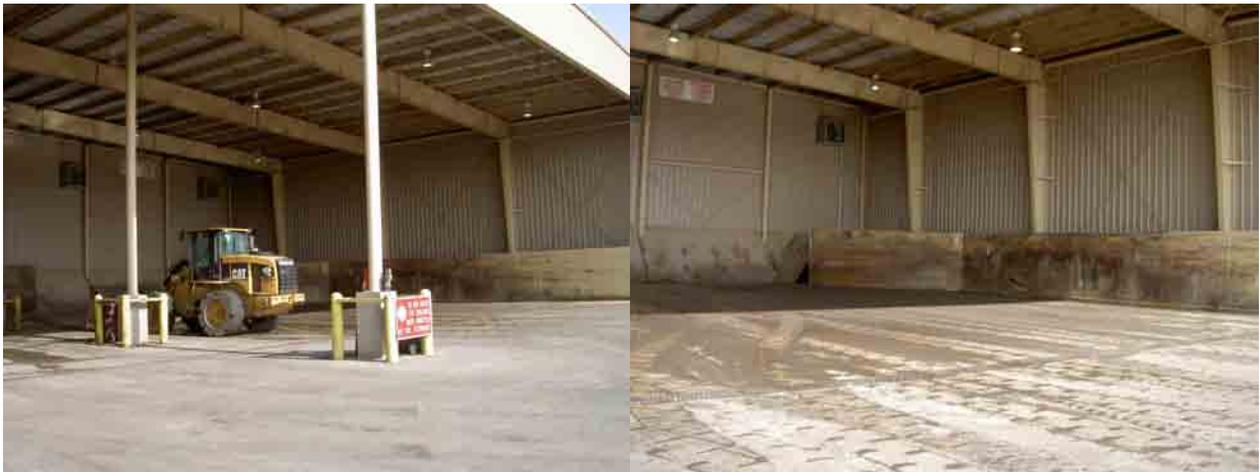
Well managed tipping floor

- 11) Monthly safety meetings are conducted at the facility by the site safety representative.
- 12) The tipping floor is cleaned and washed down daily.

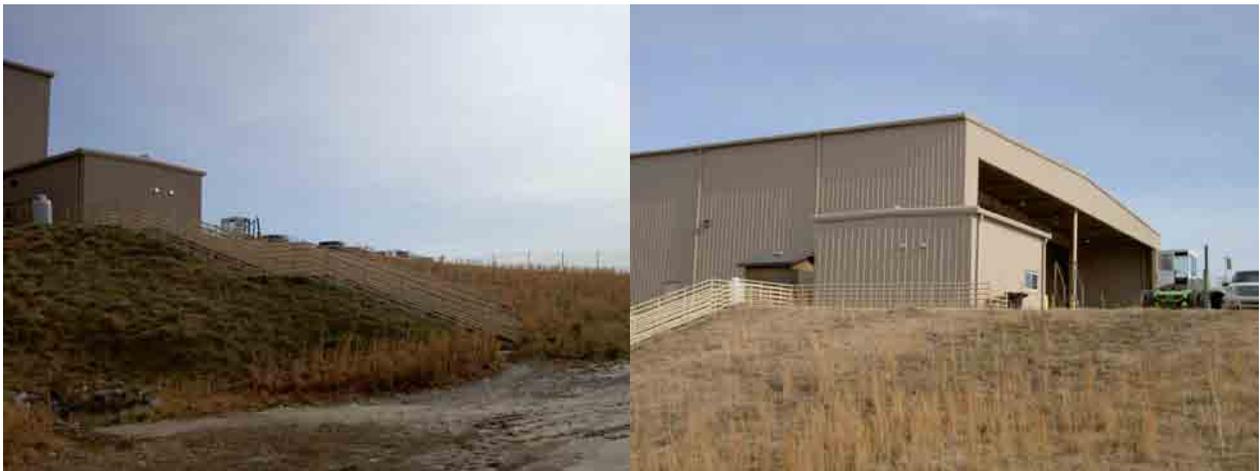
Stable access around the facility, no erosion or windblown debris

- 17) Wind blown debris is being well managed at this time.
- 18) Access around the facility is stable and no areas of erosion were noted during this audit.

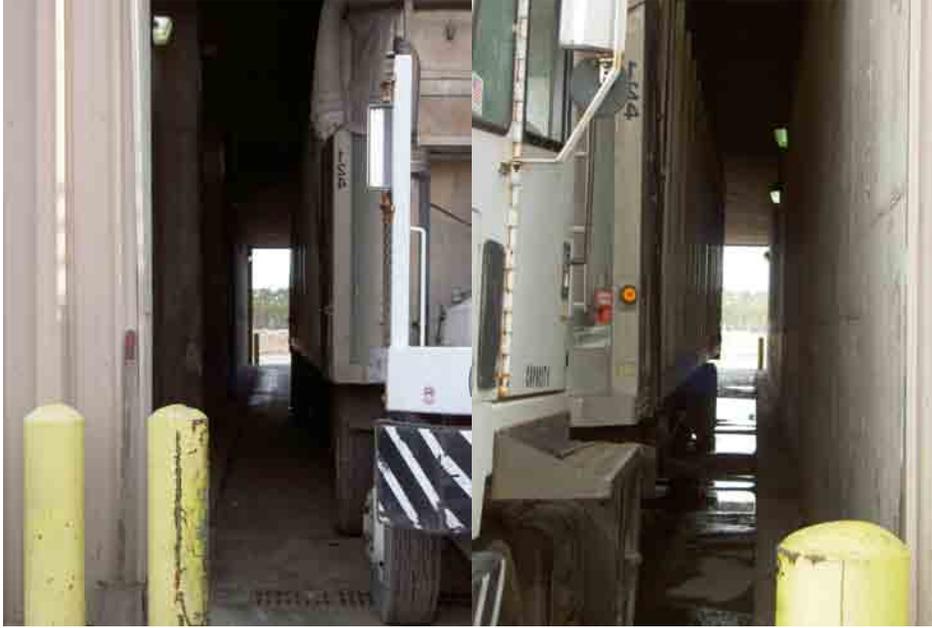
Well maintained trailer loading area

- 14) The trailer loading area is cleaned of any waste overflow as trailers are removed from the bays for transfer and at the end of the workday.
- 15) Leachate is collected on-site in above ground storage tanks and is pumped down and hauled to the Elizabeth City Wastewater Treatment Plant as needed. Leachate and the leachate collection system appear to be well managed at this time.

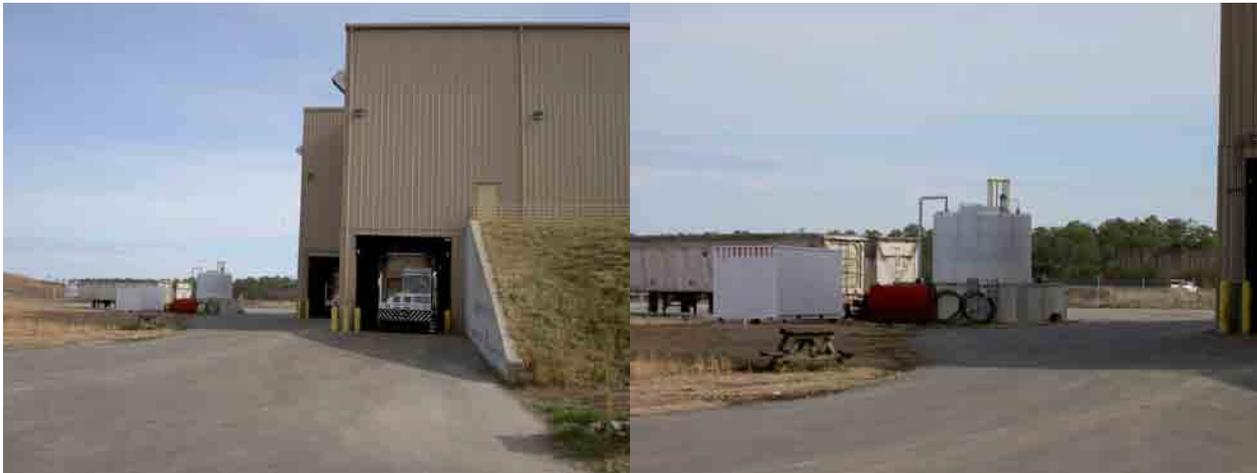
Well maintained trailer bays
