FACILITY COMPLIANCE INSPECTION REPORT
Division of Waste Management
Solid Waste Section

Date of Site Inspection: December 6, 2011 **Date of Last Inspection:** December 16, 2009

B&B Top Soil Mine, Inc. Treatment and Processing Facility
 1800 Hamlin Road
 Durham, NC 27704

Comprehensive Audit

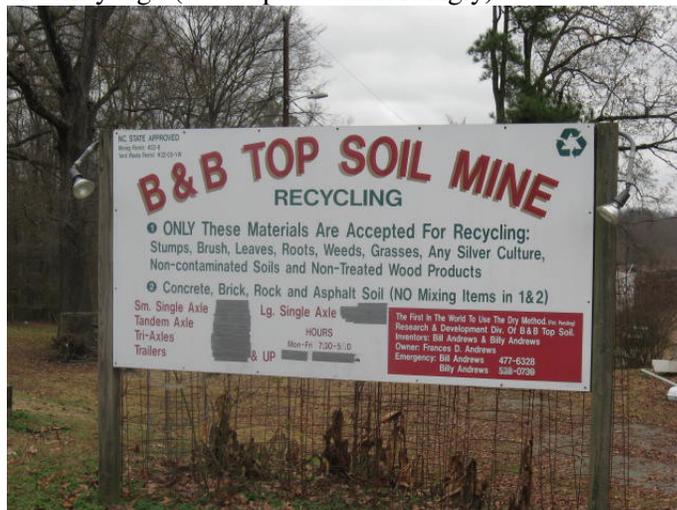
Facility sign (to be updated accordingly)

23. The facility contains proper signage. Ensure the sign is updated to exclude weeds and grasses as acceptable items.
24. The permit expiration date is November 4, 2014.

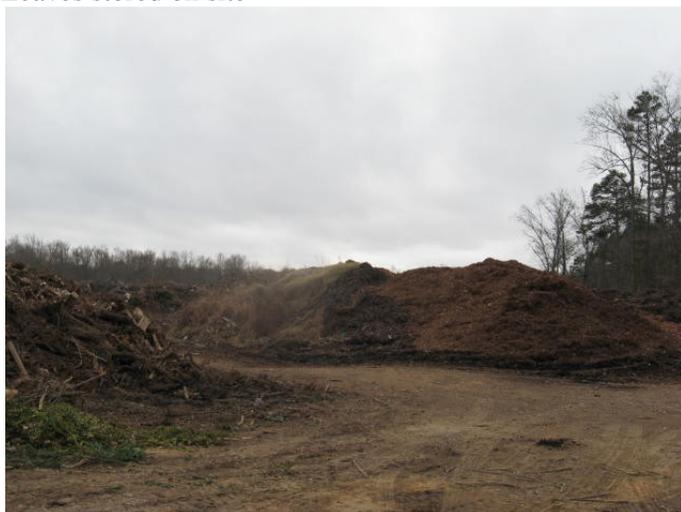
9. It is estimated that the facility currently has ~ 400 yd³ of leaves on site. And that all of it will be used/incorporated into soil or sold within a year.

Leaves stored on site

10. The facility routinely "works" the leaf pile as leaves are removed. Ensure that all of the leaves are turned/handled/moved at a routine interval.
11. The facility maintains records of the amount of material inbound and outbound. Records for January through December 6, 2011 were reviewed. The amount of material inbound and outbound is 9,906.5 yd³. The facility records material in yd³ (per the number of trucks and the hauling capacity of each truck) and divides by 5 in order to obtain tonnage.

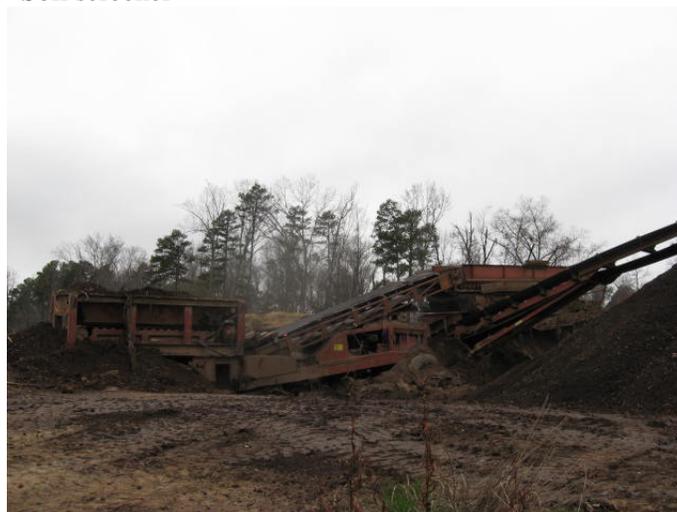
Soil screener

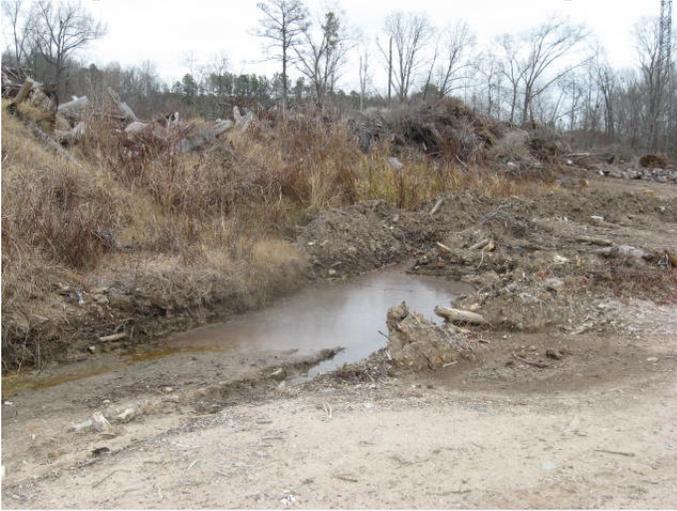
20. Ensure that water does not pond at the base of Dry Method active process piles and around amendment storage areas. The Dry Method active process pile to the north-west of the screener (left side of lot) contained an area of pooled water that did not appear to follow its prescribed channel. Billy Andrews stated that he has moved soil to the area and will grade/repair accordingly such that water does not pond.

Area of ponded water, N-W of screener (to be repaired)

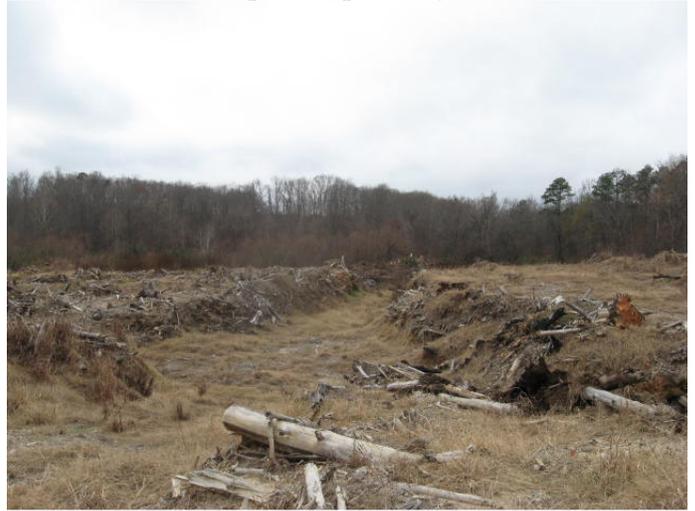
15. The facility appeared to maintain a 50 foot buffer from property lines.
16. All Dry Method active process piles appeared to be < 50 feet wide and 30 feet high.

Dry Method active process piles (right side of lot)

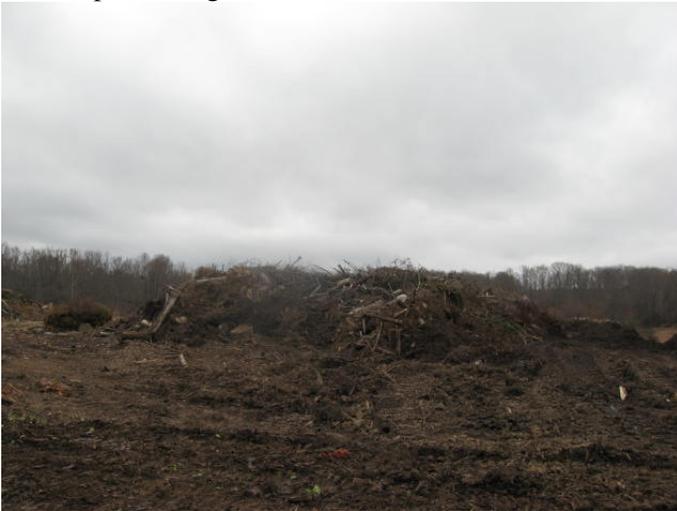
2. Material is formed into long piles resembling windrows, covered with a layer of soil allowing vegetation to grow atop, and left for 2 to 5 years to decay. The decayed material/soil is then screened and, if required, material added for specific soil blends, then sold to the public, landscapers, and builders. Wood chunks screened-out from the soil, needing more time to break-down, are staged to return to the Dry Method active process.

Process piles being worked/soil removed

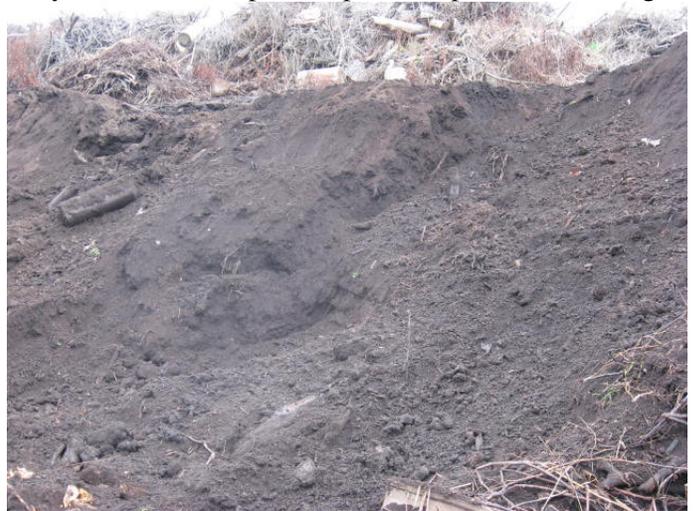
Dry Method active process pile soil, prior to screening
