FACILITY COMPLIANCE AUDIT REPORT
Division of Waste Management
Solid Waste Section

Fontana Village Resort Landfill
 Gold Village Branch Court
 Fontana Dam, NC 28733

Subject: Explosive Gas Preliminary Study
Closed Fontana Village Resort Landfill
Graham County, North Carolina
Permit #38-02

Table 1
Explosive Gas Preliminary Study
Closed Fontana Village Resort Landfill
May 6, 2011

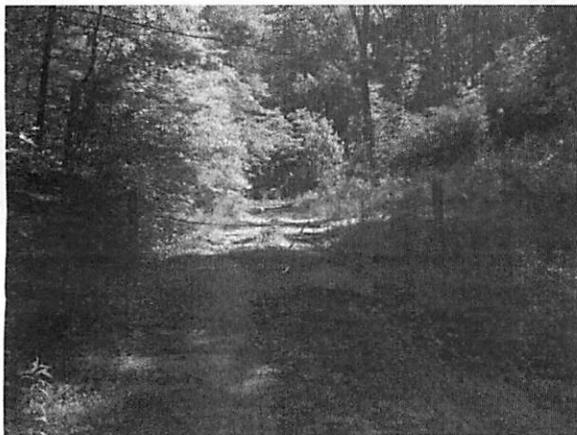
- All photographs were taken by Troy Harrison on June 21, 2011.
- The entrance to the landfill was secured by a locked cable. Landscape features were used to prevent vehicles going around the cable.

Entrance to Landfill

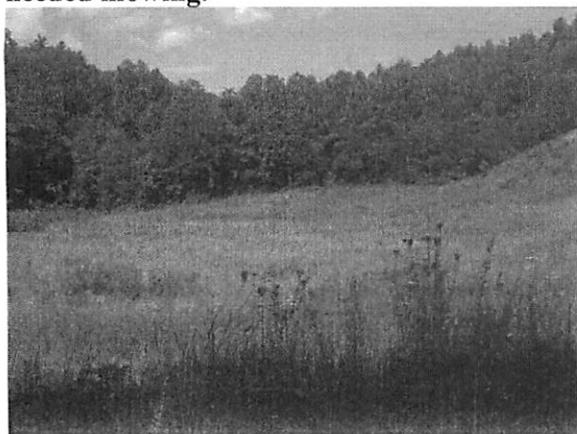
3. Vegetation was well established on the cap. The edge of waste was marked with stakes. **The landfill cap needed mowing.**

Cap of landfill

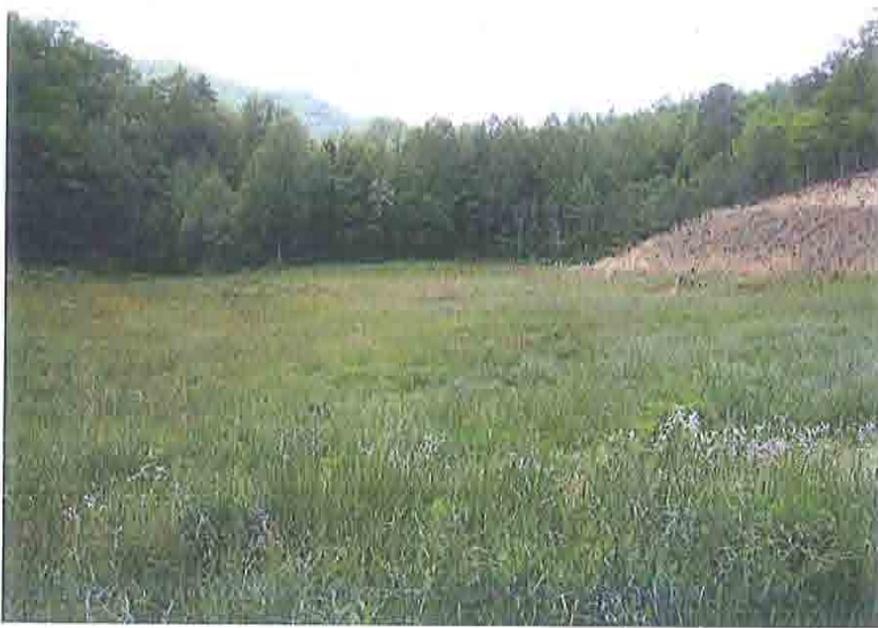
of the lower explosive limit for methane. Furthermore, areas of stressed vegetation were not directly observed.

Photo 1: View of center of the landfill area, facing west.

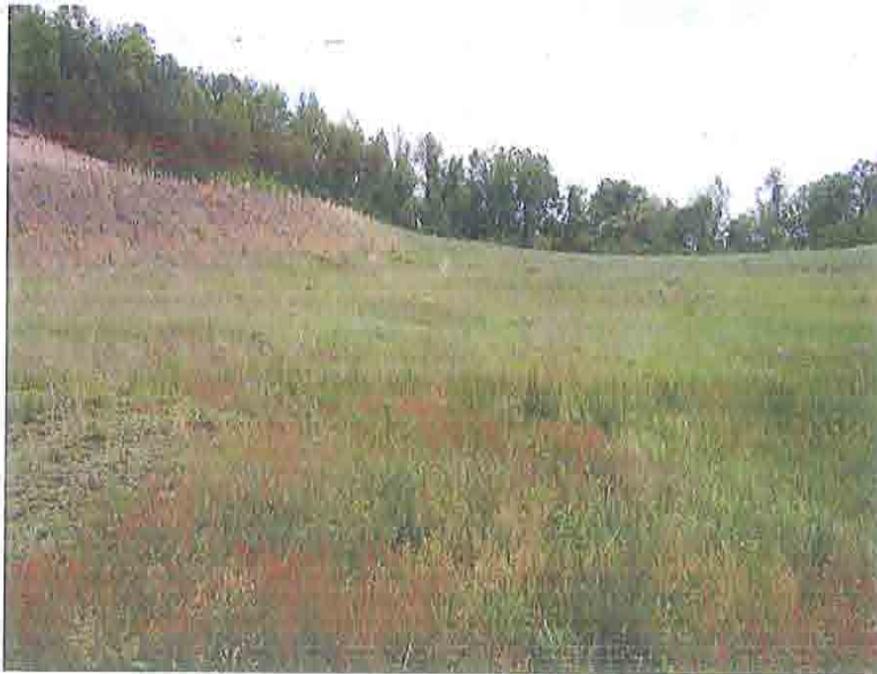
Altamont also walked the approximate edge of waste with Mr. Jeff Williams of Fontana Village Resorts. This approximate edge of waste was recorded with the GPS unit and is shown on Figure 2.

Photo 2: View of north edge of waste, facing northeast.

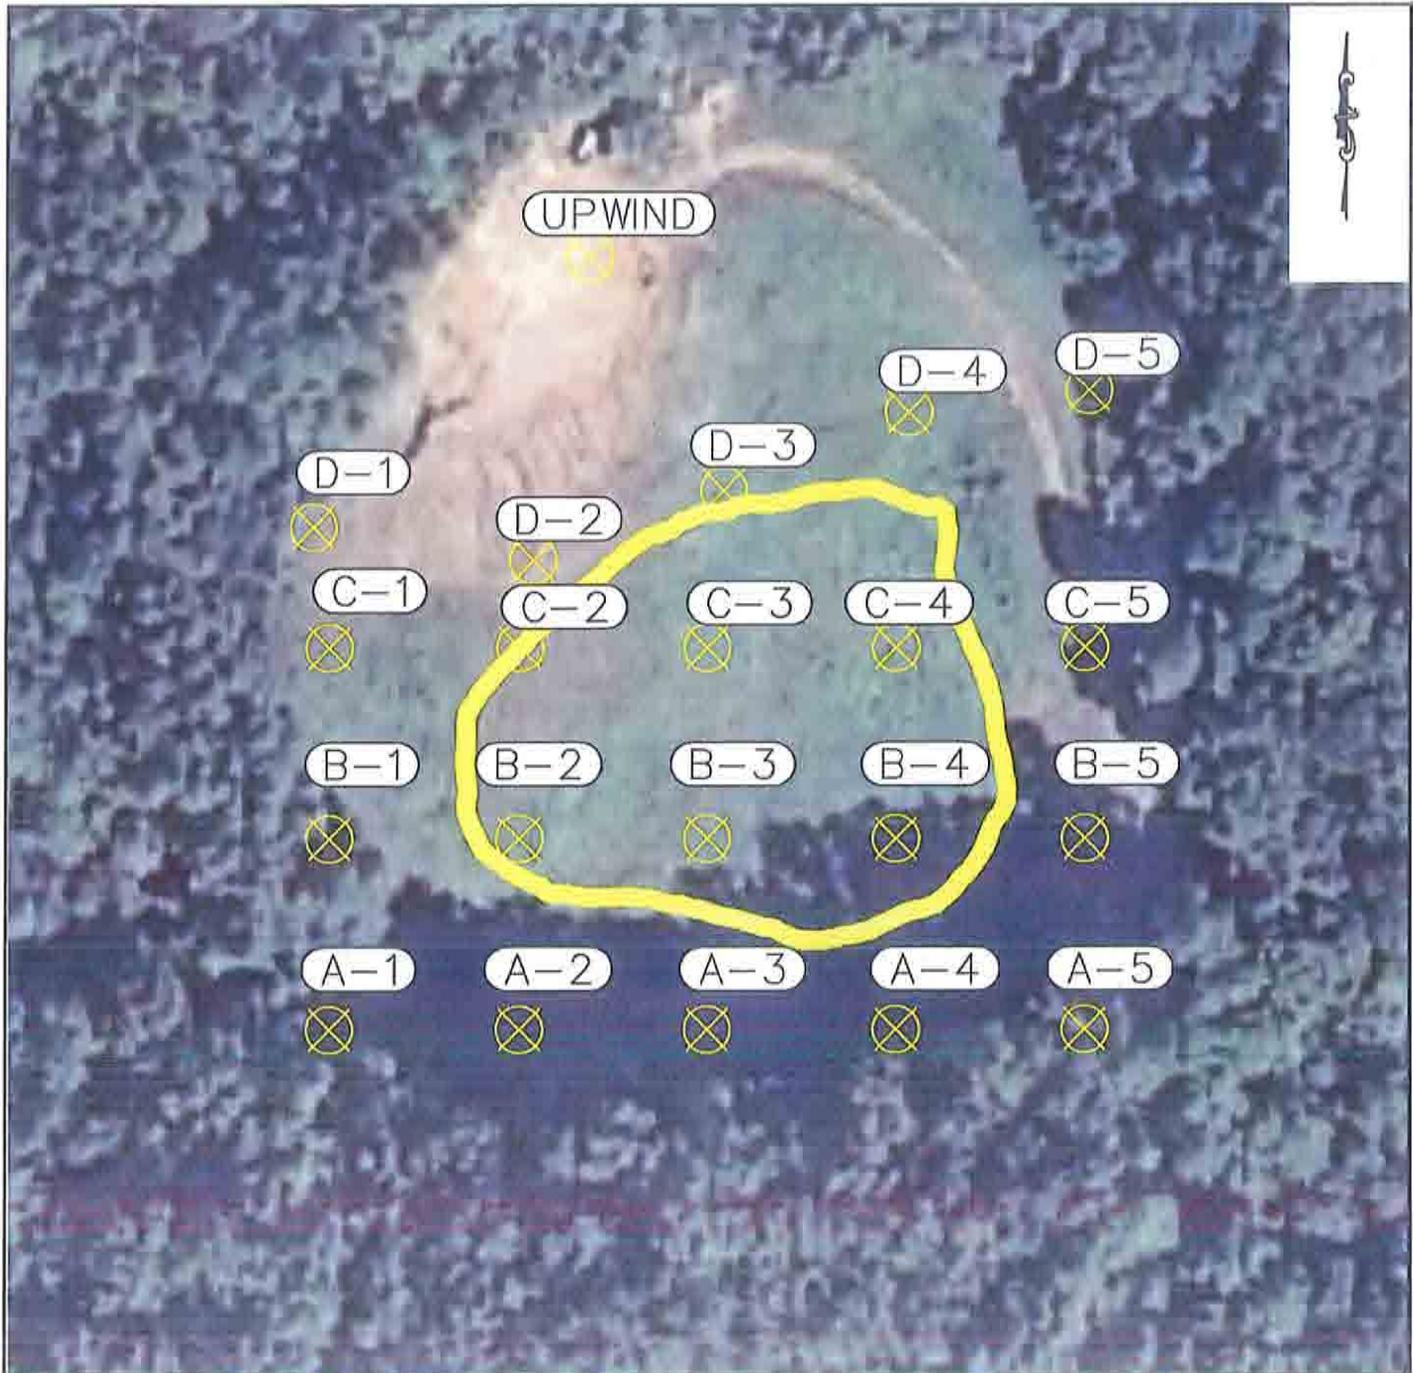
**LANDFILL GAS
 READING LOCATIONS**

Using publically available aerial information, Altamont established a 100-foot grid across the site. A map showing the location of the landfill gas readings is included as Figure 2. These grid locations were uploaded into a Trimble® GeoXH GPS Unit. This global positioning system (GPS) unit has an available subfoot post-processed GPS accuracy. Altamont used the GPS unit to locate each sampling location in the field. Once the sampling location was identified, a Toxic Vapor Analyzer (TVA) 1000 flame ionization detector, calibrated to methane, was used to detect organic vapors in parts per million (ppm). A copy of the calibration record for the TVA 1000 is attached. The "log" function was used for the TVA 1000, which records the highest reading within a selected ten second period. A background reading that was both upwind of and in close proximity to the landfill was also recorded. Each reading was recorded relevant to its respective location. The readings obtained at each location are shown on Table 1 attached.

The barometric pressure did not change significantly during the sampling event. The highest detectable explosive gas reading obtained was 1.26 ppm at location C-1, which translates to approximately 0.00252 %
