FACILITY COMPLIANCE AUDIT REPORT
Division of Waste Management
Solid Waste Section

Date of Audit: January 20, 2011

Anderson Creek C&D Landfill
 1086 Poplar Drive
 Spring Lake, NC 28390

Comprehensive Audit

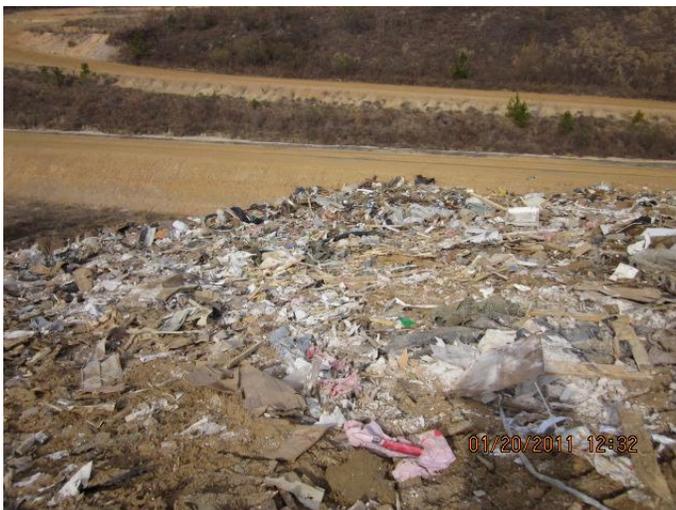
4. The sign at the entrance has the permit numbers and emergency contact information as required.
5. C&DLF units must restrict solid waste into the smallest area feasible and solid waste compacted as densely practical into cells. The waste was extending from the top of the LF to the perimeter berm at the toe of the slope. I recommend that you devise a method to determine when the working face is at or near the ½ acre limit.

C&D Waste top of LF to perimeter berm. N side.

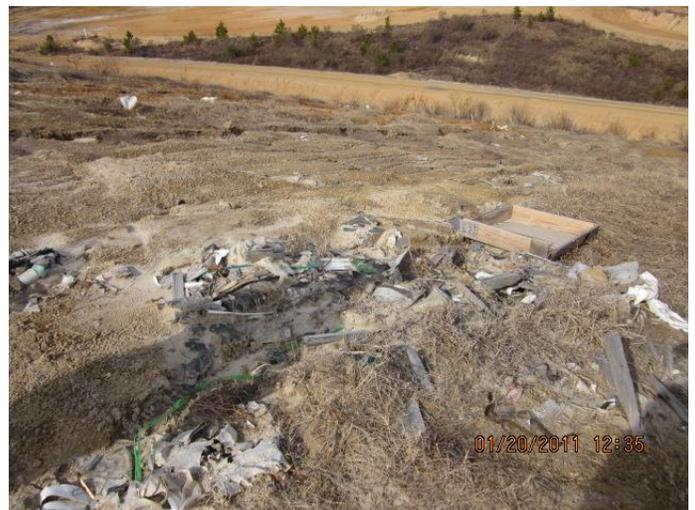
6. Notation of date and time of placement of cover material should be recorded per .0542 (n) (1) (F) as part of the operating record.
7. Several rills were observed with exposed waste on the side slopes at the time of this audit that needs to be repaired and maintained. The efforts to establish ground cover sufficient to restrain erosion need to continue.

Exposed waste, rills. N side slope.

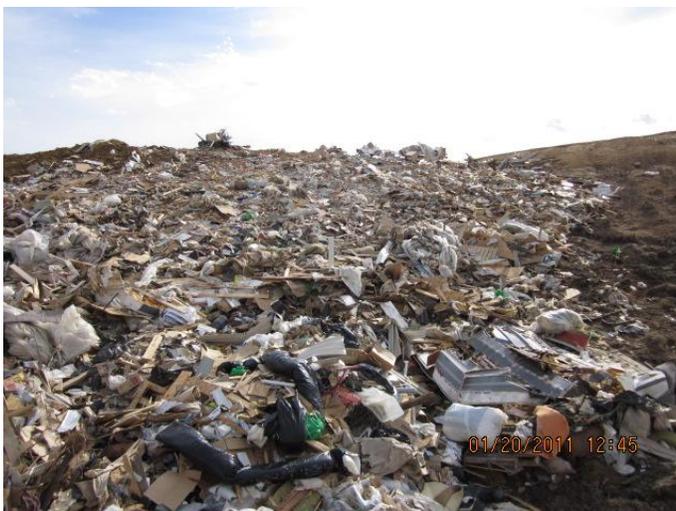
N side slope facing S.

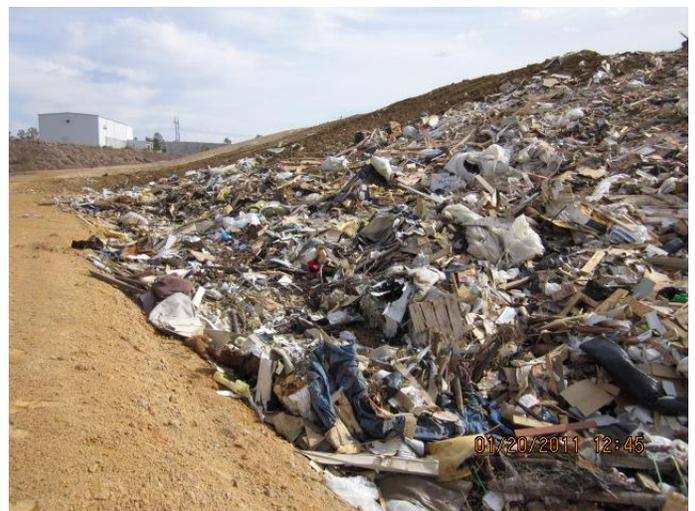
N side slope facing E.

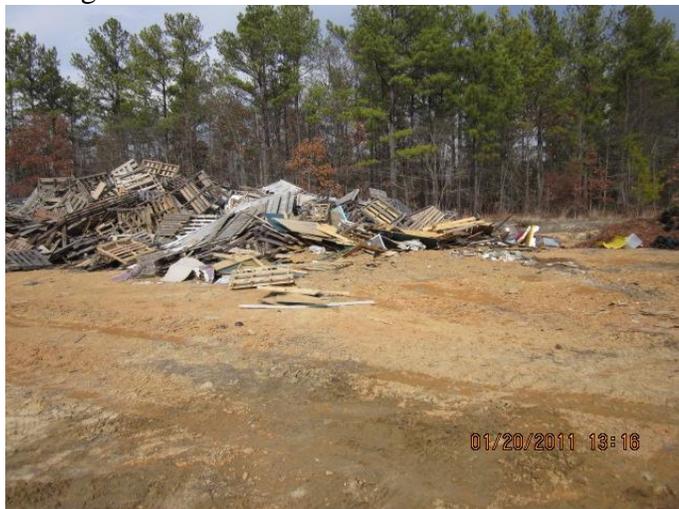
19. The county is separating pallets and clean wood for grinding adjacent to the yard waste area. Unacceptable garbage, plastic, metal, particle board and drywall were observed mixed in with the YW and pallets. Incidental and unacceptable waste should be removed from the Yard Waste area prior to close of business each day.

Yard waste pallet area. Unacceptable waste.

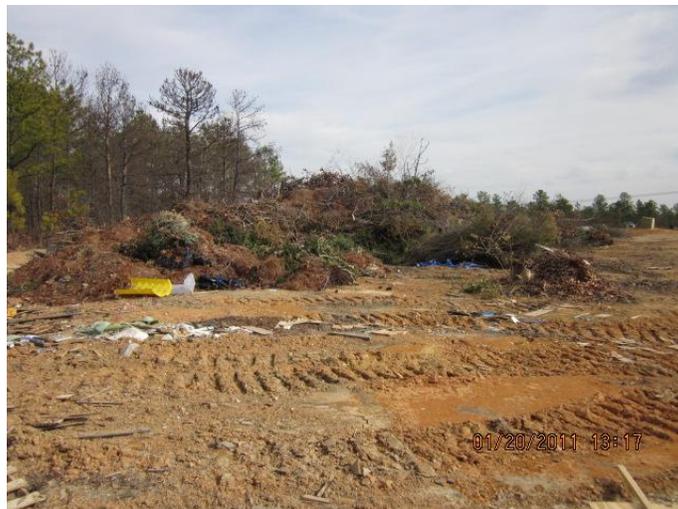
Yard waste area unacceptable waste.

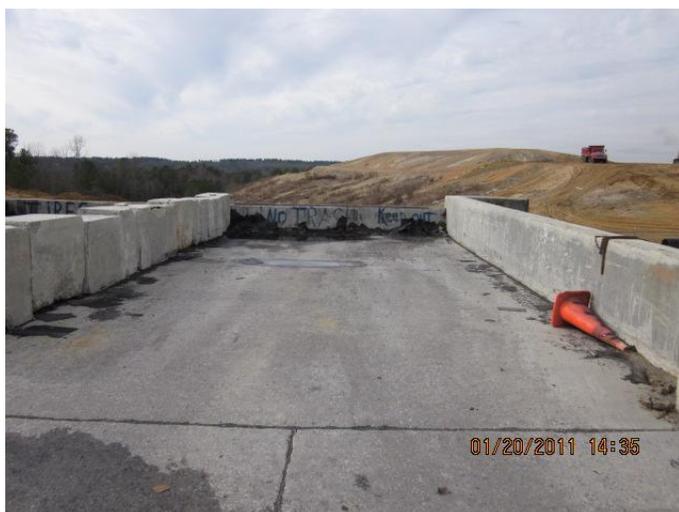
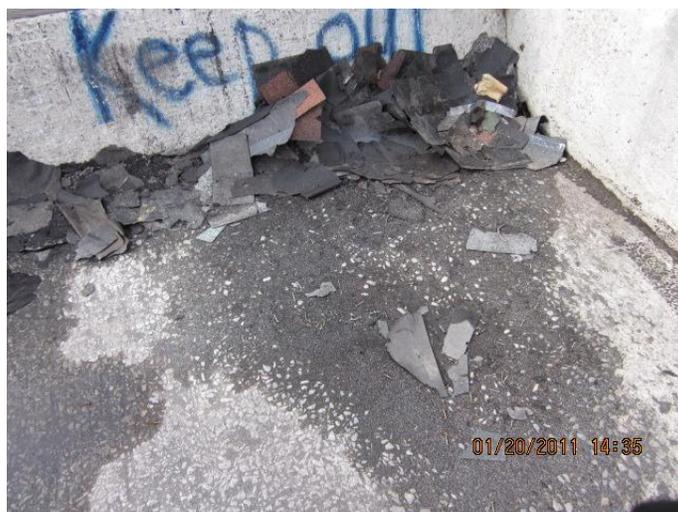
21. The facility is collecting asphalt shingles on a concrete pad adjacent to the scrap tire area. Contact the permitting branch to ensure that this activity has been included in the updated operations plan for approval.

Asphalt shingle collection site.

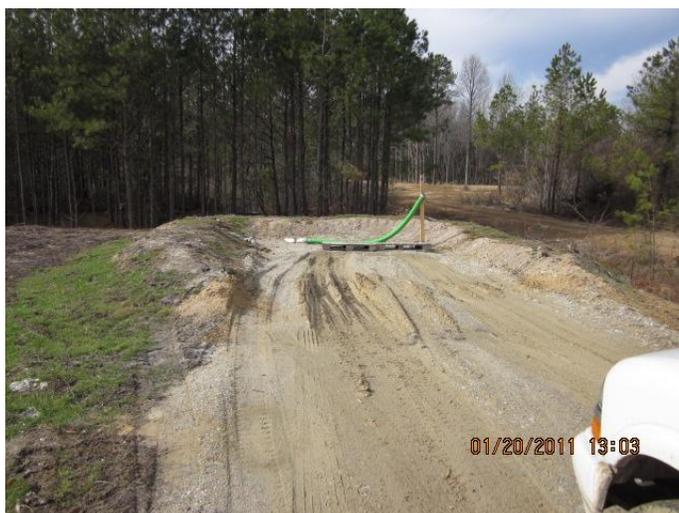
23. The MSWLF closed in 1996.
24. The leachate is being pumped from the newly installed collection system at the C&DLF and closed MSWLF by Temple's Backhoe & Septic Tank and hauled to the Lillington WWTP for disposal.

Leachate collection system truck pump area CMSWLF.

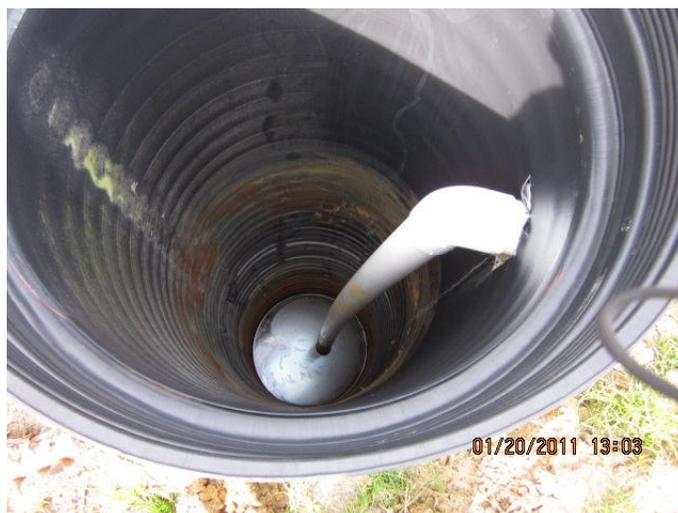
30. The opened well casings for the leachate collection system must be capped. The large opening is a safety hazard and potential conduit for additional contaminants to be introduced into the site.

Open top of well at CMSWLF.
