**FACILITY COMPLIANCE AUDIT REPORT**  
**Division of Waste Management**  
**Solid Waste Section**

Haywood County Municipal Solid Waste Landfill  
 Francis Farm Road  
 Waynesville, N. C. 28786

Comprehensive Audit

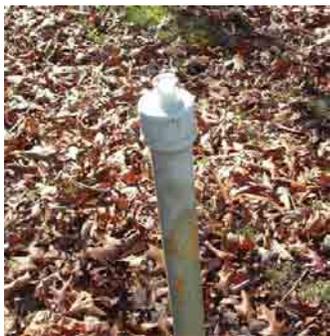
11/20/09

1. Comprehensive inspection of closed MSWLF conducted with A. Keller, D. Cotton, D. Francis, and M. Shumpert.
2. Haywood County reported on meeting with McGill & Associates regarding both the LFG assessment and the GW assessment/mitigation activities. Contract discussions with BLE for management of the LFG extraction system have been underway.
3. County is requesting conference call with all involved Section personnel to discuss steps taken to date by county regarding both LFG and GW monitoring/assessment.
4. LFG wells caps have been retrofitted to meet industry standards (for LFG monitoring).

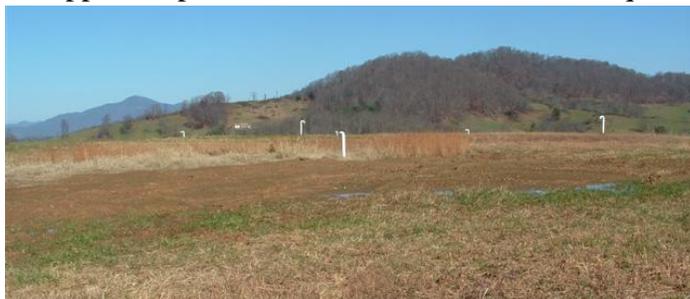
11/20/09

- 7. LFG wells #3 and #6 (according to data sheet) indicated 100% LEL on 11/2 and 11/13. This information was previously communicated to the Section (A. Keller).
- 8. Cap integrity was discussed. Some settlement had occurred (repairs to this area were evident) on top of the landfill. Please note that maintaining the cap integrity and effectiveness of the cap system are part of the approved post-closure conditions and will require ongoing attention.
