**FACILITY COMPLIANCE AUDIT REPORT**  
**Division of Waste Management**  
**Solid Waste Section**

**Dates of Audit:** 10/12/10                      **Date of Last Audit:** 07/21/10

**FACILITY NAME AND ADDRESS:**  
 Haywood County Municipal Solid Waste Landfill  
 Francis Farm Road  
 Waynesville, N. C. 28786

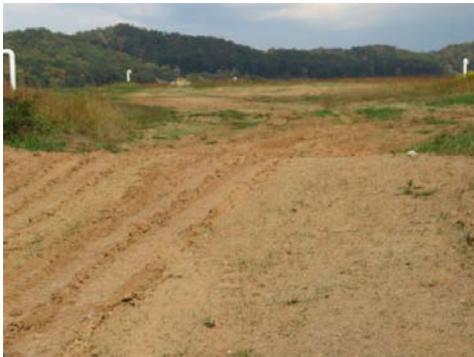
10/12/10

1. Partial audit inspection of closed MSWLF conducted by A. Keller and S. King as follow-up to the Notice of Violation issued on July 21, 2010.
2. The closed MSWLF cap appeared to be in good condition following the installation of landfill gas (LFG) vents and wells associated with gas extraction system. Further work will be required to fully establish vegetation on the areas disturbed during the installation event.

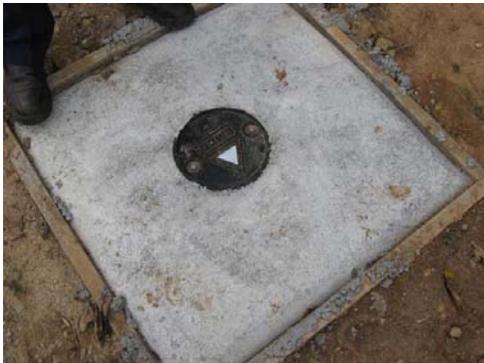
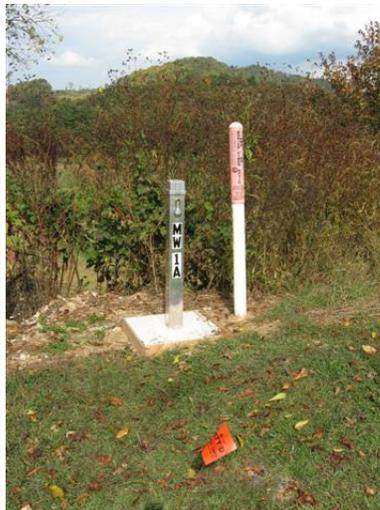
10/12/10

3. Groundwater monitoring well installation had been completed at the time of the audit (in accordance with the approved Groundwater Assessment Plan). Wellheads need to be locked and labeled (subcontractors still working on completing wellheads).

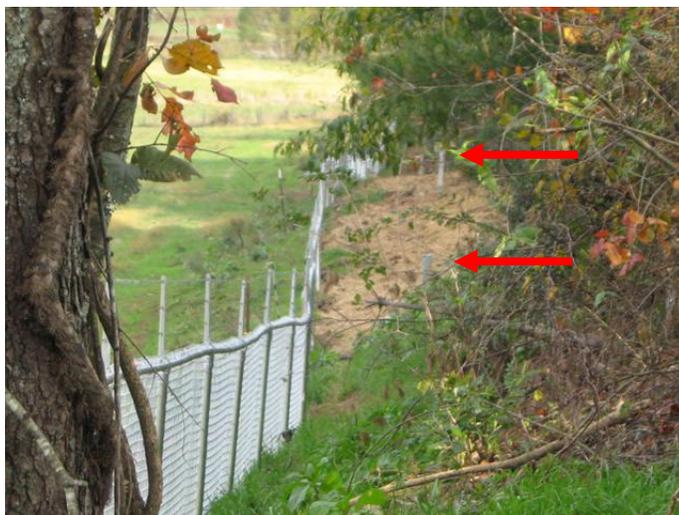
10/12/10

Newly installed MM-1, MM-2, and property boundary fence (northern edge of property).

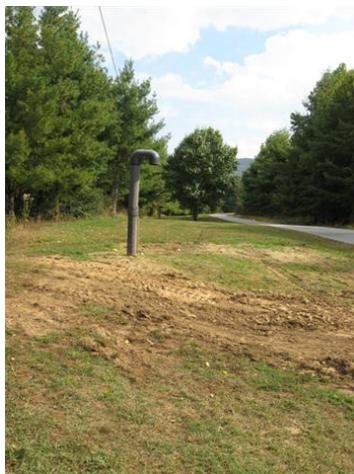
10/12/10

8. The landfill edge-of-waste (EOW) potentially extends beyond what current site maps indicated (per conversations between A. Keller and J. Bishop, and A. Keller and S. King). Further document review and site investigation was conducted and the investigation was ongoing at the time of the inspection.

As part of the LFG mitigation activities at the facility, additional gas vents were installed on the north, outer edge of the access road (seen above). It was stated (S. King) that waste was encountered during the installation of several gas vents, confirming that the EOW extends beyond current site map

boundaries. In the LFG Assessment and Remediation Plan (September 2010), the County stated that, as part of the Assessment Plan, *Haywood County will perform limited excavation to attempt to define the limits of waste along the northern and eastern portions of the landfill. Once the limit of waste is determined, the points will be surveyed and placed on a revised Overall Site Plan of the facility.* Note that the Francis Farm Landfill was operational in the early 1970's and that limited documentation exists to clarify the historical EOW.
