FACILITY COMPLIANCE INSPECTION REPORT
Division of Waste Management
Solid Waste Section

Date of Site Inspection: 9/22/2011

Evergreen Packaging Industrial Landfill
 State Road 1550
 Canton, NC 28716

Partial Site Inspection – nearing closure on cell 6A West

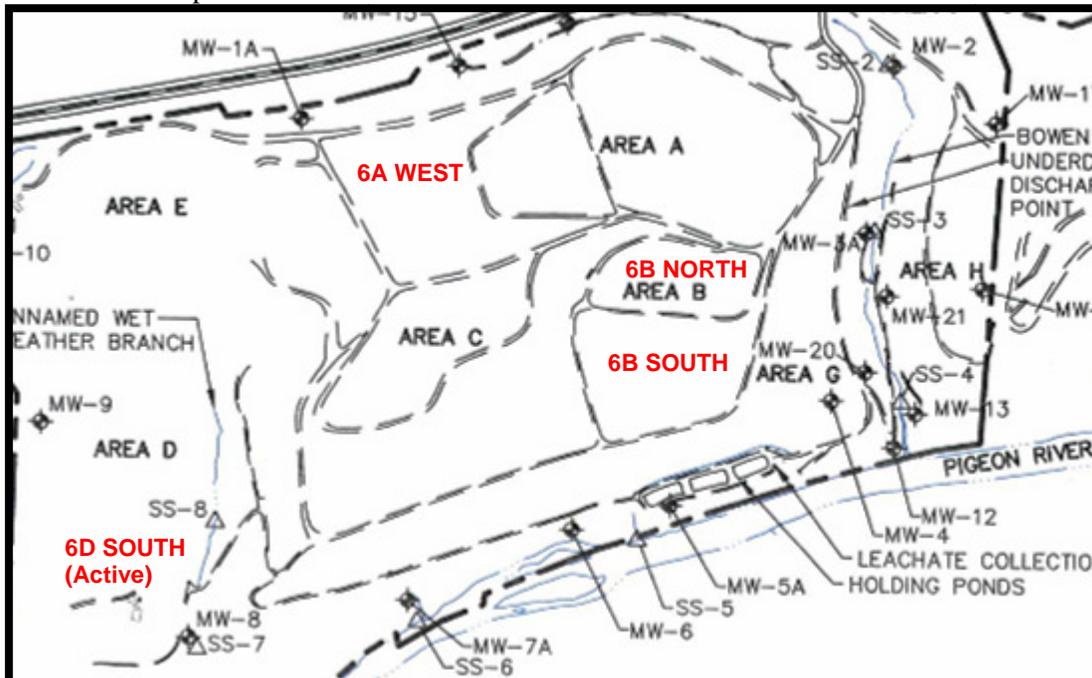
1. On site to conduct partial inspection of facility. Area 6A West undergoing closure activities at the time of the inspection. Cell 6D South was actively accepting waste.
2. General Site Map:

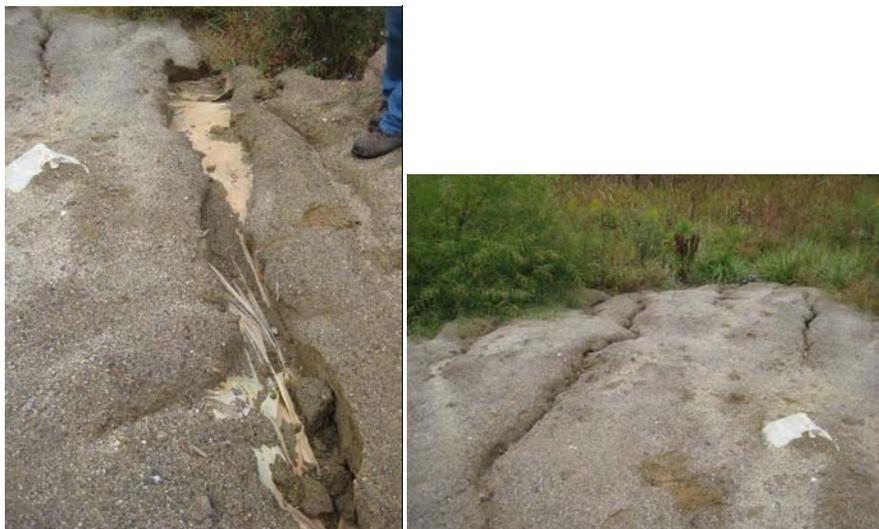
3. The asbestos disposal area is located between Areas F and H. The approved Operations Plan (DocID 11173, dated May 2010) states that “before the end of the day, at least 18 inches of soil will be placed over the plastic

covered asbestos waste.” During the site inspection, visible plastic sheeting used to contain the asbestos was visible due to erosion rills in the soil cover. It appeared as though the original 18-inches of soil had been placed at the time of disposal, but excessive erosion had not been prevented.

On September 22, 2011, exposed asbestos waste was observed at the dedicated asbestos disposal area. It appeared as though adequate soil cover had initially been utilized, but that excessive on-site erosion had degraded the cover and exposed waste in multiple areas. **In order to become compliant with the 15A NCAC 13B .505 (4)(b) requirement, please immediately repair the erosion noted during the inspection and insure that this region of the landfill receives adequate monitoring and maintenance.** (see Item #3 below).

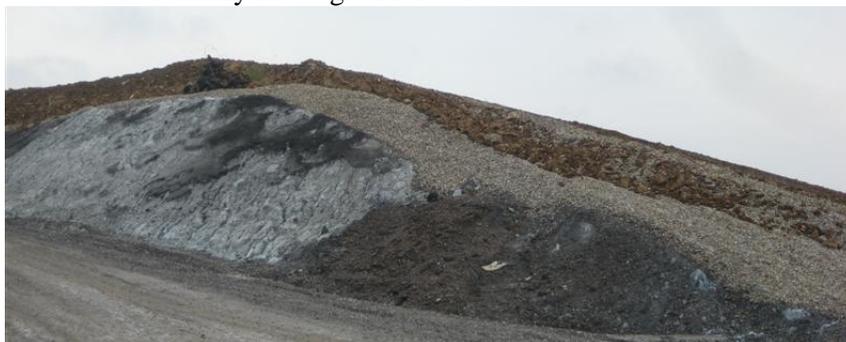
9/22/11

4. The PTO Modification dated June 15, 2011 approved the Closure activities amendment for Landfill No. 6, Area 6A – West (see map above), for the use of off-site soils. Closure activities were ongoing at the time of the inspection. The final waste lift was covered with gravel, off-site contaminated soils, gravel, “clean” soils, and then followed by seeding/erosion controls.

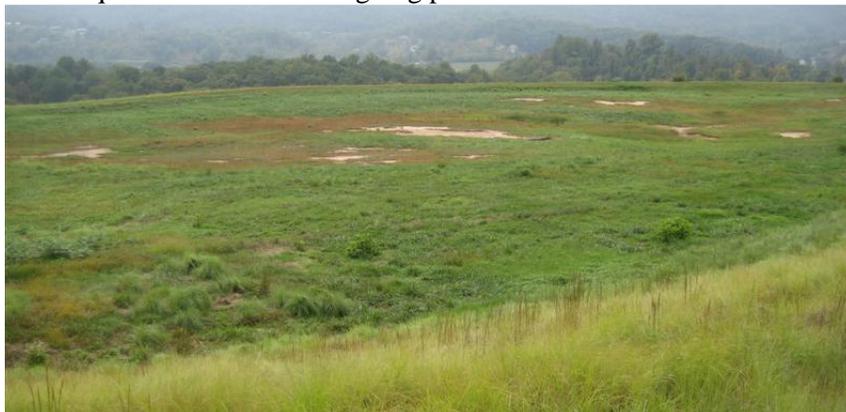
9/22/11

5. During the site inspection areas of settlement and lack of vegetation were noted on the landfill cap for Area C. This issue had been verbally discussed during the previous site inspection at it had been stated (J. Giaque) that off-site soils remaining from the closure of 6A West were to be used to repair this region of the landfill. As discussed on 9/22/11, regardless of the remaining material/soils available from the closure activities, these areas require attention and on-going post-closure maintenance.
