**FACILITY COMPLIANCE AUDIT REPORT**  
**Division of Waste Management**  
**Solid Waste Section**

Haywood County Municipal Solid Waste Landfill  
 State Road 1338, White Oak Community  
 Waynesville, N. C. 28786

Comprehensive Audit

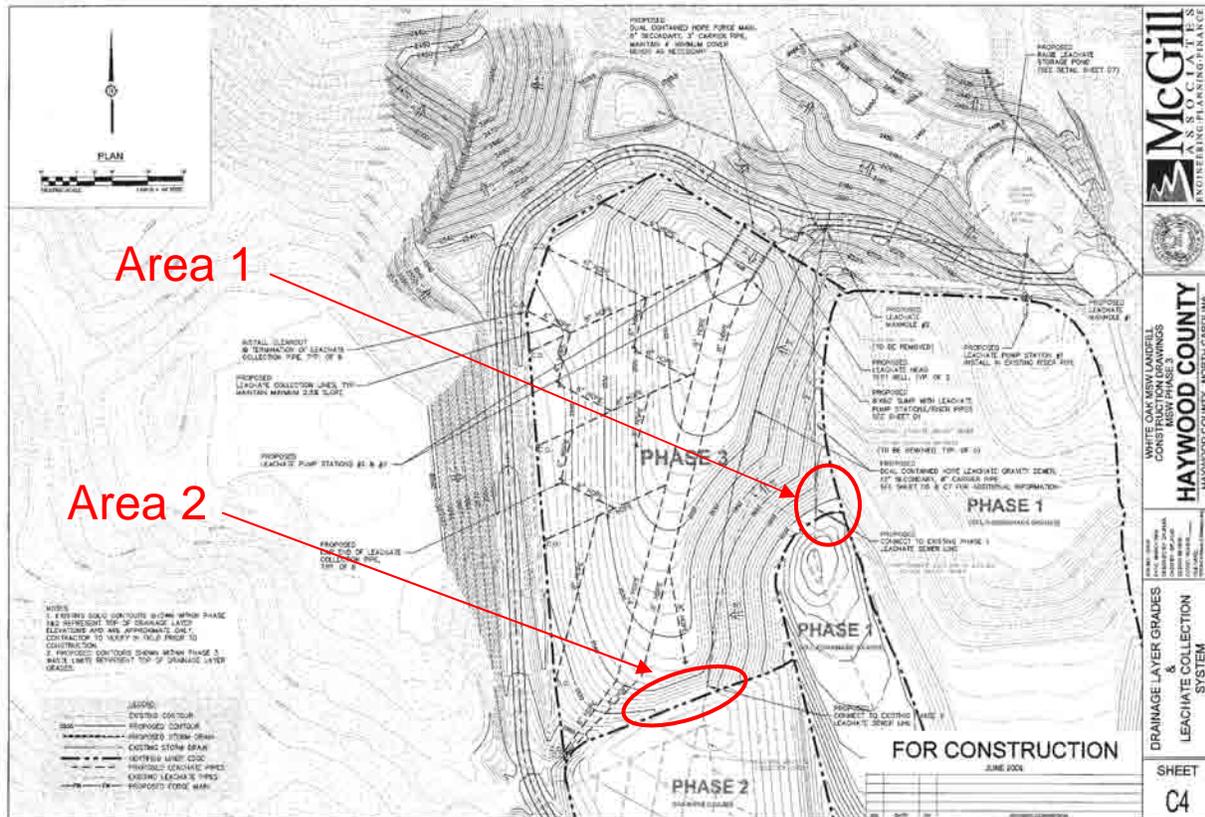
Haywood County self-reported waste outside of the base liner system on August 6, 2009. During the August 7, 2009 audit, and ensuing follow-up site inspections, it was estimated that the violation occurred during the 2001-2003 time frame in Areas 1 and 2 (see map below). On August 21, 2009, a site inspection documented leachate release off the base liner system in both Area 1 and Area 2. The release occurred onto soils already impacted by the waste outside of the liner in the Phase 3 expansion region. Removal of waste outside the liner system was completed by August 25, 2009. Assessment activities relating to the leachate-impacted soils in the Phase 3 expansion region were directed by a Section hydrogeologist and were completed and reported to the Section by October 28, 2009.

During the August 2009 activities associated with the self-reported waste outside of liner violation, intermediate soil cover was removed from several locations (in Phase 1 and Phase 2 fill areas). Follow-up site inspections documented the uncovered waste in Areas 1 and 2 (see map below). The inspection conducted on March 30, 2010 confirmed the lack of intermediate soil cover in these regions.

1. The Section was notified on 08/06/09 (verbal communication from S. King) that during the Phase 3 construction activity waste was discovered outside the liner system (Phase 1, Cell 2 to Cell 4 junction and at the sump pump at the eastern edge of Phase 2).
2. During the site inspection on 08/07/09, two areas of concern were noted:  
**Area 1** is at the junction of Phase 1, Cells 2 and 4. It was estimated (by McGill and S. King) that this region was actively receiving waste in the 2000-2002 timeframe.  
**Area 2** is located near a sump pump/cleanout line in the Phase 2 portion of the MSWLF.

**In order to achieve compliance, Haywood County must, within 30 days, submit a plan detailing actions the County will take to prevent waste outside of the base liner system during future fill activities associated with all current and future waste disposal activities. Other actions may be required of the Division at a later date.**

**In order to achieve compliance, Haywood County must, within 30 days, place a minimum of one foot of intermediate soil cover over all exposed waste in Area 1 and Area 2.**

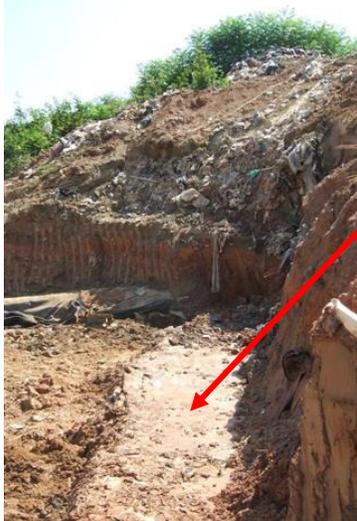
Edge of Liner Shelf, Area 1

- c. Not all waste was cleared from the corner junction of Area 1 at the time of the site inspection (some waste outside of liner), and waste appeared to have been spread outside the liner in Area 2. However, the Area 2 waste appeared to be incidental (mixed with soil – unable to determine cause of waste in this area). It was communicated that this waste needed to be removed from outside the liner (brought back up to the working face for proper disposal).
- d. In Area 1, during the attempt to uncover the liner system (in order to tie-in the liner with the new Phase 3 liner system) a vertical wall of waste was exposed. No dimensions were noted as to how far the waste exceeded the liner system. The vertical “wall” of waste was approximately 20-25’ in height and, during the time of the audit, extended onto the edge-of-liner shelf.

- e. It was stated (by Haywood County) that this area would be amended to pull the waste further back off the liner (in order to stabilize the area). It was communicated to Haywood County that from a compliance standpoint, the critical elements were: remove all waste from outside the liner system, contain all leachate within the liner, and manage the waste and impacted soils (return them to the working face).

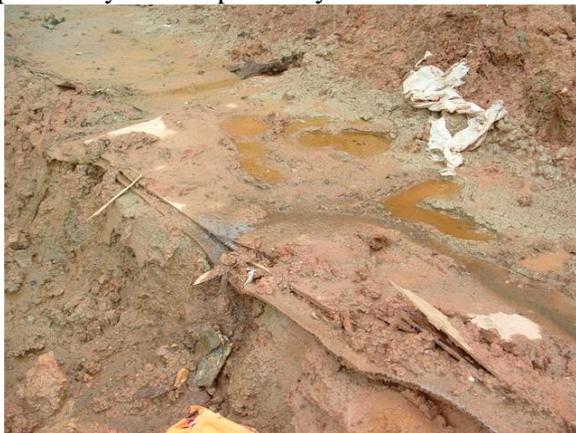
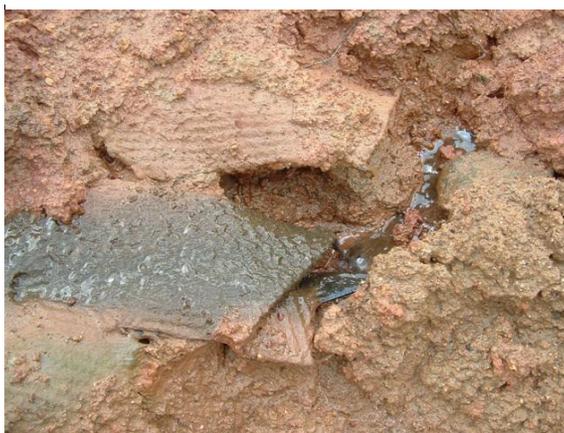
- 1. On site with Bill Wagner (8/21/09) to follow-up on waste removal/leachate containment.
- 2. Area 1 exhibited leachate seeps from the vertical wall (exposed during attempt to clear to liner of Phase 1). Leachate was leaving the liner system during the inspection and contacting soils in the new Phase 3 area in the region which had previously been impacted by the waste outside the liner.

- 3. The County was notified that the existing leachate containment was not adequate. A follow-up meeting with the County was conducted on 8/22/09 to discuss containment actions:

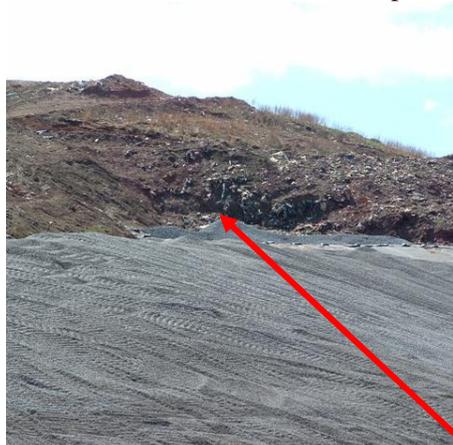
**Area 1 03/30/2010**

11. Areas 1 and 2, noted above, did not have adequate soil cover in place on the intermediate sections of the existing Phase/cell regions at the time of the audit. While these regions have steep, unstable slopes due to the excavation to uncover the liner (for the Phase 3 expansion), the areas are required [15A NCAC 13B .1626 (2)(c)] to have one foot of intermediate soil cover in place.
