FACILITY COMPLIANCE AUDIT REPORT
Division of Waste Management
Solid Waste Section

Date of Audit: 03/08/2011

Haywood County Municipal Solid Waste Processing Facility
 278 Recycle Road
 Clyde, NC 28721

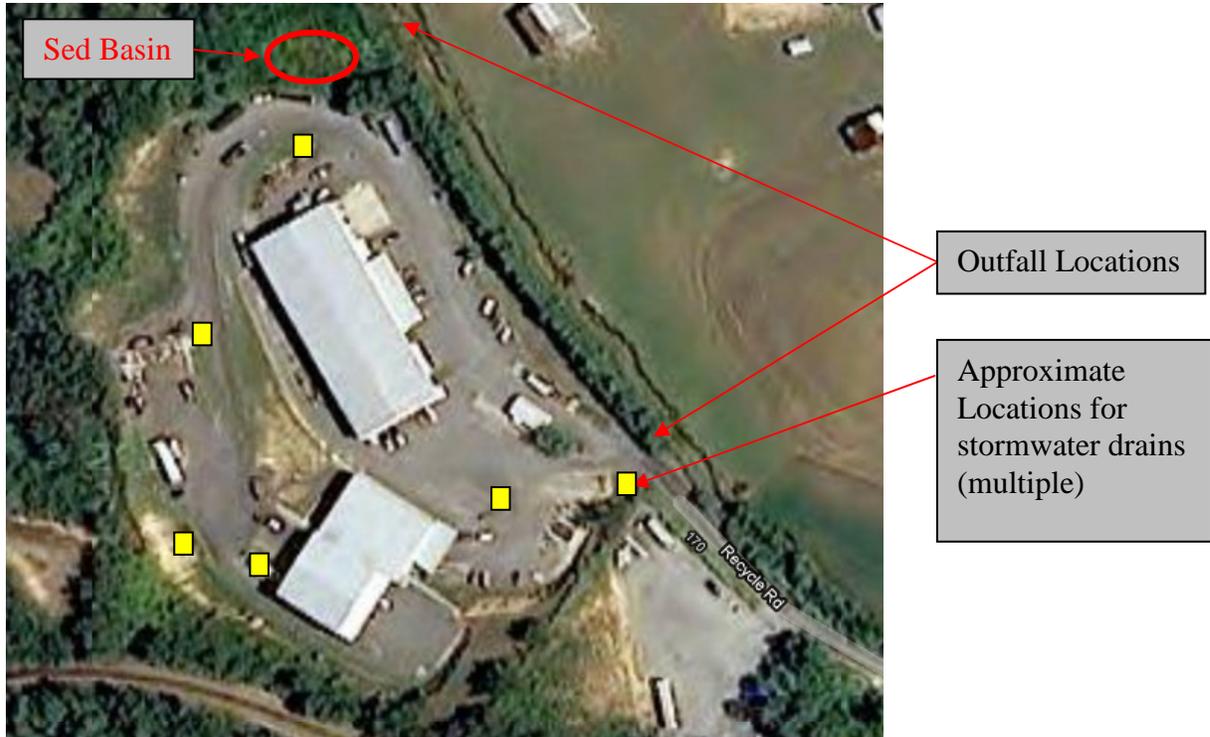
1. On site to conduct partial site inspection in conjunction with Susan Wilson, Division of Water Quality (DWQ), Surface Water Protection Section. Weather: dry, sunny, upper 40's.
2. Reviewed stormwater outfall locations, drains, erosion control measures (see map below).

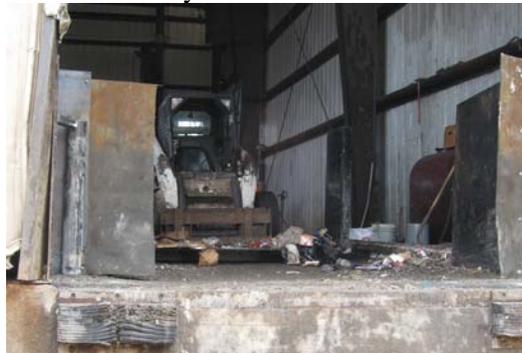
3. It was previously stated (02/09/11) that the drains in the tipping floor, and the drains beneath the transport vehicle loading areas tie in to the sewer system (per S. King). Since that time, the County has investigated all drainage points at the facility and determined that the drain located at the loading bay was a stormwater drain rather than a sewer drain. The following precautionary measures have been implemented to prevent waste/leachate from reaching this drain:
 - a. Drain sleeve and temporary socks placed in and around the drain.

- b. Side guards to direct waste directly into the receiving bay of the transport truck have been installed on both sides of the bay.

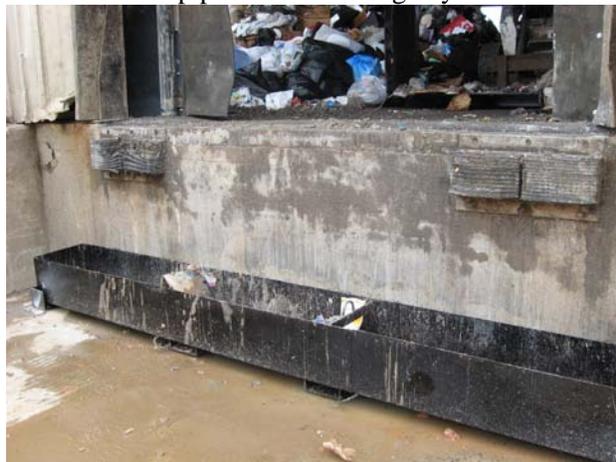
- c. Installation of a drip pan at the loading bay entrance to capture any waste/leachate.

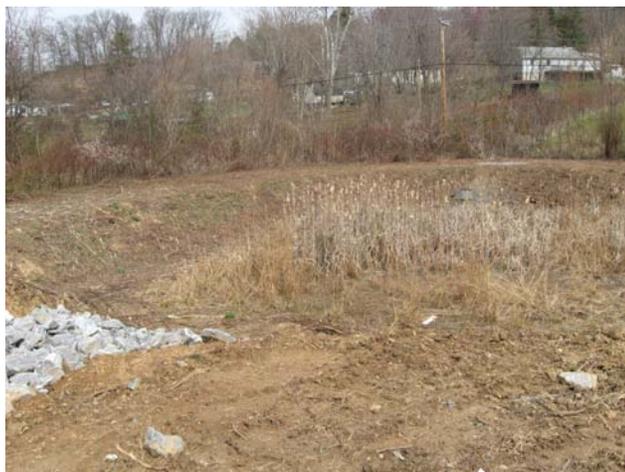
4. The Transfer Station tipping floor appeared to be in good condition. No accumulation of wastes was noted on walls or support beams at the time of the audit. The White Goods area was controlled/in order.
5. The facility had partial Stormwater Discharge Records for review (Permit # NCG 130039). Site map and discharge point locations were reviewed. The sedimentation pond region of the site (near discharge collection point) was inspected. Significant work had been done to repair/restore the sed basin.

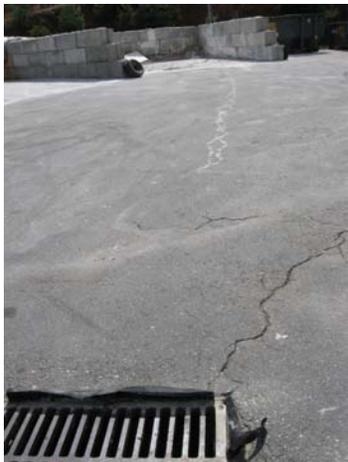
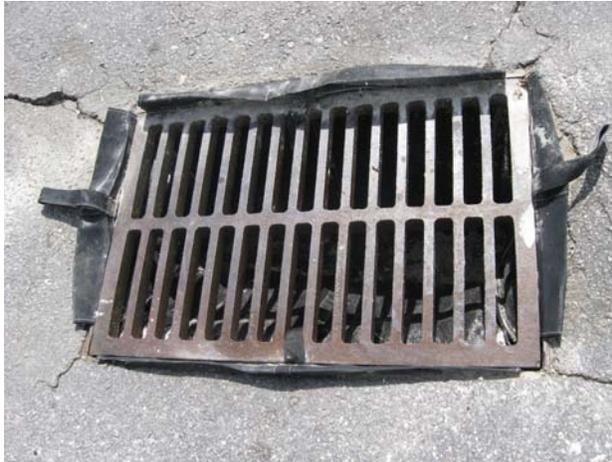
6. Windblown materials were minimal at the time of the audit. The one area of note during the previous audit (sed basin area) had been cleared of windblown wastes.
7. Previous audit reports commented on the need to ensure that no particulate from the drywall/gypsum storage pile reach the stormwater drain. The facility has installed drain sleeves to capture particulate at this location. (see photo below).

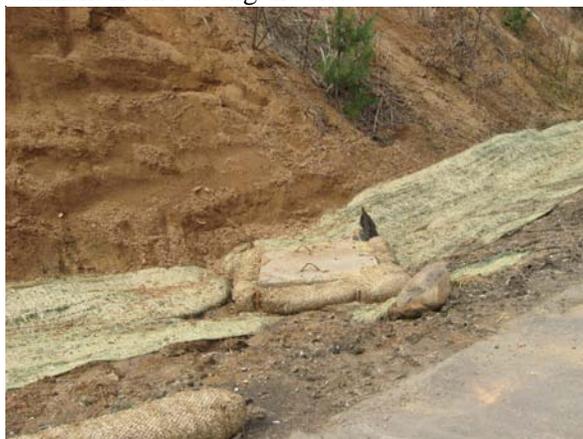
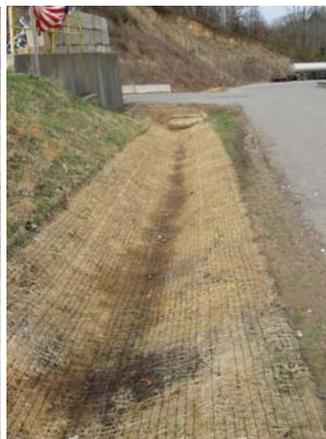
8. Erosion and sediment control measures at the drainage ditch locations had been implemented at the facility to control sediment from leaving the site.
