**FACILITY COMPLIANCE AUDIT REPORT**  
**Division of Waste Management**  
**Solid Waste Section**

**Date of Audit:** 06/11/2010

Henderson County Solid Waste Landfill

1. On site to conduct follow-up audit to the previous (03/10/10) comprehensive audit of the closed MSWLF, closed C&DLF located on top of the closed MSWLF, and the inactive stand-alone C&DLF (awaiting formal closure from the Section). In addition to these three fill areas, the following fill activities are located within the facility boundary (a 1992 Gas Monitoring Probe Location Map, sheet one; a 1992 Base Area Existing Solid Waste Disposal Facility map, sheet 1; and a 1993 Site Plan Proposed Final Contours/Existing Contours sheet 2):
  - a. Closed TVA Disposal Area (1978)
  - b. Closed Disposal Area 1982 Permit
  - c. Demolition Landfill (inactive)
  - d. Asbestos disposal site (inactive)
  - e. Asbestos disposal site (proposed)

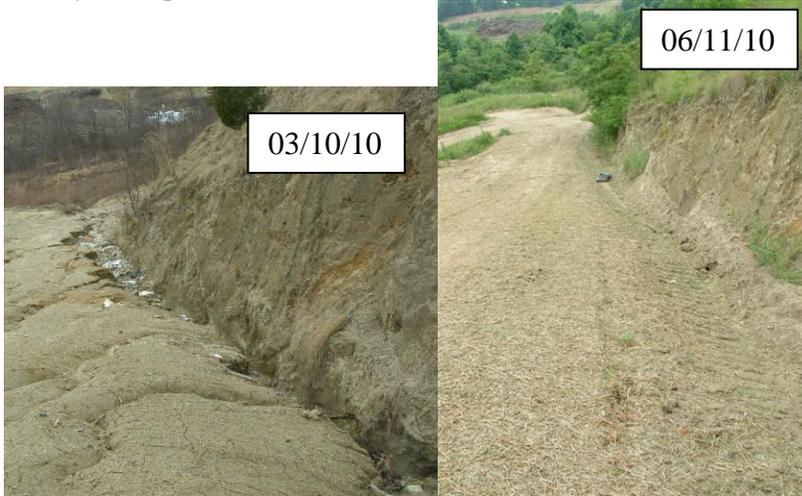
1. During the previous audit the erosion ditch pictured below (located below the CDLF) had exposed waste. The County has repaired this area of the facility (see photos below).

In order to resolve the Notice of Violation, the County met the June 4, 2010, compliance deadline to correct the settlement, subsidence, erosion, and vegetation requirements at the C&DLF unit.

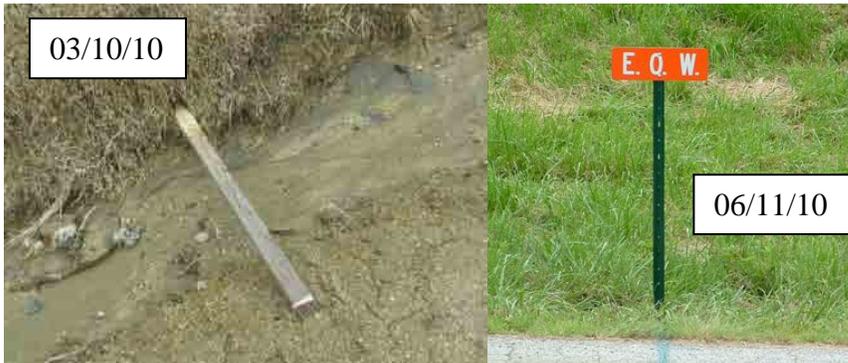
2. During the previous audit it was stated that the *EOW markers will need to be re-established for the closed C&DLF.*

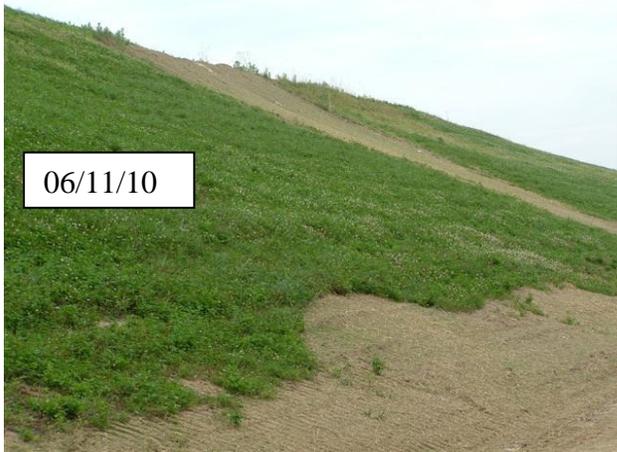
3. During the previous audit, slumping was visible on the southwestern slope of the landfill and several leachate seeps were noted. The County had conducted substantial work to correct the slumping, repair the seeps, and stabilize vegetation on the cap system.

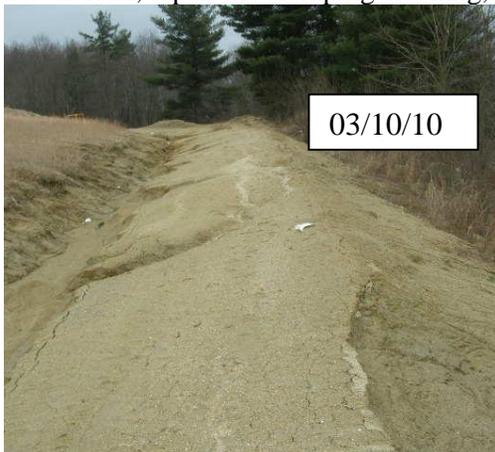
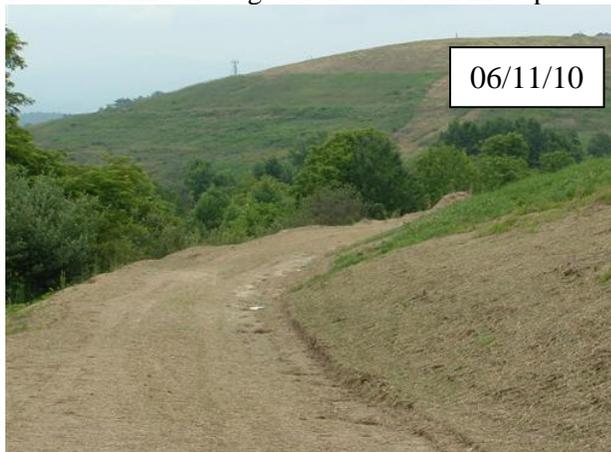
4. During the previous audit, the access road on the C&DLF was slumping and eroding and the ground cover appeared unstable (visible cracking). The County has conducted substantial work in this region to stabilize the access road, repair the slumping/cracking, and to stabilize the vegetation on the CDLF cap.

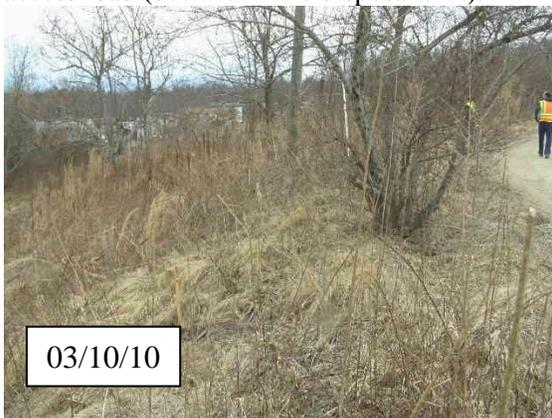
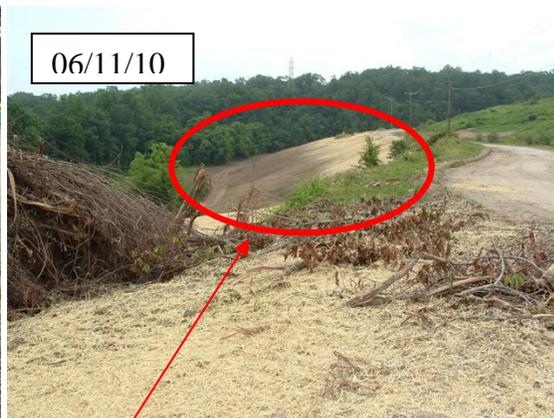
1. During the previous audit it was noted that significant vegetation had taken root on the outside perimeter of the access road (but within the disposal unit).

Note: a large amount of established woody/tree growth had been removed/cleared during this process, the slope was re-graded and seeded to re-establish manageable grass cover, and seeps had been repaired.

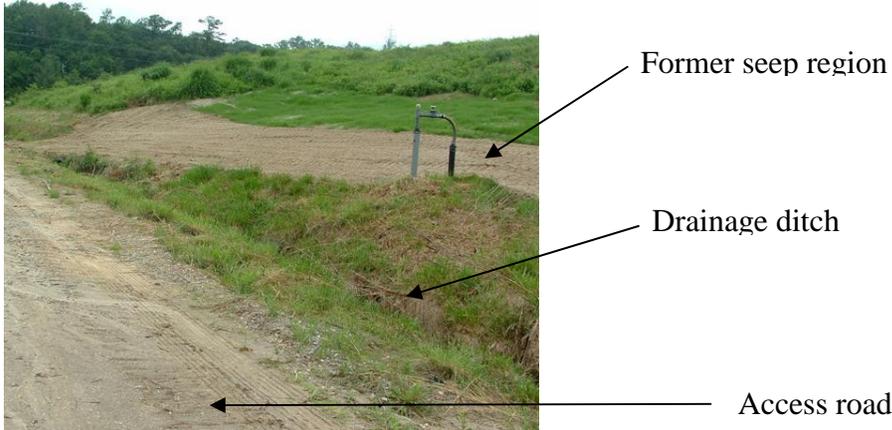
2. The County had corrected the EOW markers to reflect the disposal units/site maps. Additional EOW markers will be installed following completion of the work (clearing of trees, reshaping of the cap system, etc.) at the MSWLF.
3. Several seeps were noted along the closed MSWLF cap system. The County has repaired these seeps and seeded the repaired area.
