**FACILITY COMPLIANCE AUDIT REPORT**  
**Division of Waste Management**  
**Solid Waste Section**

**Date of Audit:** March 16, 2011

Western Carolina University  
 MSW Landfill  
 Monteith Gap Road (State Road 1336)  
 Cullowhee, NC 28723

Comprehensive Audit of Closed MSD Landfill

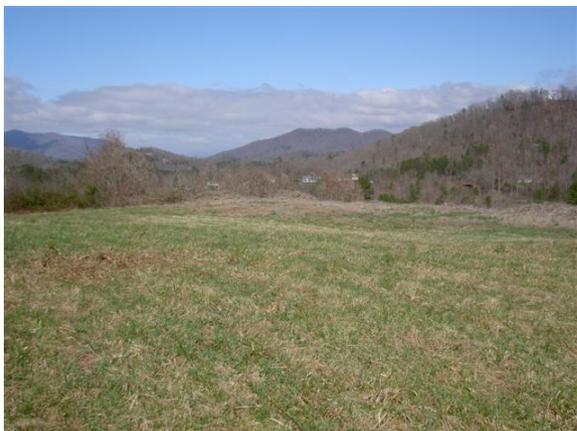
1. All Photographs were taken by Troy Harrison on March 16, 2011.
2. The facility ceased receiving waste on 10/08/1993 and the final soil cover was in place as noted in a 4/21/94 audit report.
3. Vegetation was well established and well maintained on top of the landfill. The slope of the landfill was heavily covered with kudzu with a few dead trees. Groundhog burrows were observed throughout the area where kudzu was growing.

Top level of Landfill being well maintained

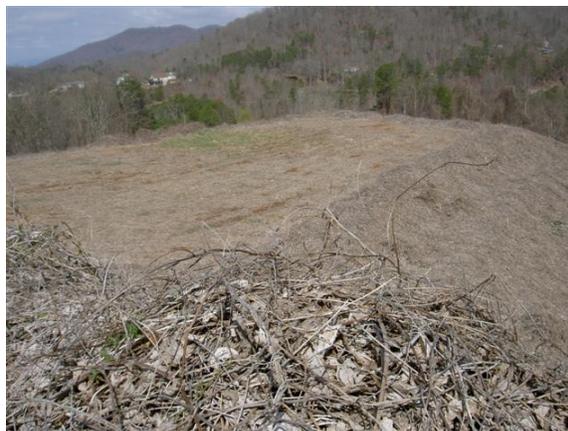
Second Top level being maintained and unmaintained Eastern slope

**It is requested that Western Carolina submit a plan to remove the kudzu and woody vegetation from the slope of the landfill and the area sown with native grasses. The plan must include a plan to remove groundhogs from the slope of the landfill. Please submit this plan to Troy Harrison by July 1, 2011. The plan must also include provisions for the placement of "edge-of waste" markers.**

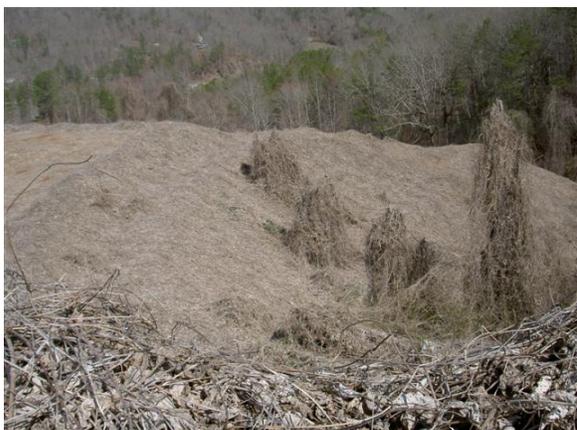
Unmaintained Eastern slope with Woody Vegetation

Post Closure Condition 4 states: "The integrity and effectiveness of the final cover system and any permanent erosion control devices must be maintained. This could include making repairs to the cover as necessary to correct the effects of settlement, subsidence, erosion or other events."

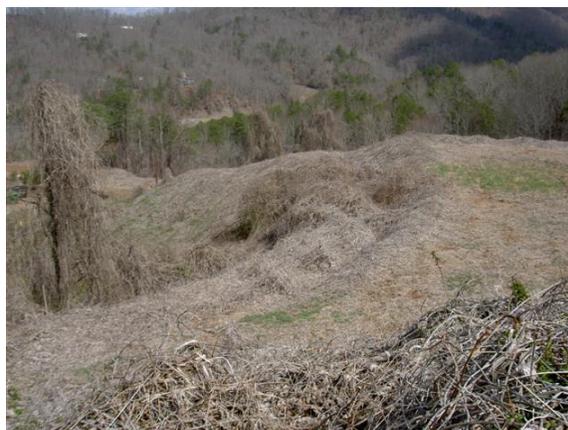
Unmaintained Western slope with Woody Vegetation

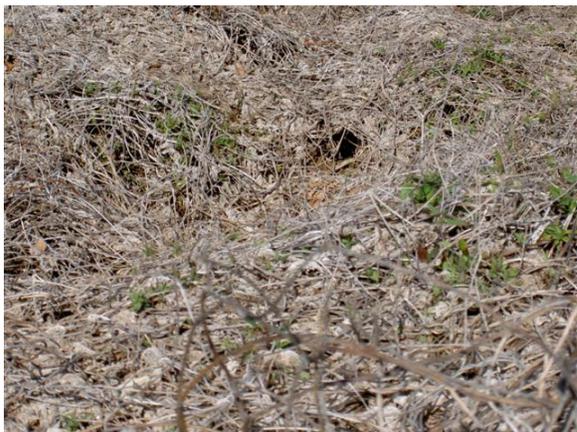
Groundhog Burrow

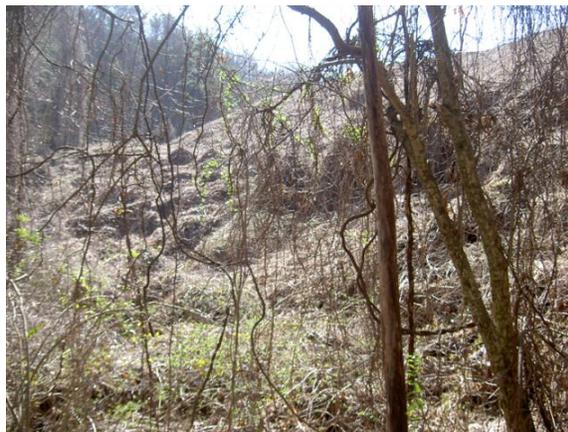
Looking south from the bottom at the Unmaintained Eastern Slope

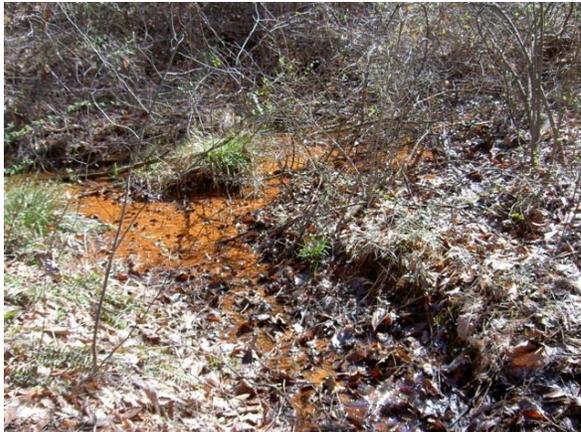
Discoloration in a stream below the landfill was observed. This stream was sampled during the July 1, 2004 sampling event and will need to be included any future sampling activity. Copies of this report will be forwarded to the NC DENR-Division of Water Quality for review.

Stream near Northeastern edge of Landfill

1. Within 30 days, begin annual surface and groundwater sampling, and
2. Within 90 days, submit results of surface and groundwater sampling to:
