**FACILITY COMPLIANCE AUDIT REPORT**  
**Division of Waste Management**  
**Solid Waste Section**

Jackson County MSW & C&D Transfer Facility  
 Scott Creek Transfer Station  
 48 Recycle Place  
 Sylva NC 28779  
 828-586-7509

Comprehensive Audit of MSW Transfer Station

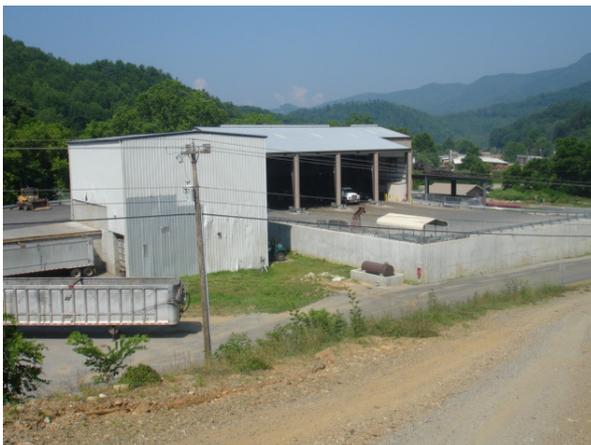
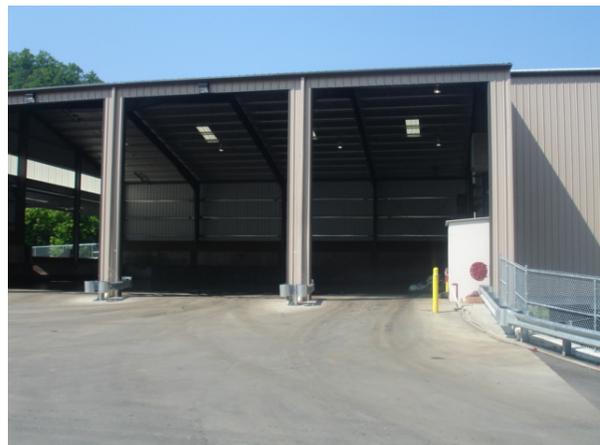
11. The transfer station was observed in operation. Smaller loads and private individuals have access to a separate area from large commercial haulers to place waste for transfer. No windblown debris was observed. The area around the transfer station and the rest of the property was very clean and well maintained.

Commercial Disposal Area

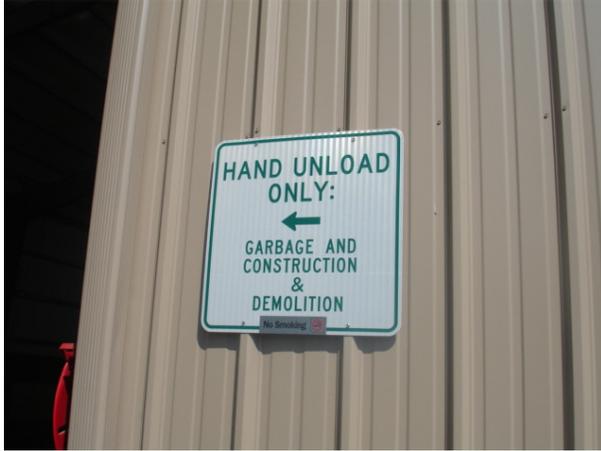
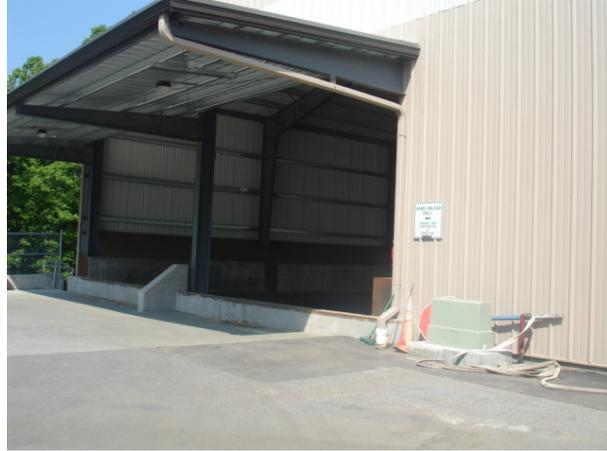
Small generator disposal area

Small Generator Disposal Area

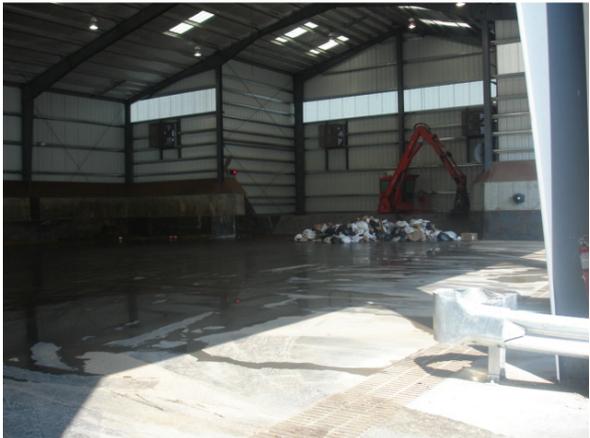
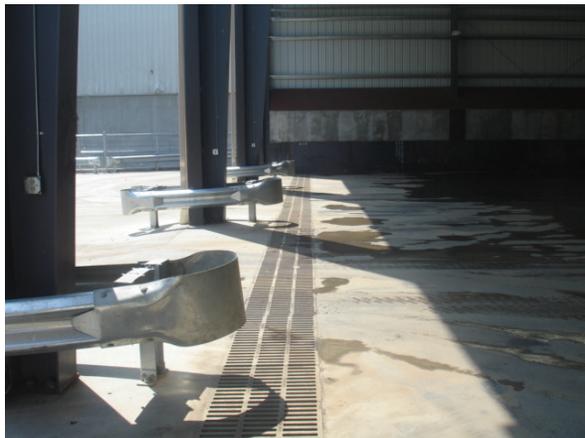
12. The tipping floor was observed as being in very good condition. The Staff was loading the waste into the semi-trailer. Any leachate resulting from the waste on the floor was collected by the drain which flows to the leachate collection system. There was very little odor observed. No noticeable vectors were observed.

Tipping floor

Tipping floor Drain

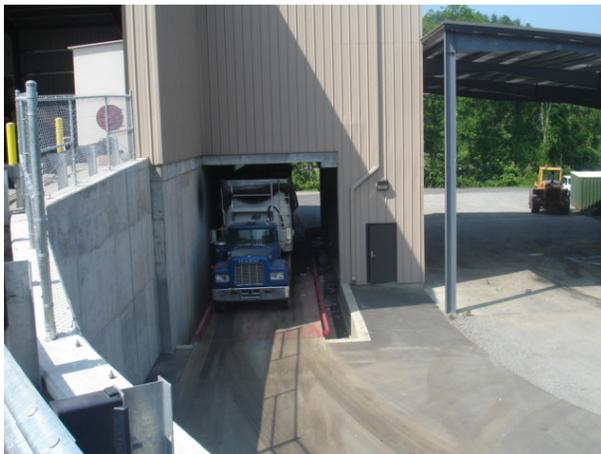
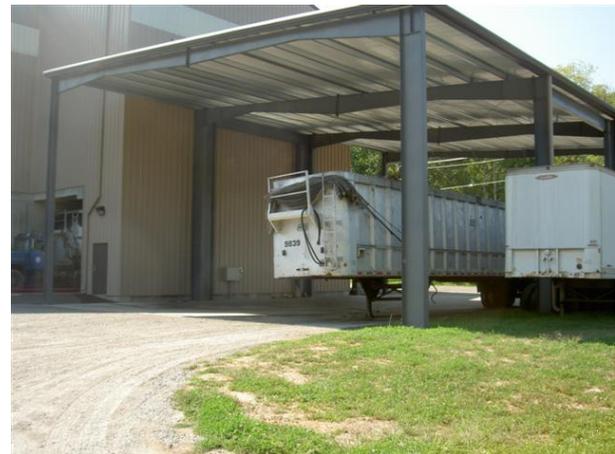
13. Waste is loaded into semi-trailers located below the tipping floor. Once the semi-trailers are full they are stored under a shed until removal by a contracted trucking company. The shed is paved with concrete which has a drain that is connected to the leachate collection system.

Semi-trailer being loaded (left) and storage shed (right)

Semi-trailer in storage shed with trailer

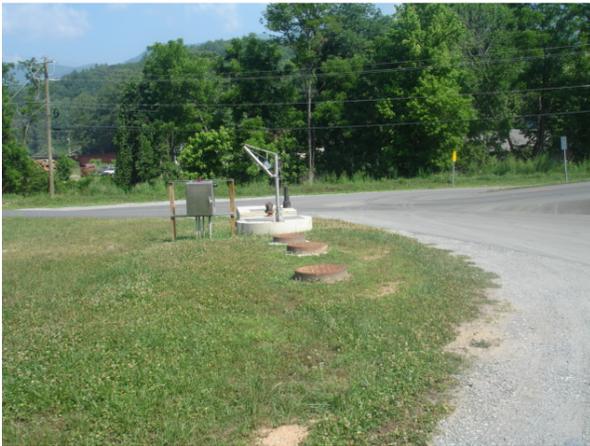
14. The leachate collection system was observed. Leachate was being pumped to an oil separator, then to a septic tank, then to the wastewater treatment plant (WWTP). There were two pumps that are used in case of a malfunction. No evidence of a leachate backup or overflow was observed.

Leachate collection and pump area

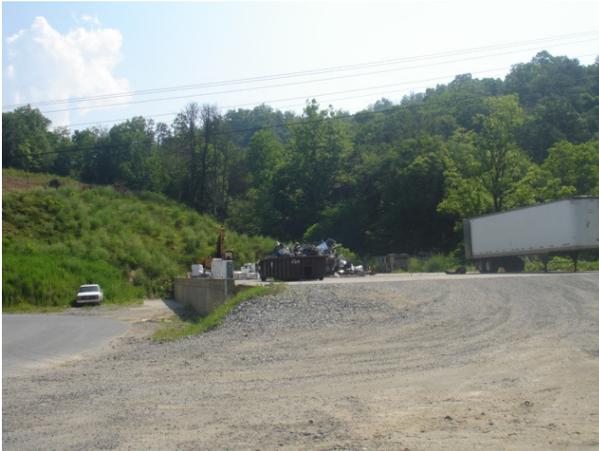
16. The former transfer station was being used as the cardboard and paper collection area.
17. The tire, battery, white goods and metal collection area was observed located on a concrete surface. Batteries were stored upright on a pallet. The white goods were stored upright. The removal of Freon is done by a contractor. All tires were observed stored either in a semi-trailer or under a shed.

White Goods, Metal and Scrap Tire collection area

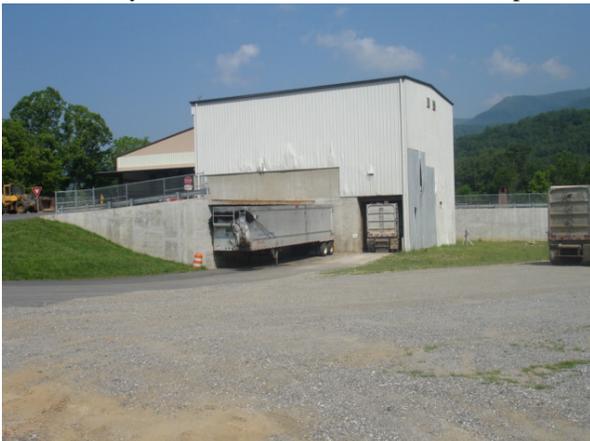
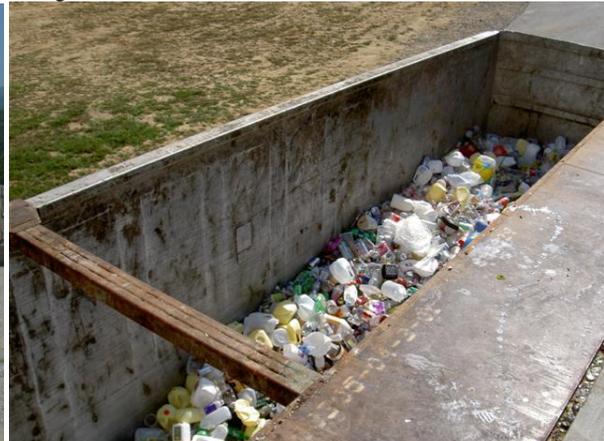
18. A mixed recyclables area was observed. Mixed plastics and glass are collected in a semi-trailer

Mixed Recyclables Trailer

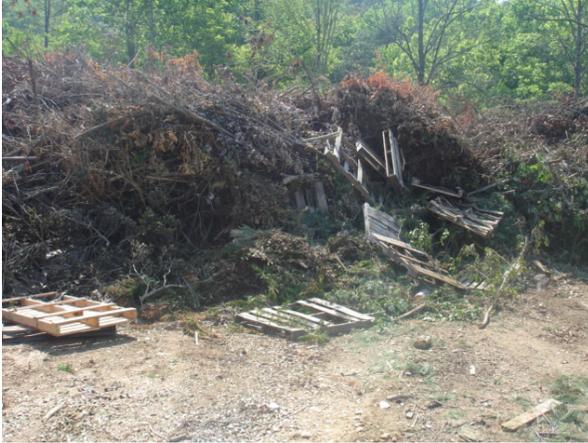
19. The facility is permitted to operate a wood grinding treatment and processing area. This area was observed. Processed and unprocessed wood waste was observed. Only natural wood waste was observed. The facility is also permitted to accept wooden pallets for grinding.

Un-Processed Wood Waste

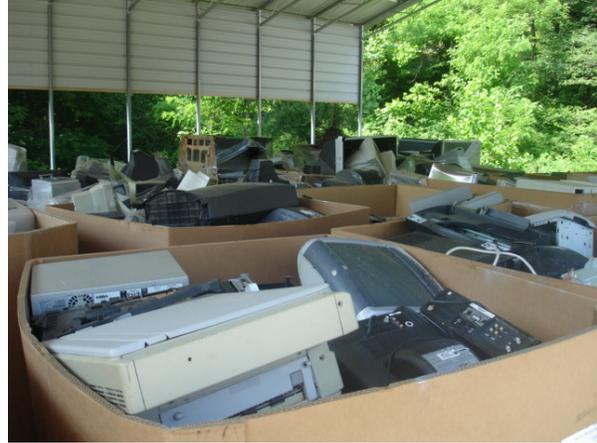
Electronics Collection Area

20. There was a new electronics collection area that appeared well managed and covered.
21. The facility is permitted to accept yard trash.
