**FACILITY COMPLIANCE AUDIT REPORT**  
**Division of Waste Management**  
**Solid Waste Section**

**Date of Audit:** 7 April 2011

Jones County Landfill  
 Landfill Rd (NC SR#1343)  
 Trenton, NC

Partial; follow-up audit to review corrective measures taken in response to FCAR 52-01, 030811

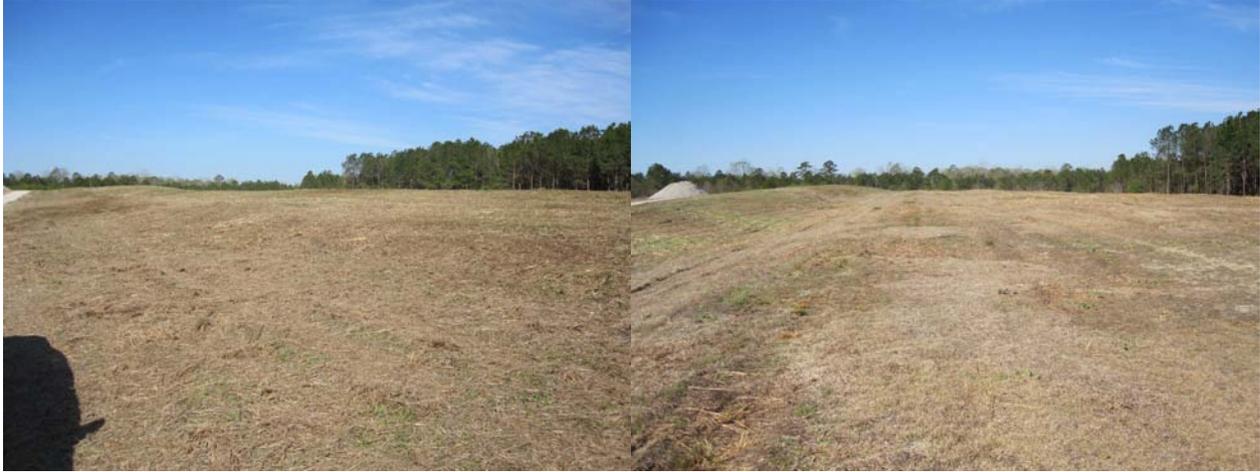
- 6) A coppice-type cover of native warm season grasses has been established throughout the landfill. Overall, the cover crop has been well established and no areas of erosion were noted during this audit.

- 7) The facility has recently been mowed. All brush, woody vegetation, and trees have been removed from the

landfill and ground for re-use as mulch.

Landfill cap, trees and woody brush removed; overall well established cover crop

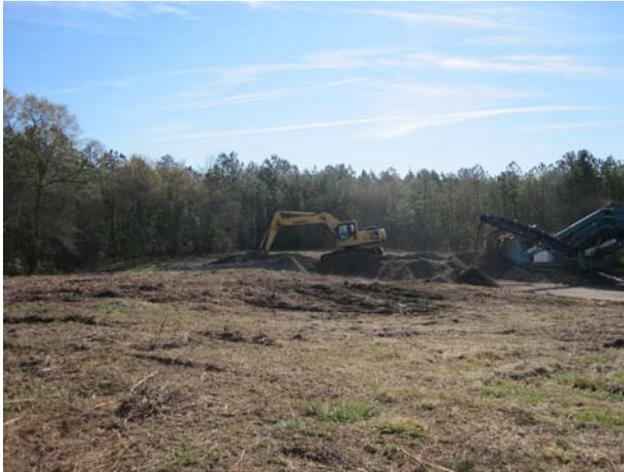
- 10) CR Peele/Sitemaxx Construction Inc of Jacksonville, NC was on site during this audit grinding all the stockpiled concrete and brick for re-use by Jones County.

Contractor grinding concrete and brick for re-use

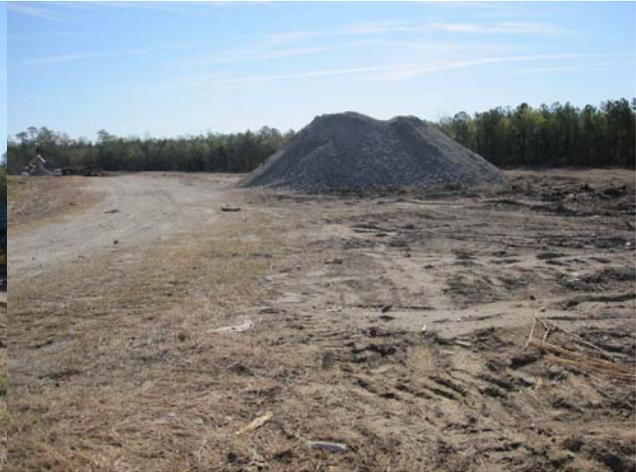
Ground concrete staged for re-use/removal from site
