**FACILITY COMPLIANCE AUDIT REPORT**  
**Division of Waste Management**  
**Solid Waste Section**

**Date of Audit:** 19 May 2011

Jones County Landfill  
 Landfill Rd (NC SR#1343)  
 Trenton, NC

Partial; follow-up audit to review continued corrective measures taken in response to FCAR 52-01, 030811

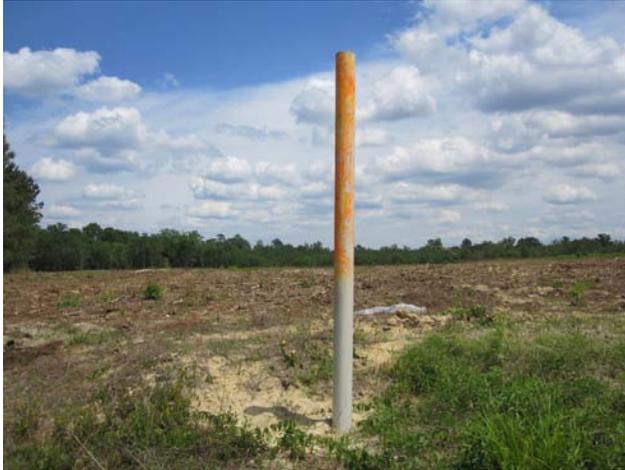
- 4) Permanent, highly visible, edge-of-waste markers have been installed delineating the waste disposal footprint.
- 5) High visibility markers have been installed adjacent to the facility's groundwater monitoring wells.

Edge of waste markers installed

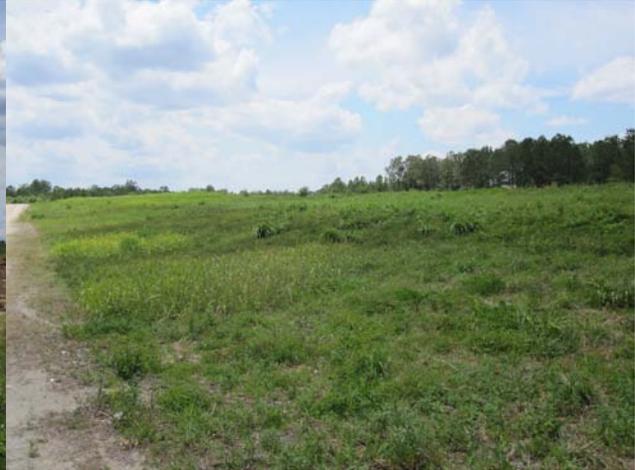
- 6) A cover crop of native warm season grasses has been established throughout the landfill. Overall, the cover crop has been well established and no areas of erosion were noted during this audit.

Sideslope with well established cover

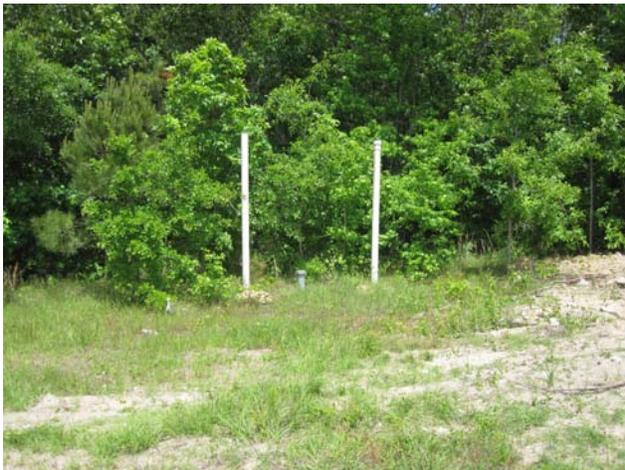
Monitoring well marked for visibility

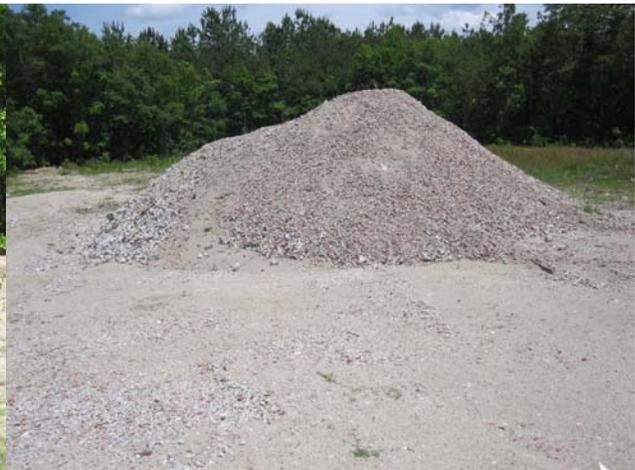
- 8) All grinding/crushing operations have been concluded. Crushed concrete and brick have been staged on-site in an area adjacent to the landfill for re-use by Jones County.
- 9) Two small piles of waste screened from the crushed materials remains on-site. \*Please remove these materials from the site and transport them to a Permitted Facility for proper management.
- 10) Digital photographs were taken during this audit; *please see photographs attached below.*
- 11) \*Continued corrective actions are needed as a result of this audit.

Crushed concrete and brick staged for re-use/removal from site
