**FACILITY COMPLIANCE AUDIT REPORT**  
**Division of Waste Management**  
**Solid Waste Section**

Lined MSWLF		LCID		YW		Transfer		Compost		SLAS		<b>COUNTY: McDowell</b> <b>PERMIT NO.: 56 - 01</b> <b>FILE TYPE: COMPLIANCE</b>
Closed MSWLF	<b>X</b>	HHW		White goods		Incin		T&P		FIRM		
CDLF		Tire T&P / Collection		Tire Monofill		Industrial Landfill		DEMO		SDTF

McDowell MSW – Closed October 7, 1994  
 2849 NC Hwy 226 S.  
 Marion, NC 28752

Comprehensive Audit.

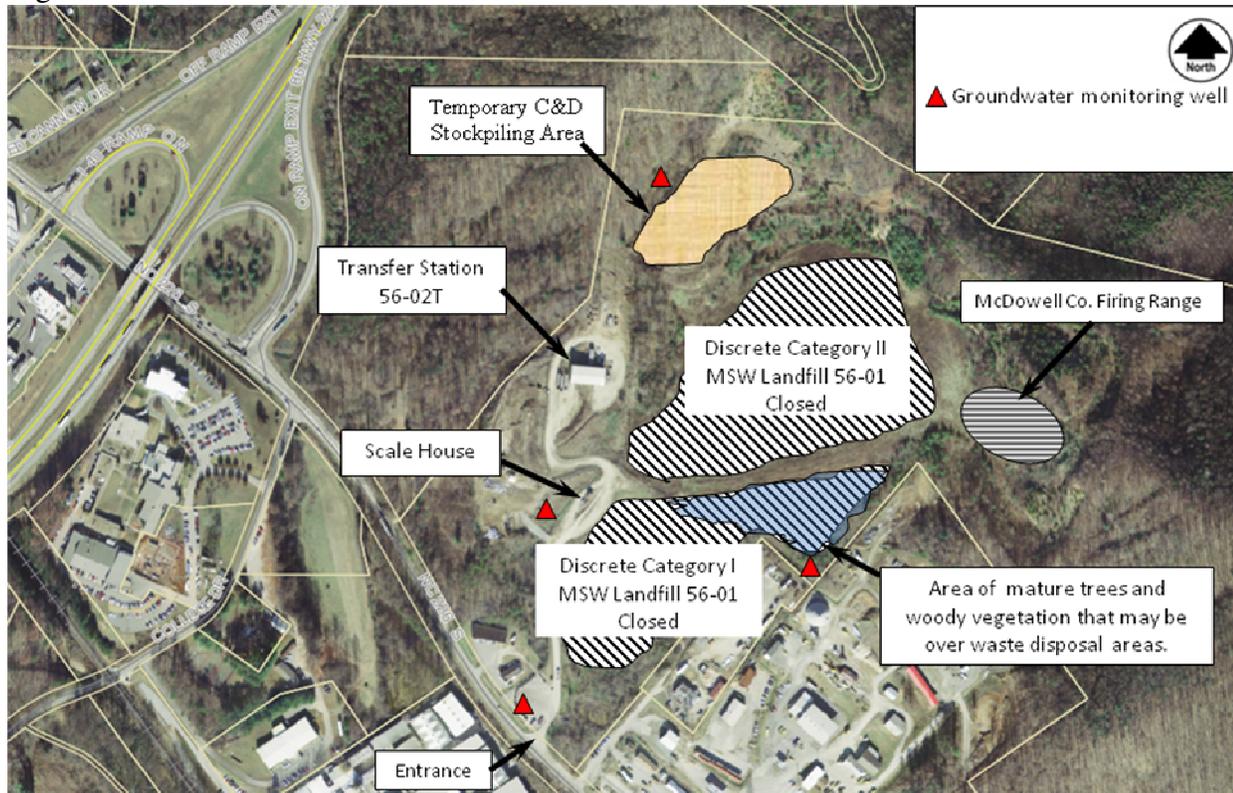
Figure #1. McDowell County GIS aerial. (Approximate limits of Waste disposal areas and monitoring well locations.)

- The closed McDowell County municipal solid waste (MSW) landfill consists of two separate areas: “Discrete Category I Landfill” and “Discrete Category II Landfill”. (Figure 1)

- In a letter dated 10/31/07 the Solid Waste Section Regional Engineer (Larry Frost) approved a “Methane Investigation at the McDowell County MSW Landfill (Permit #56-01). The purpose of the investigation was “*to execute an assessment of the methane potential at the former McDowell County Landfill.*”
- On 10/20/07 McDowell County’s consultant (Shield Engineering) requested that NCDER approve the installation of three methane extraction wells at the McDowell County MSW Landfill.
- On 12/06/07, the Permitting Branch Supervisor (Ed Mussler) of the Solid Waste Section (SWS) approved the Shield Engineering’s request to install three methane extraction wells.
- On 1/16/09 the SWS approved McDowell County’s request to construct a *Qualifying Firing Range* adjacent to the closed MSW landfill. (Figure 1)

4. During the audit, four groundwater monitoring wells were located. (Figure 1 and Photos #7 through #13).

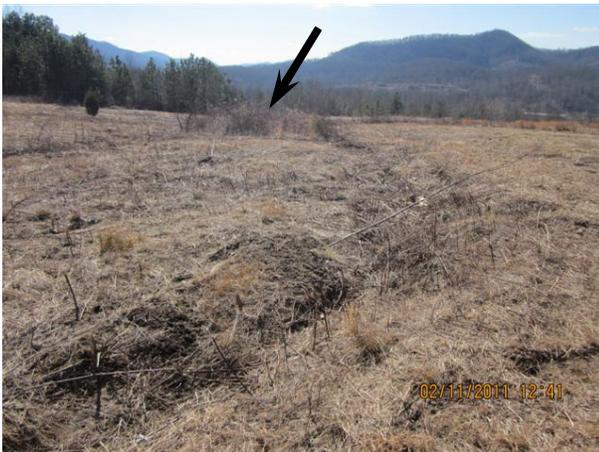
Approximately 60% of the “Discrete Category II” landfill’s cap had been recently mowed. Inspection of the mowed area found multiple areas of woody vegetation concentrated around areas of surface subsidence and small gullies. (Photos #1 through #4)

1. Small gully in the cap of the “Discrete Category II” landfill. (Note the woody vegetation in the background.)

**Within 30-days of your receipt of this report, please finish moving the cap of “Discrete Category II” landfill; remove all woody vegetation and trees from the cap; repair and re-grade the cap where needed to correct the effects of settlement, subsidence, erosion.**

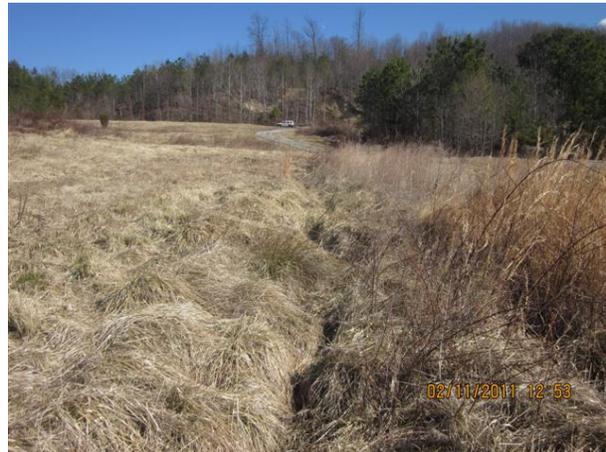
2. Small gully along the south edge of the cap of the “Discrete Category II” landfill. (Note the woody vegetation on the right.)

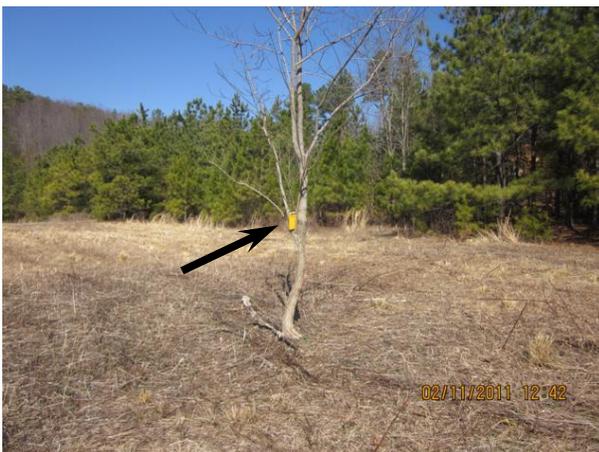
3. Small tree near the northern edge of the “Discrete Category II” landfill. (Note the 4 ½” x 7 ½” yellow field book in the tree for scale.)

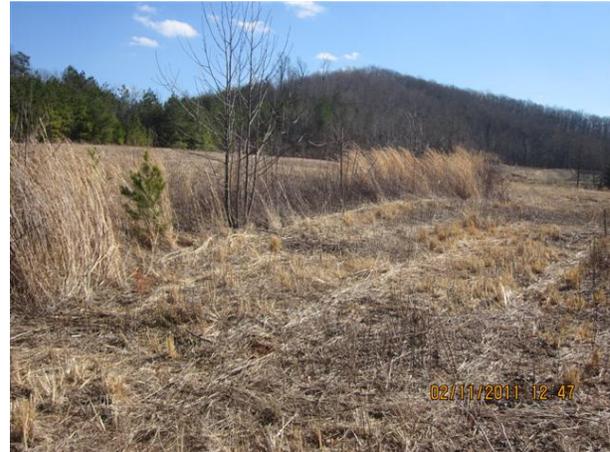
4. Woody vegetation and several small trees in a gully running east and west near the center of the “Discrete Category II” landfill.

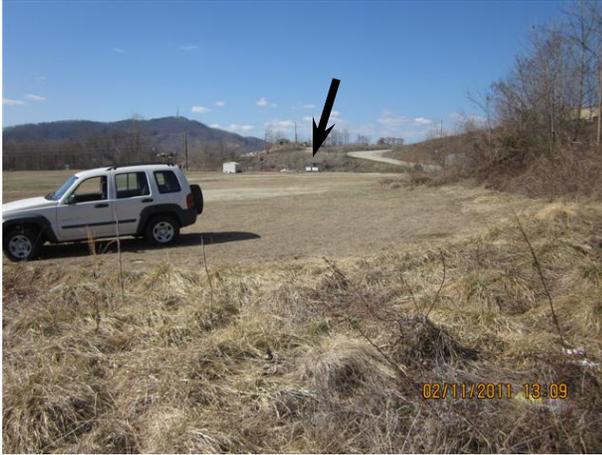
2. The “Discrete Category I” landfill was well maintained – mowed and free of surface erosion and subsidence. However, it appears that the northeast quadrant of this landfill may be covered with mature trees. (Photos #5 and #6) The waste boundaries must be determined and marked (Item #3 below) to confirm that the cap is free of trees and woody vegetation to ensure that the integrity and effectiveness of the final cover system is not compromised.
3. Permanent waste boundary and property line markers must be installed at both the “Discrete Category I” landfill and the “Discrete Category II” landfill. (See the attached May 29, 2009 Memo: *Permanent Edge-of-Waste Markers at Construction and Demolition Debris Landfills, Industrial Solid Waste Landfills and Municipal Solid Waste Landfills*)

5. Looking, WNW across the “Discrete Category I” landfill. (Note the scale house in the background.)

**Within 60-days of your receipt of this report, please determine and mark the limits of waste in both the “Discrete Category I and II” landfills; and determine and mark the property lines of the landfill(s) in accordance with the attached May 29, 2009 Memo.**

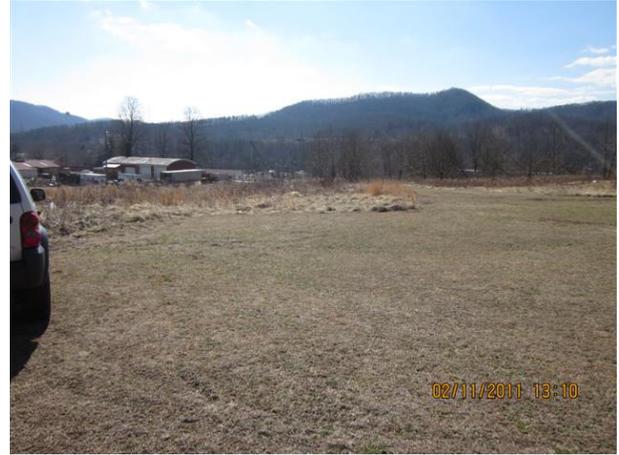
6. Looking SWS across the “Discrete Category I” landfill.

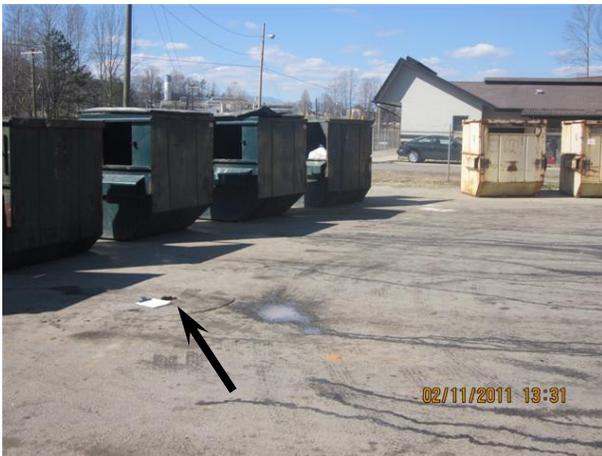
7. “Flush mount” ground water monitoring well in the convenience center collection area at the entrance.

All four of the ground water monitoring wells must:

- Be secured with a locking well cap to ensure against unauthorized access and use; and
- The well casing shall be terminated no less than 12 inches above land surface unless all of the following conditions are met:
  - (1) specific conditions directly related to business activities, such as vehicle traffic, would endanger the physical integrity of the well; and
  - (2) the well head is completed in such a manner so as to preclude surficial contaminants from entering the well.
- Be equipped with a steel outer well casing or flush-mount cover, set in concrete, and other measures sufficient to protect the well from damage by normal site activities; and
- Have a permanently affixed identification plate which can be correlated with an updated site map.

**Within 90-days of your receipt of this report, please ensure that all of the groundwater monitoring wells are secured with locking well caps; marked with permanent, unique, identification plates; and are identified on an updated site map.**

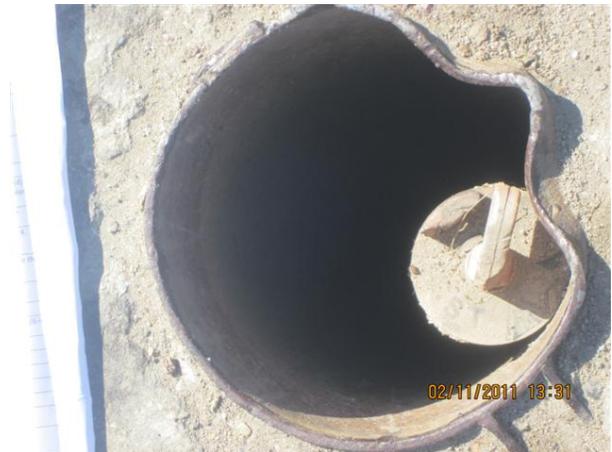
8. Close-up of the “flush mount” ground water monitoring well. Note the absence of the required “flush mount” cover.

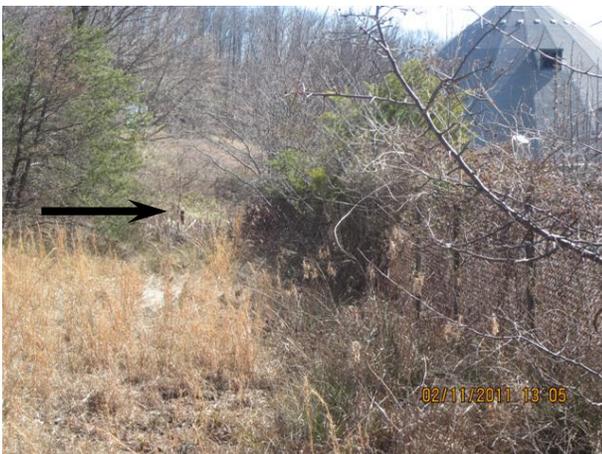
9. Ground water monitoring well located off the SE quadrant of “Discrete Category I” landfill.

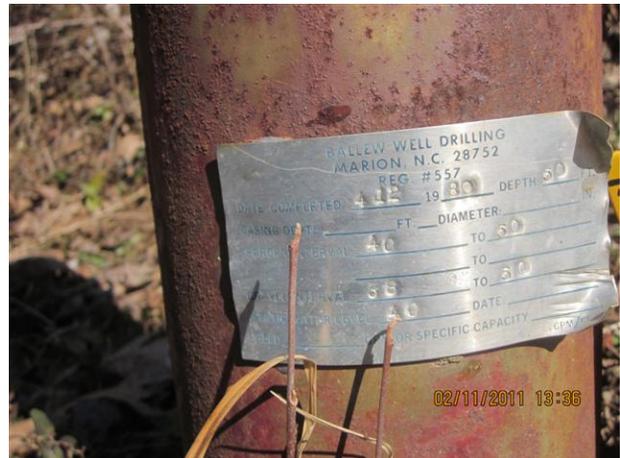
10. Well tag on ground water monitoring well in photo #9.

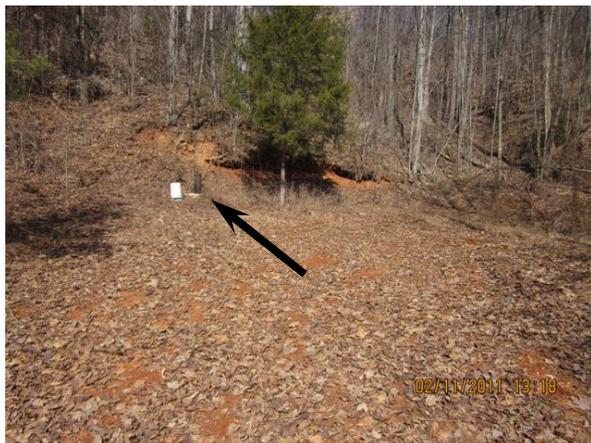
11. Ground water monitoring well located north of the transfer station.

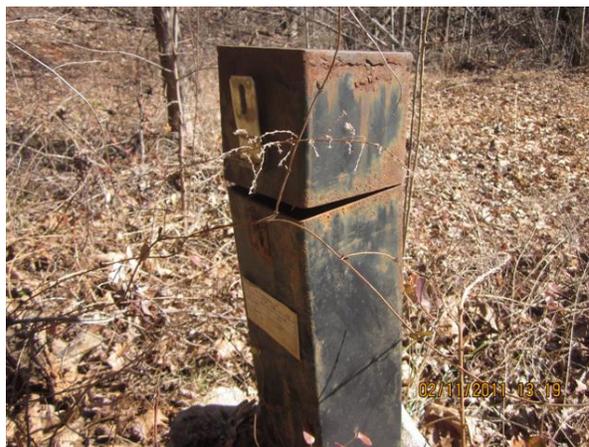
12. Close-up of ground water monitoring well located north of the transfer station. (Note that the well is not properly secured with a lock.)

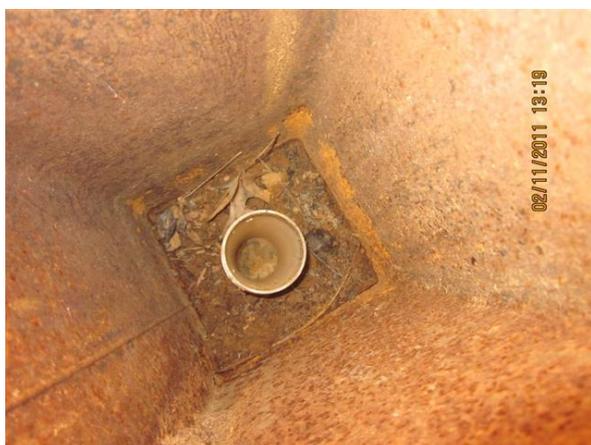
13. Looking down the steel casing of the ground water monitoring well, located north of the transfer station, at the un-capped PVC well pipe.

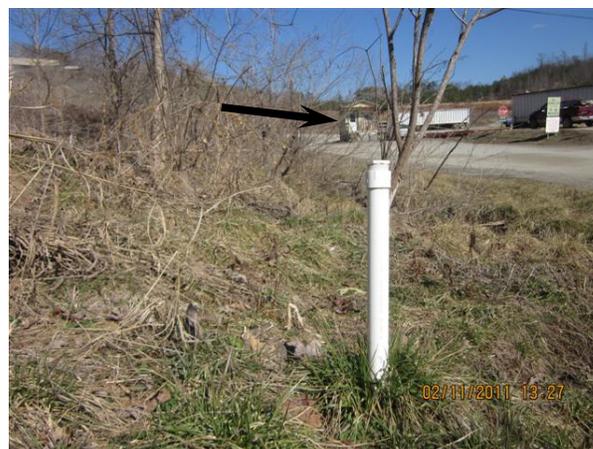
14. Looking NE at the ground water monitoring well located southwest of the scale house. (Note the scale house in the back ground.)

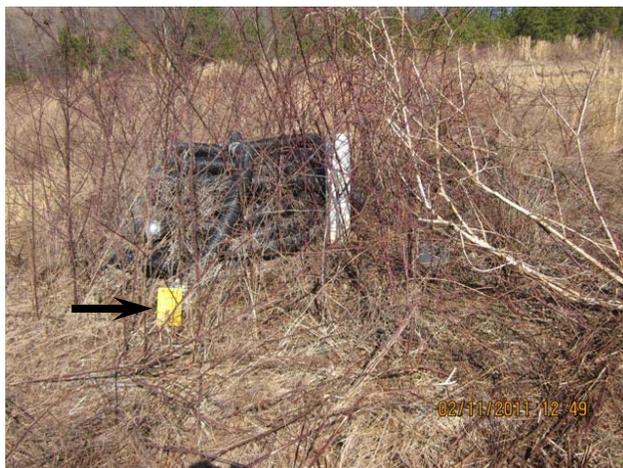
5. During the audit, what appeared to be two of the tree methane extraction wells that were approved for installation by the SWS on 12/06/07, were located. (Photos #15 & #16)

15. Six inch diameter white PVC methane extraction well located near the center of “Discrete Category II Landfill”. Note that the well is not capped. (Note the 4 ½” x 7 ½” yellow field book in for scale.)

**Within 30-days of your receipt of this report, please:**

- a. **Determine if the third approved methane extraction well was ever completed and if so, where was it installed.**
- b. **Submit either a proposal for completing the methane extraction project, or a plan for terminating the project. If the project is to be terminated, the existing methane extraction wells should be abandoned in accordance with the SWS’s “Landfill Gas Monitoring Guidance – November 2010”. This guidance can be downloaded from the following web site:**

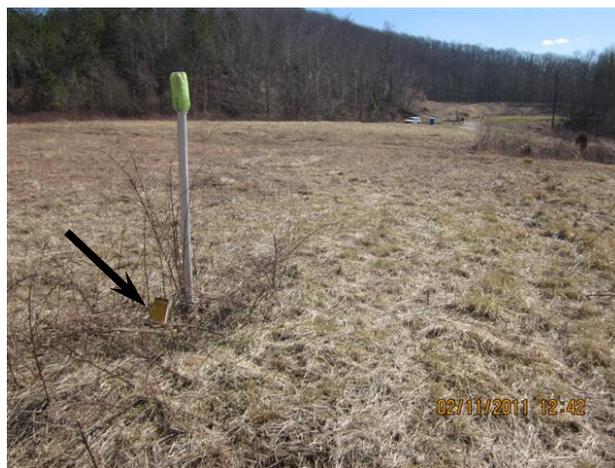
16. Four inch diameter white PVC methane extraction well located northern quadrant of “Discrete Category II Landfill”. (Note the 4 ½” x 7 ½” yellow field book in for scale.)
