## FACILITY COMPLIANCE AUDIT REPORT

### Division of Waste Management Solid Waste Section

Date of Audit: 6/18/10

McDowell County Transfer Station  
 2849 NC Hwy 226 South  
 Marion, NC 28752

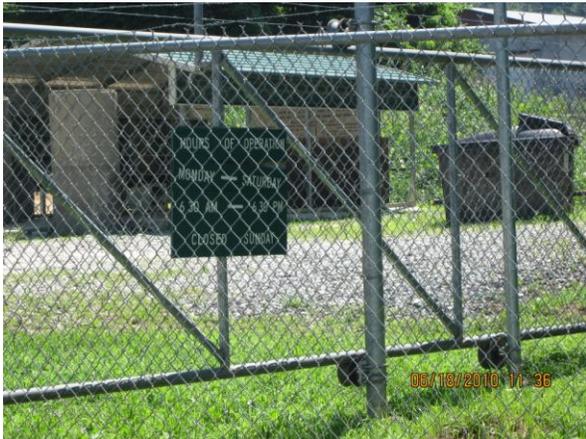
4. Permit, hours of operation, and materials acceptance signage at the facility entrance prominently displayed & legible. (See photo #1 below.)

1. Hours of Operation Sign at front gate.

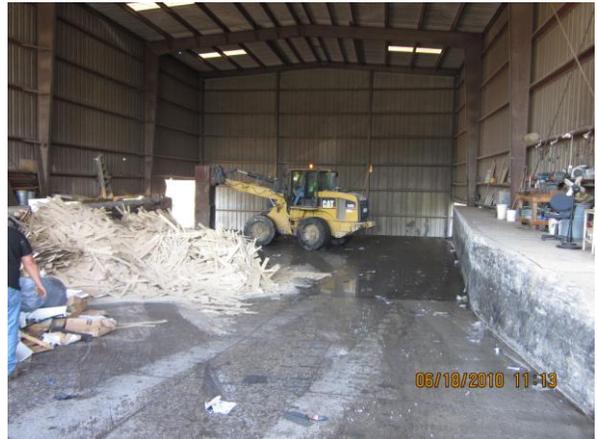
5. Municipal solid waste was being unloaded onto the tipping floor during the inspection. (See photo #2 below.)

2. Front-end loader moving waste off the tipping floor and into a transfer trailer.

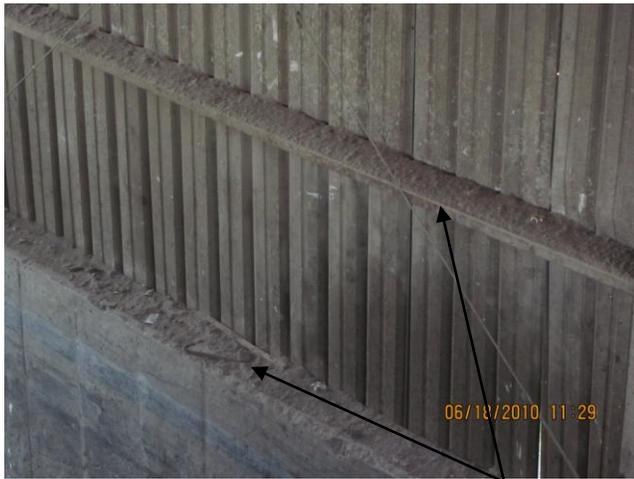
*During the audit, Mr. Wagner observed that the interior walls of the transfer station need to be washed down and the receiving bay floor and walls need washing. (See photos #3 and #4 below.)*

**McDowell County is in violation of 15A NCAC 13B .0201(h) by failing to maintain the McDowell County Transfer Station in a sanitary condition.**

6. The tipping floor was partially covered with waste, and appears to be in good condition.
7. The walls of the transfer facility have some debris buildup and will need to be washed; especially in the receiving bay (See photos #3 and #4 below.)

3. Looking at the back wall of the receiving bay at the debris and waste on the horizontal supports that need cleaning.

To come into compliance with Violation #1, (15A NCAC 13B .0201(h) McDowell County must, within 15 days of receipt of this Report, washed down and clean the walls and floor of the receiving bay floor of the transfer station.

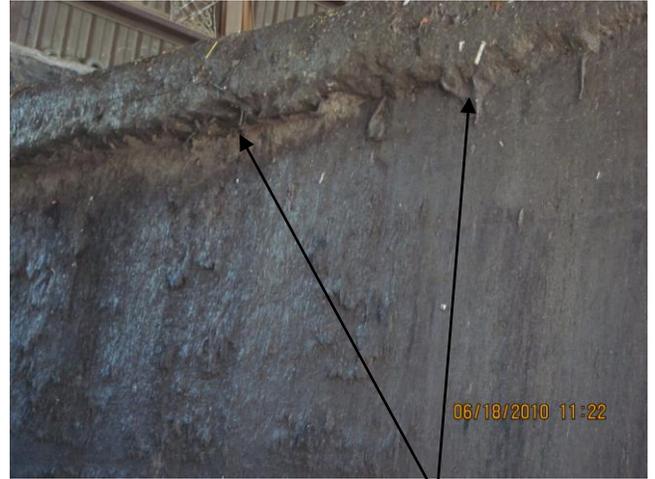
4. Looking up from the receiving bay, at the grime and debris clinging to the lip of the tipping floor that needs to be cleaned.

9. During the audit, a small stream of water from the holding tanks was being directed onto the tipping floor to “lubricate” the floor and lessen the wear and tear on the front-end loader’s bucket. This water was spilling off the tipping floor and into the receiving bay and eventually out of the receiving bay and beyond the area of the leachate control system. (See photos #4, #5, #6, #7 and #8 below.)

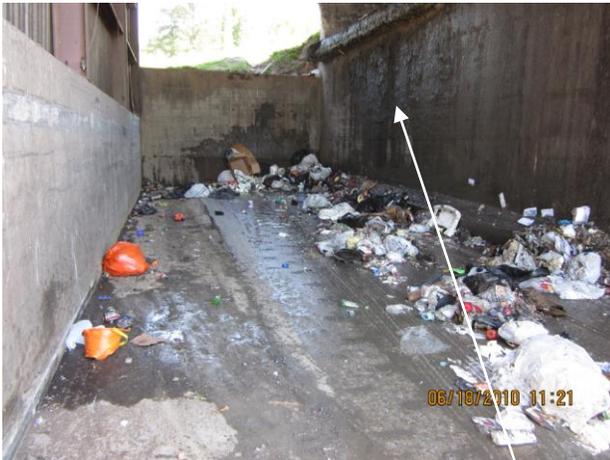
*During the audit, Mr. Wagner observed that leachate from the tipping floor of the transfer station was spilling onto the floor of the receiving bay and flowing down to the edge of the access road. (See photos #5, #6, #, and #8 below.)*

**McDowell County is in violation of 15A NCAC 13B .0402(1) by failing to maintain and operate a transfer station in accordance with their permit. Permit condition #8, of Part I (Operating Conditions), requires that “All water that comes into contact with solid waste, including vehicle wash-down waster, is leachate and must be captured and properly treated before release to the environment.”**

**McDowell County is in violation of 15A NCAC 13B .0402(3) by failing to either, contain on-site or properly treat, all water that comes into contact with solid waste prior to discharge from the site.”**

5. Looking into the receiving bay from the entrance / exit. Note the sheens of leachate coming from the tipping floor, on the right-hand wall and on the floor.

To come into compliance with Violations #2 (15A NCAC 13B .0402(1)) and #3, (15A NCAC 13B .0402(3)) McDowell County must, immediately control and capture all leachate generated within the transfer station; and within 5 days of receipt of this Report, ensure, and document, that all elements of the leachate collection system (drains, pipes, holding tank, etc.) are in good repair and functional. McDowell County must, within 21 days of receipt of this Report, submit to Bill Wagner (at the address below), documentation showing that the leachate collection system is in good repair and functional. This documentation must include a site map showing the details of the leachate collection system.

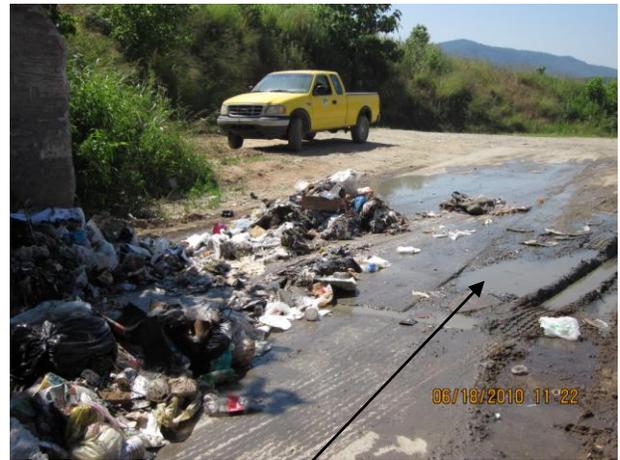
6. Looking from within the receiving bay, at the entrance / exit. Note the leachate leaving the receiving bay, and moving beyond the leachate control system. (A leachate collection drain, that feeds an underground holding tank, is believed to be located in the area of the standing water on the right.)

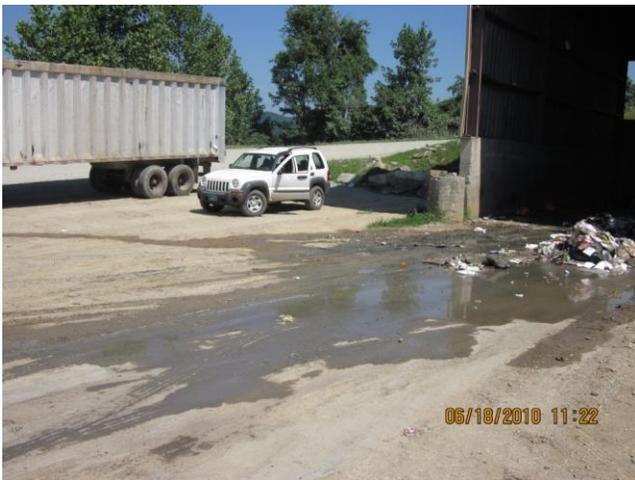
7. Looking at the flow of leachate out of the receiving bay.

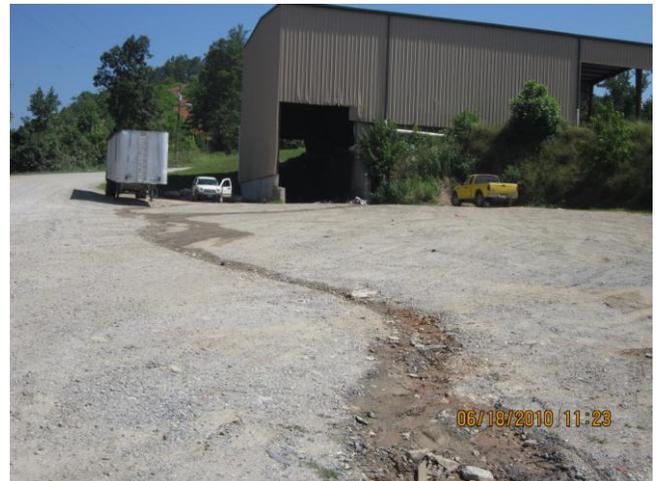
8. Looking at the flow of leachate out of the receiving bay, and on down the edge of the access road.
