FACILITY COMPLIANCE AUDIT REPORT
Division of Waste Management
Solid Waste Section

Date of Audit: November 18, 2010

Macon County MSW Landfill (Highlands)
 1080 Rich Gap Road
 Highlands, NC 28741

Comprehensive Audit of Closed MSW Landfill

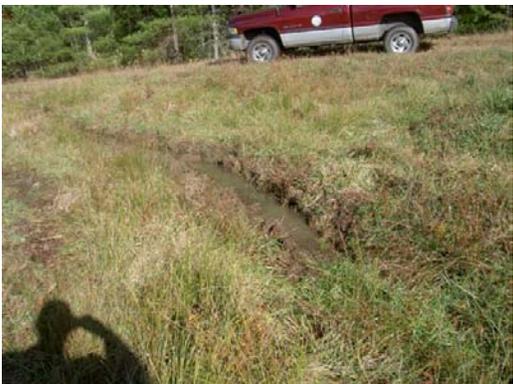
Ponded water on landfill cap

5. No evidence of erosion was observed. No leachate breakouts were observed. **Ponding of water on the cap was observed in two areas. These areas and any other areas of ponded water on the landfill cap need to be repaired and contoured to shed water.**

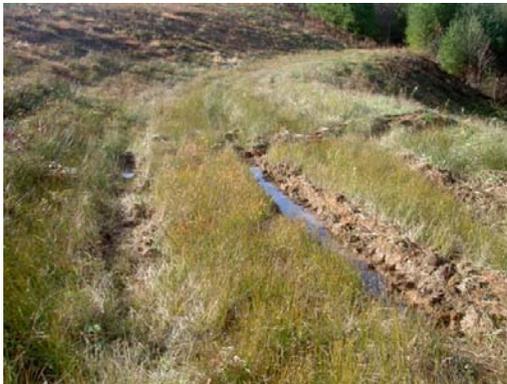
Ponded water on landfill cap.

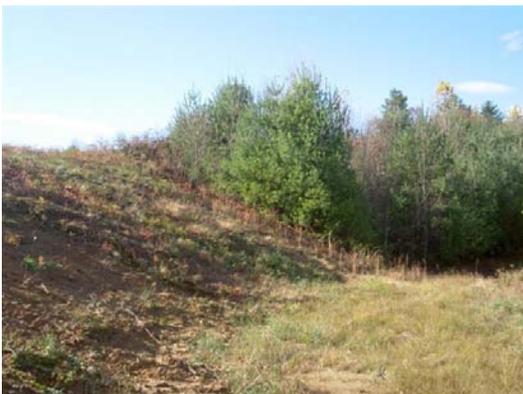
Small trees growing on landfill cap

6. Vegetation on the cap was well established and the edge of waste was well marked. The landfill was last mowed in October, according to Macon County staff. **Small trees were observed growing on the cap. In order to maintain the integrity of the cap, woody vegetation must be removed. It is requested that this be completed within 60 days of receipt of this audit report.**

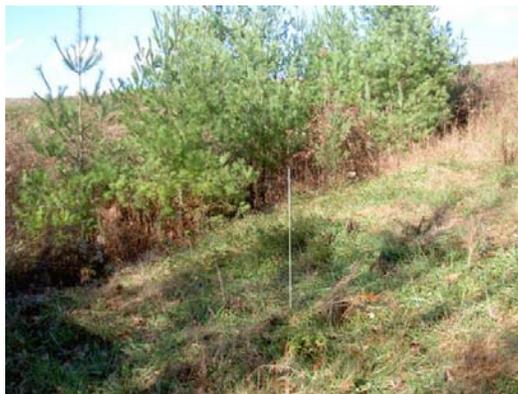
Small marker is edge of waste.
