FACILITY COMPLIANCE AUDIT REPORT
Division of Waste Management
Solid Waste Section

Date of Audit: March 4, 2010

Macon County Municipal Solid Waste Facility
 1448 Lakeside Drive
 Franklin, NC 28724

Partial Audit of MSW Landfill

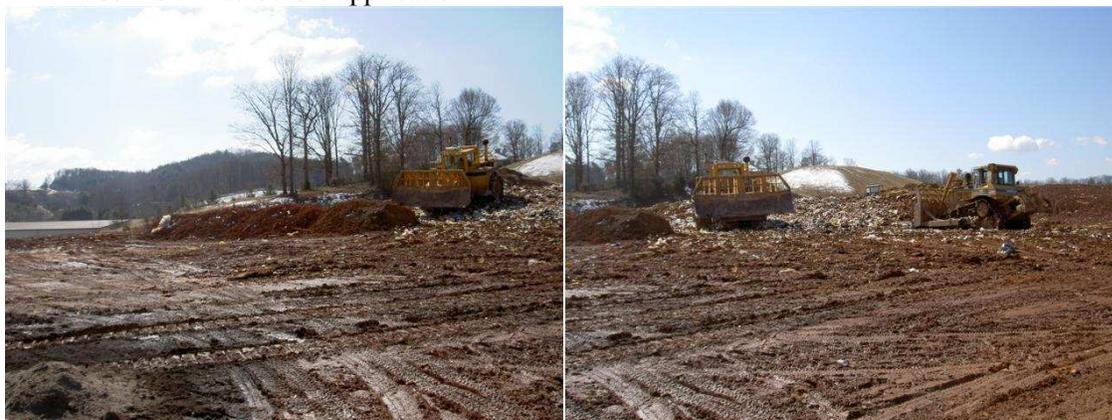
4. The MSW landfill was operating in Phase 2, Cell 1 (active since 1998).
5. The facility is permitted to use a mixture of 50% and 50% mulch as an alternate daily cover (ADC). This activity is noted in the operations plan (Section 4.2). No mulch was observed at the working face. Mulch and soil is mixed before application.

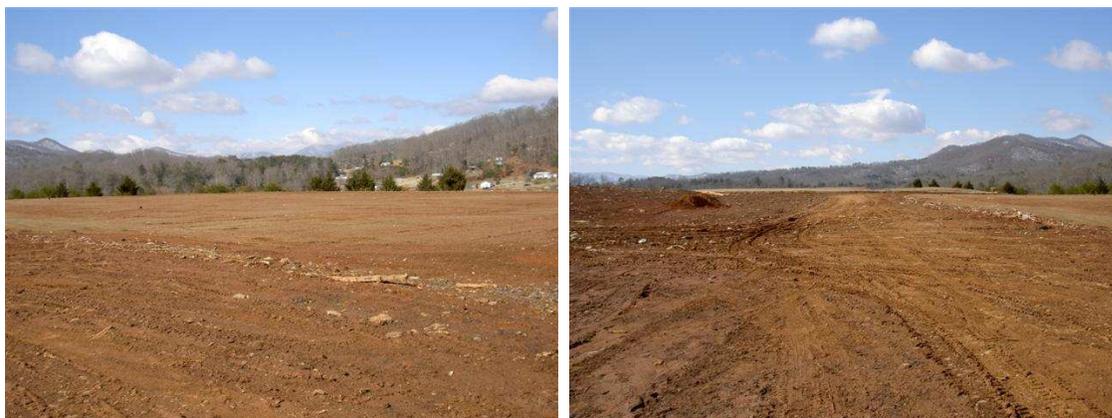
6. The daily and intermediate cover looked very good.

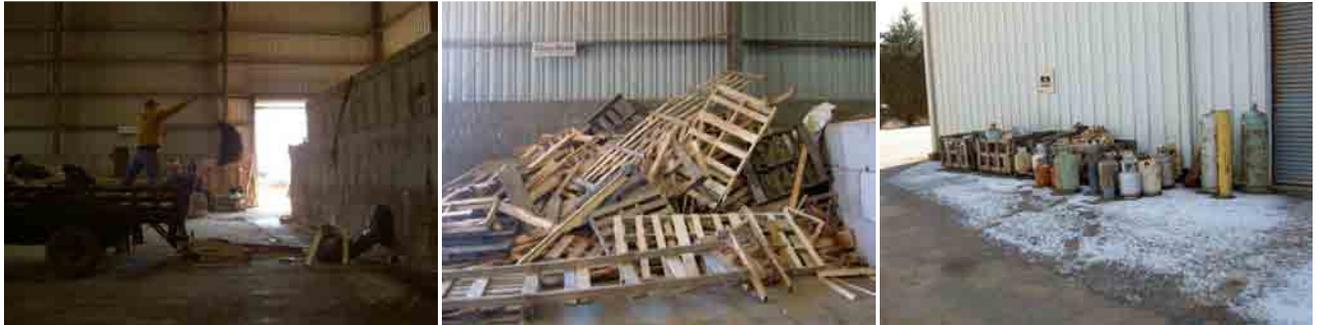
10. The Treatment and Processing (T & P) Facility is located in a covered building and was observed in operation. This facility is permitted to receive all waste allowed for disposal in the MSW Landfill and is used by the general public. Waste is placed on the floor and recyclables are removed by Staff. Material that cannot be recycled is loaded into a semi-trailer and transported to the MSW Landfill. The area was very clean and well staffed. There are drains in the floor to catch any incidental liquids (leachate) and connects to the Franklin wastewater treatment plant.

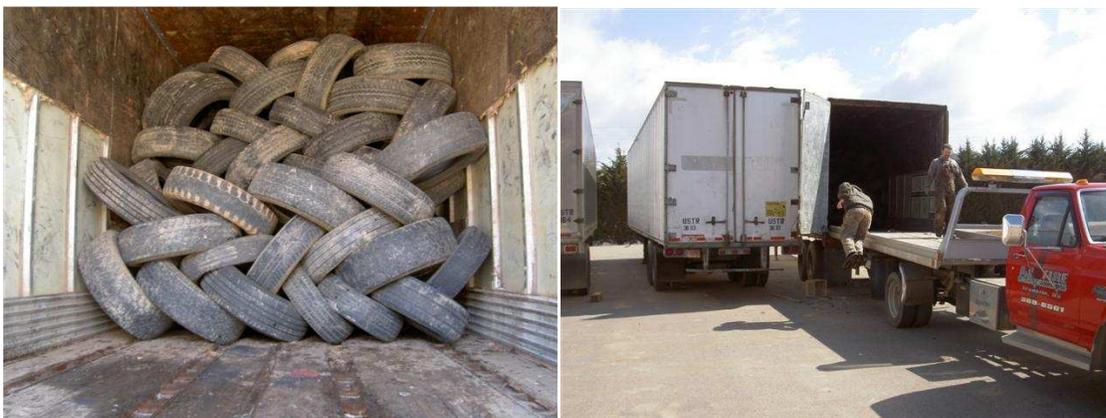
13. There were 3 trailers on site. Two trailers were empty and the third one was about 2/3 full. Tires were being loaded into a trailer at the time of the audit. All tires not intended for use by the facility were in the trailers.

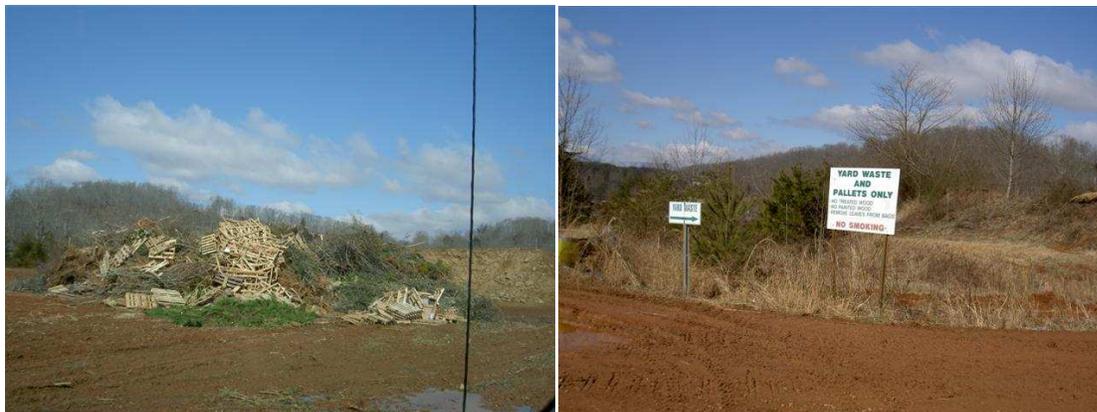
14. This area is used to generate mulch for the alternate daily cover. Material was in a pile waiting for grinding consisted primarily of landclearing debris, yard trash and pallets. This material is not available to the public. A very small amount of manufactured wood was observed. This will be removed by staff, according to Mr. Stahl.

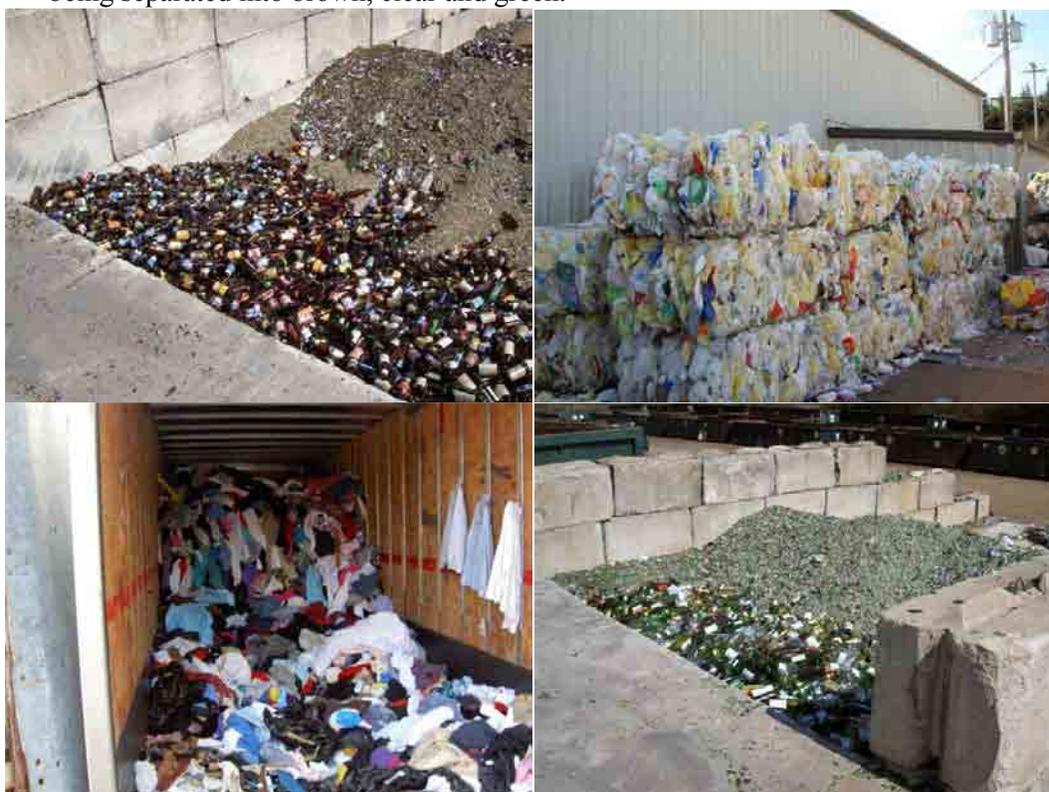
15. A recycling operation is part of the approved operations plan.
16. Macon County accepts materials dropped off at the facility and from collections sites located through out the county. Recycled materials are baled and sent to appropriate recycling companies.
17. There were separate areas for metals, aluminum, steel cans, clothes, cardboard, paper and plastics. Glass was being separated into brown, clear and green.

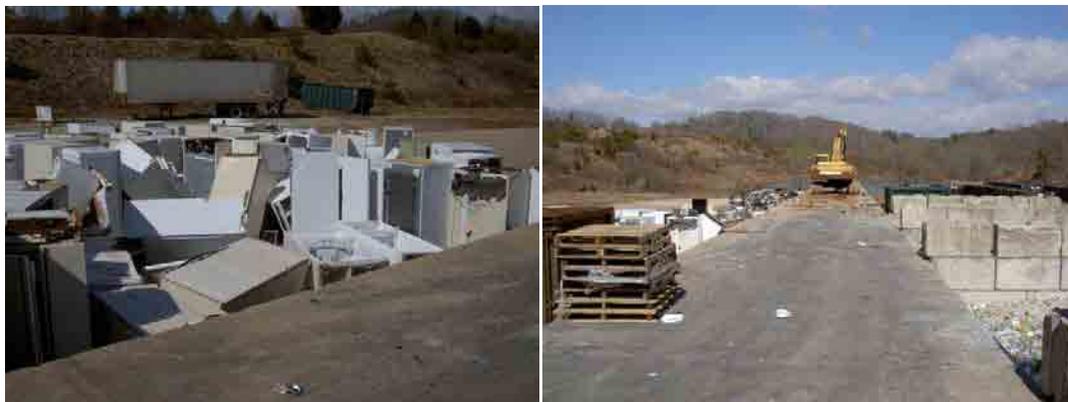
18. The White Goods Area is located in the recycling area. Freon is removed by the facility. There was a backlog of white goods because Freon cannot be removed below 50°F.

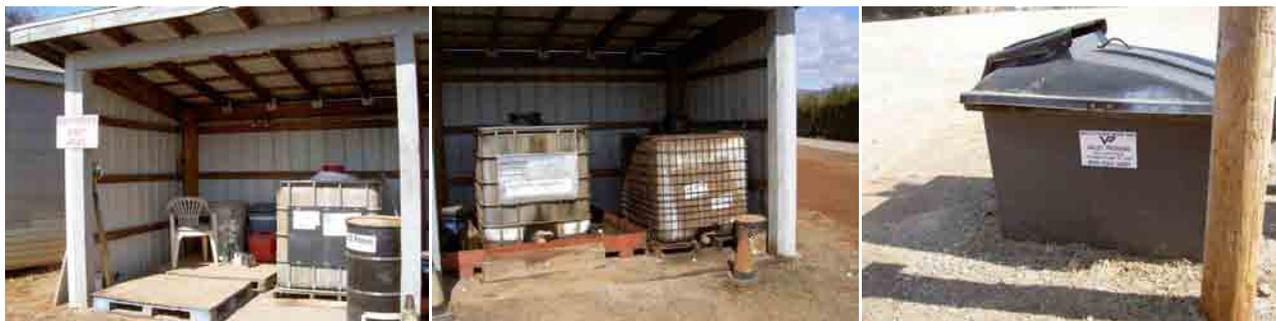
19. Used oil, household grease, batteries, anti-freeze and used oil filters were being accepted. With the exception of household grease, these were located in a shed. **This operation will need to be included in the next Operations Plan revision.**
