FACILITY COMPLIANCE AUDIT REPORT
Division of Waste Management
Solid Waste Section

Date of Audit: February 15, 2011

Macon County Municipal Solid Waste Facility
 1448 Lakeside Drive
 Franklin, NC 28724

Comprehensive Audit of MSW Landfill

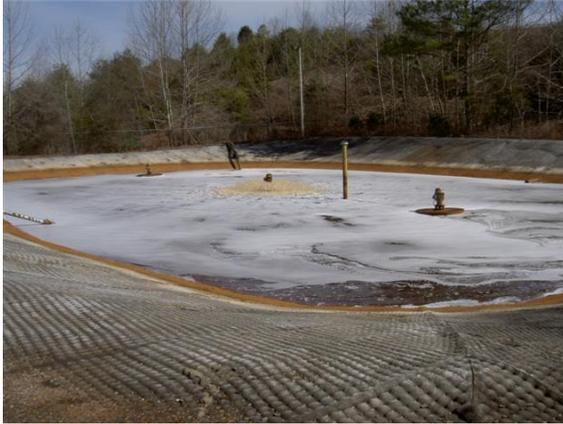
10. Leachate is pumped to a collection pond for pretreatment before being sent to the Town of Franklin Wastewater Treatment Plant located next to the facility. The leachate management plan was reviewed, which included a contingency plan in the event of a temporary failure. The pond appeared to be in good condition.

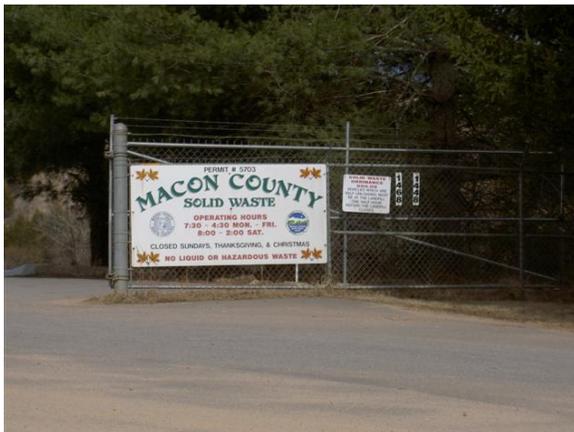
11. Tire forms were reviewed. All forms were filled out correctly.
12. No open burning was observed at the facility.
13. All public roads were well maintained. Traffic signs were in place to direct the public to appropriate areas of the facility. A sign was placed at the entrance to the facility which stated the hours/days of operation, “No liquid or hazardous waste” and the Solid Waste Permit Number.

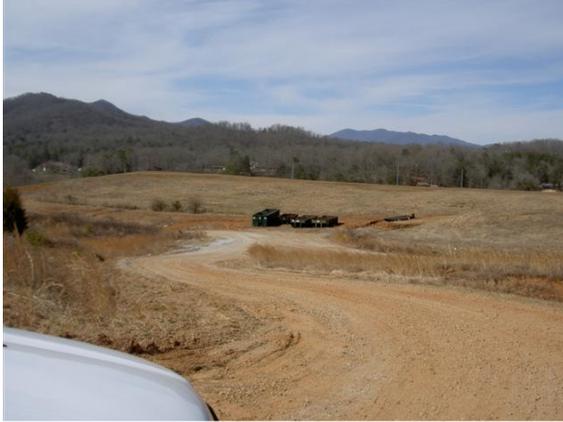
14. Phase 1 has 2' of final cover which had been seeded, but not the final cap. No significant erosion was observed. **There is one area that was wet and a possible leachate seep. This will need to be repaired immediately.**

Phase 1 looking West

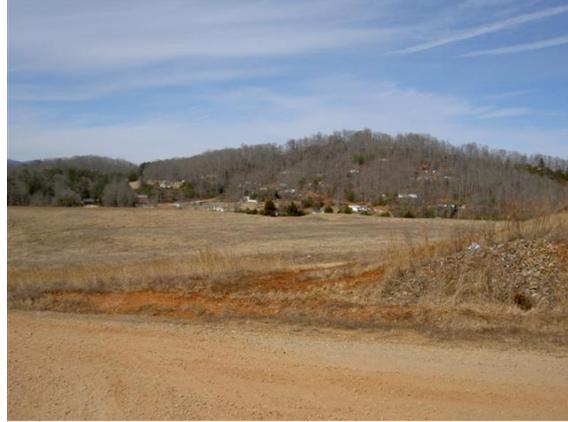
Continuation of Phase 1 looking West

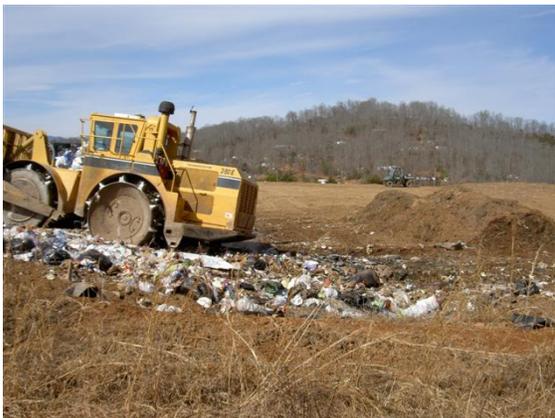
15. The MSW landfill was operating in Phase 2(active since 1998).
16. The facility is permitted to use a mixture of 50% soil and 50% mulch as an alternate daily cover (ADC). This activity is noted in the operations plan (Section 4.2). Mulch and soil is mixed before application. The facility also uses a fabric tarp as an alternate daily cover as approved in the permit.

Mixture of 50% soil and 50% mulch pile used as ADC

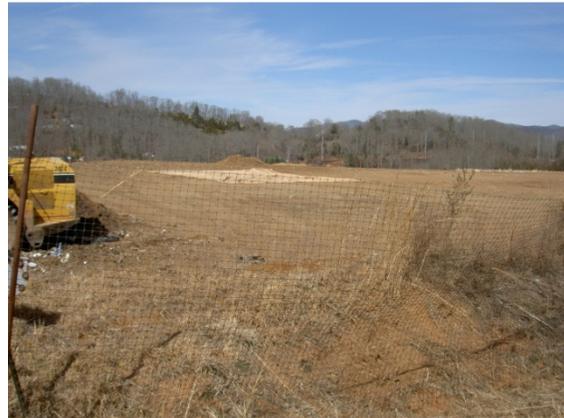
Tarp in background used as ADC

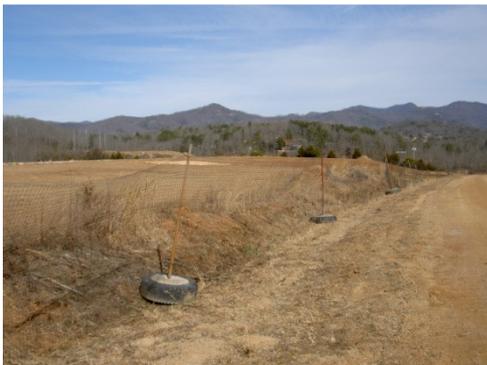
17. The daily and intermediate cover looked very good. No erosion issues were observed. No surface water was observed impounded over waste. No solid waste was observed deposited in water.
18. Fencing was in place to catch wind blown litter. Landfill staff picks up litter every day.

Fencing used to catch litter

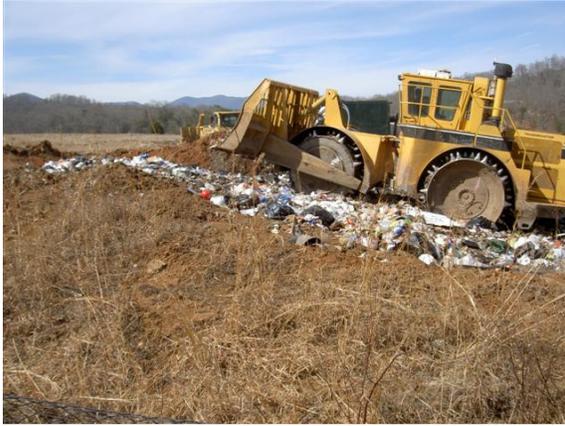
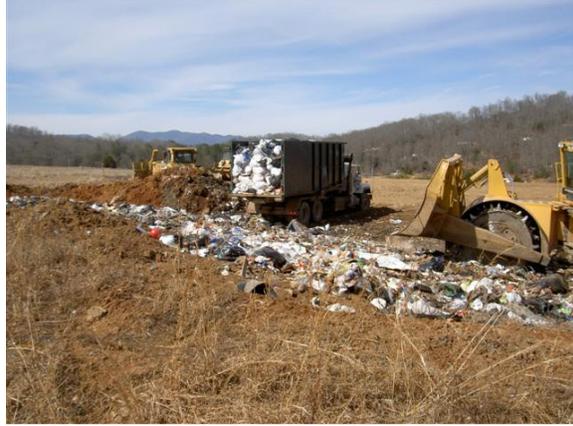
19. The working face was very small during the audit. There was no banned material observed with the exception of incidental amounts.

Working Face

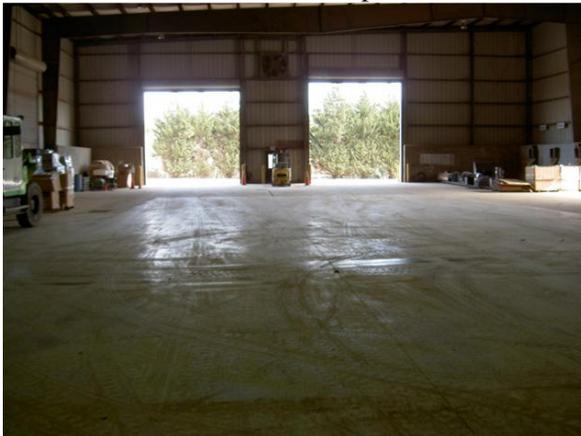
Looking toward entrance of MSW T&P Facility

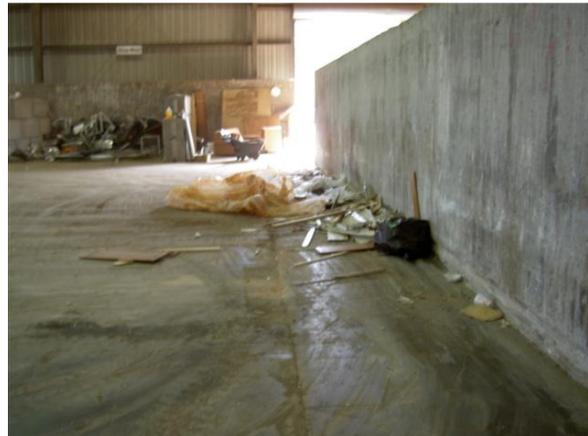
20. The MSW Treatment and Processing (T & P) Facility is located in a covered building and was observed in operation. This facility is permitted to receive all waste allowed for disposal in the MSW Landfill and is used by the general public. Waste is placed on the floor and recyclables are removed by Staff. Material that cannot be recycled is loaded into a semi-trailer and transported to the MSW Landfill. The area was very clean and well staffed. There are drains in the floor to catch any incidental liquids (leachate) and connects to the Franklin wastewater treatment plant.

MSW T&P working area

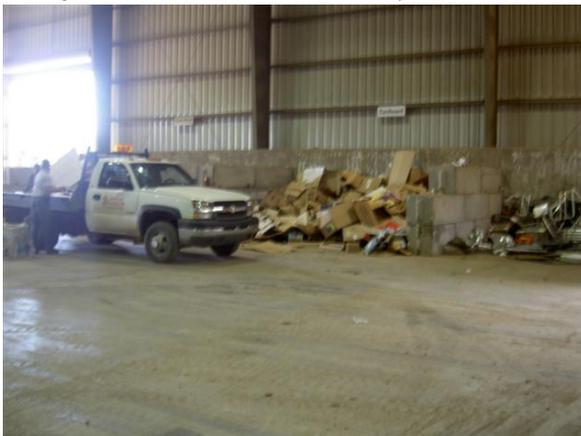
Cardboard and Metal Recycling

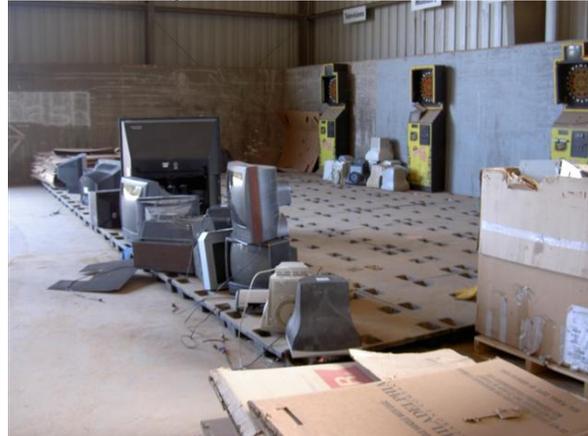
Electronics Recycling

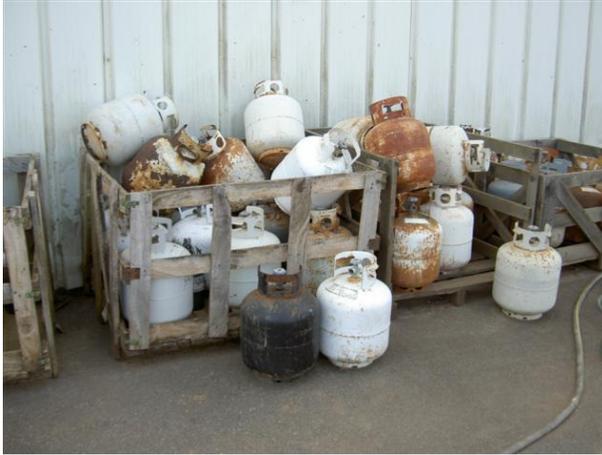
21. Separate areas are designated for clean wood, TVs, computers, , aluminum, glass, plastics, cardboard and scrap metal inside the building.
22. Used propane tanks and other gas tanks (not gasoline) are stored outside the T & P building.

Propane Tank Collection Area

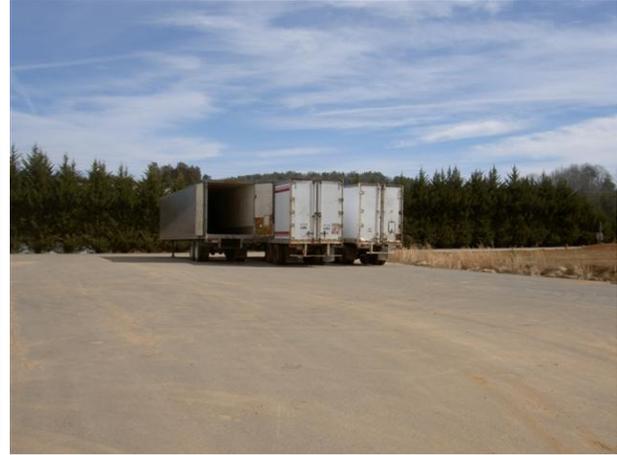
Scrap Tire Collection Trailers

23. There were 3 trailers on site. Two trailers were empty and the third one was about 1/3 full. Tires were being loaded into a trailer at the time of the audit. All tires not intended for use by the facility were in the trailers.

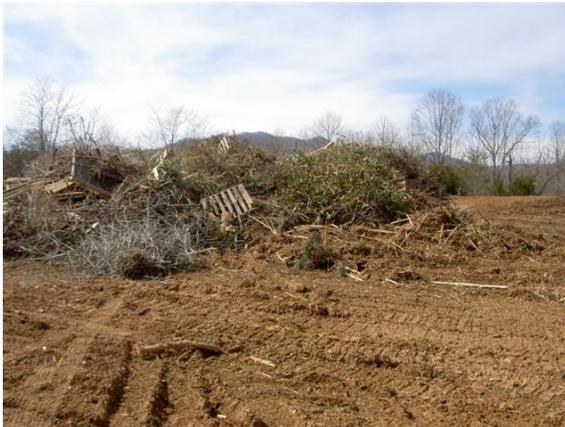
24. This area is used to generate mulch for the alternate daily cover. Material was in a pile waiting for grinding consisted primarily of landclearing debris, yard trash and pallets. This material is not available to the public. A very small amount of manufactured wood was observed which will be removed. A customer was observed

Wood Grinding T & P area looking West

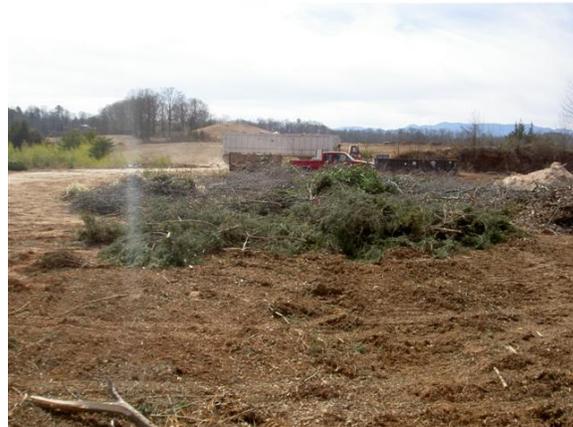
Wood Grinding area looking South (MSW landfill in background)

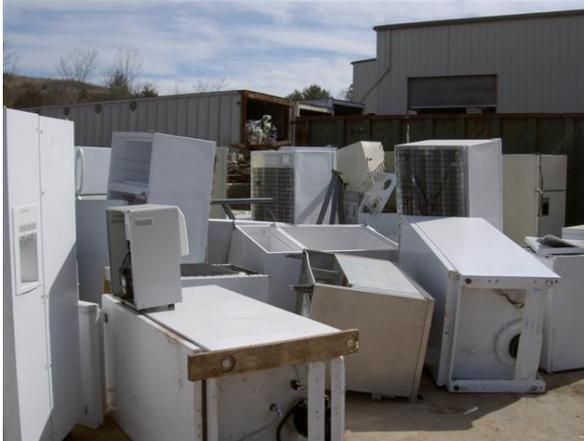
28. The White Goods Area is located in the recycling area. Freon is removed by the facility.

White Goods

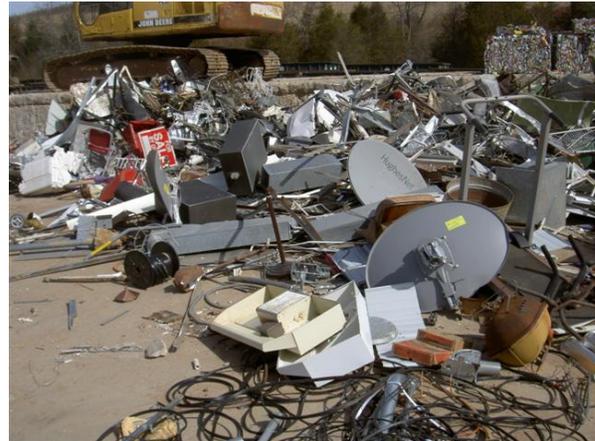
Metal Recycling Area

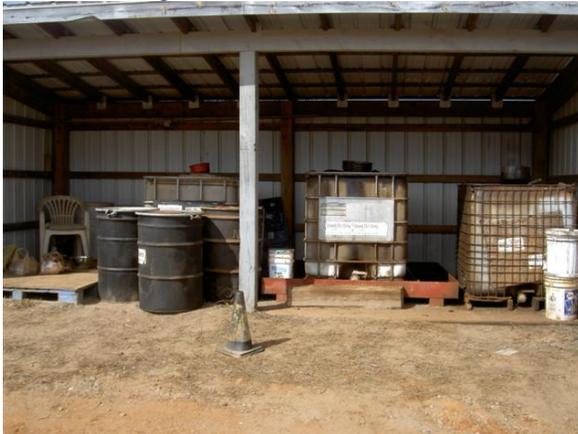
29. Used oil, household grease, batteries, anti-freeze and used oil filters were being accepted. With the exception of household grease, these were located in a shed.

Used oil/oil filters, anti-freeze and battery collection area

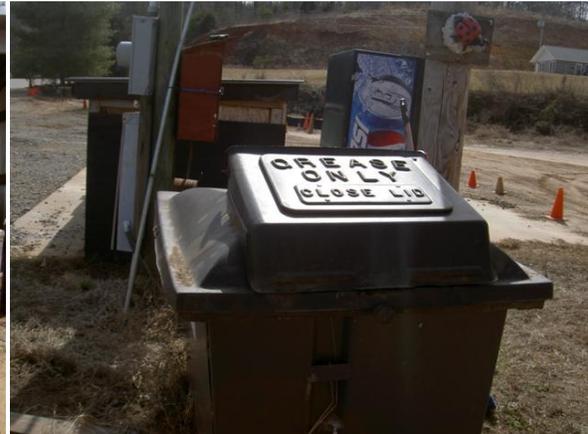
Used household grease recycling area
