**FACILITY COMPLIANCE AUDIT REPORT**  
**Division of Waste Management**  
**Solid Waste Section**

**Date of Audit:** March 30, 2010

B & B Concrete Products, Inc.  
 1687 Georgia Highway  
 Franklin, N. C. 28734

Comprehensive Audit of Type III Compost Facility

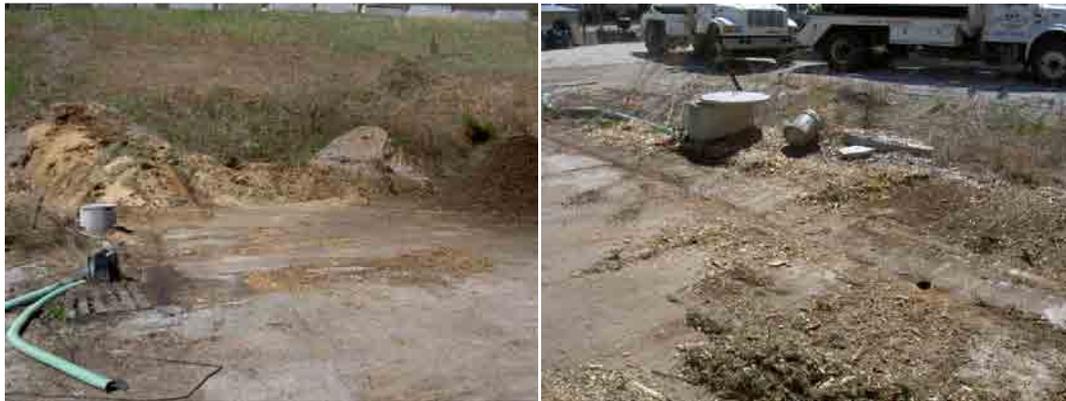
3. The only materials included in the compost pile are wood chips from a sawmill, brush from a grinding operation and grease from restaurants. The normal composition is 20 yards of grease and 40 yards of chips/brush/
4. Little odor was observed at the pile. No flies or other vectors were observed.
5. The site is not located in a 100 year flood plain and no wells were observed within 100' of site.
6. The compost is located on top of a concrete pad and any leachate drains to one side into a drain which empties into a septic tank. The company also operates a septic tank pumping service.

Photo of drainage system taken by Troy Harrison on 3/30/10.

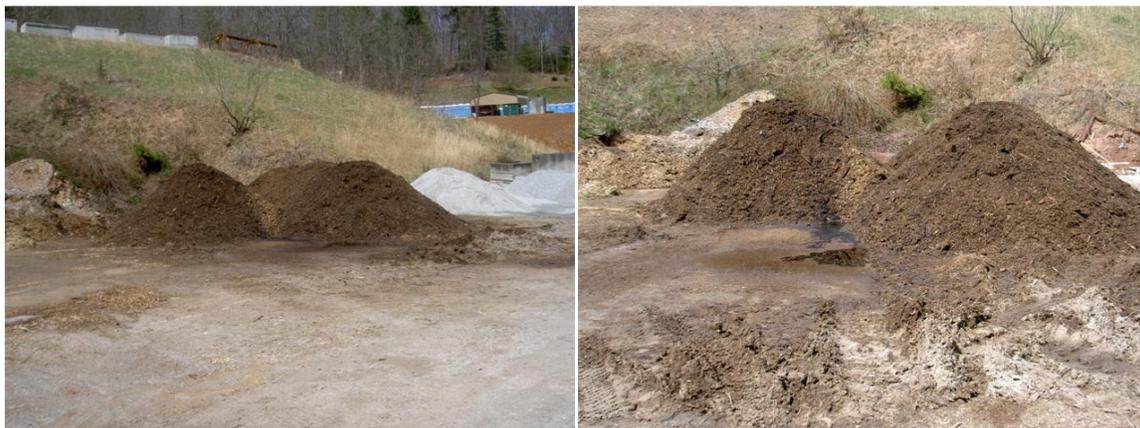
7. The site is not open to the public. Access is by a single private road that is staffed during work hours and controlled during off time.
8. There were two piles of compost. The finished pile had an internal temperature of 152°F and the unfinished pile was 144°F. Turning of the piles may be required to prevent excessive temperatures. **It was observed that the two piles were touching which could cause cross contamination. Each pile must be separated.**

Photos of compost piles taken on 3/20/10 by Troy Harrison
