FACILITY COMPLIANCE AUDIT REPORT
Division of Waste Management
Solid Waste Section

Madison County Municipal Solid Waste Landfill
 389 Long Branch Road
 Marshall, NC 28753

CLOSED: One Category I MSWLF cell and Two Category II MSWLF cells per the 10/19/1994 Landfill Closure Plan drawing no. 93131.
 Closure Letter dated: 12/21/95

Comprehensive Audit

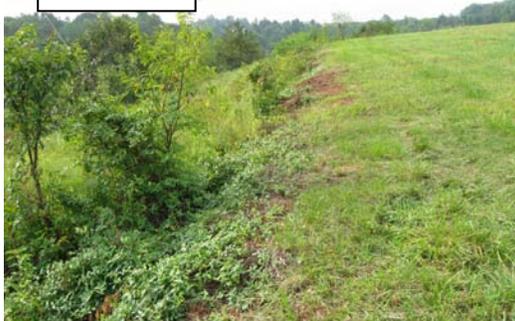
09/17/10

2. The closed landfill caps (three units) had been recently mowed/maintained. Edge-of-Waste (EOW) markers were in place around the perimeter of the mowed portion of the cell. Further maintenance was scheduled (per J. Huff) for the sloped edges of the cap systems.

Be aware that woody/tree growth can encroach upon the cap system. As these types of root systems will most likely extend beyond the erosion layer into the impermeable layer of the cap (thus destroying the integrity of the cap system and creating a path for water into the landfill), and as trees both inhibit the proper mowing and necessary maintenance of the cap while impeding on the ability to visually inspect the cap integrity, this woody shrub/tree growth must be eliminated. Any stumps and root systems of larger trees must be removed and the cap system repaired.

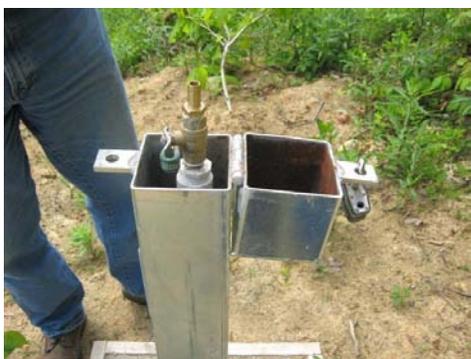
05/03/11

4. During the site inspection, field calibration was verified and G-4, 5, 6, and 7 were sampled for LFG. Results as follows:

Well ID	% Methane by Volume	% LEL
GP-4	0	0
GP-5	42	>100%
GP-6	50	>100%
GP-7	0	0

All newly installed GP wells were locked, labeled, and constructed with sampling ports.

The County planned to complete the monitoring event (collection from all required locations and additional screenings, as needed) later in the day. It was recommended that the sampling frequency be increased as part of the assessment of LFG migration at the facility.

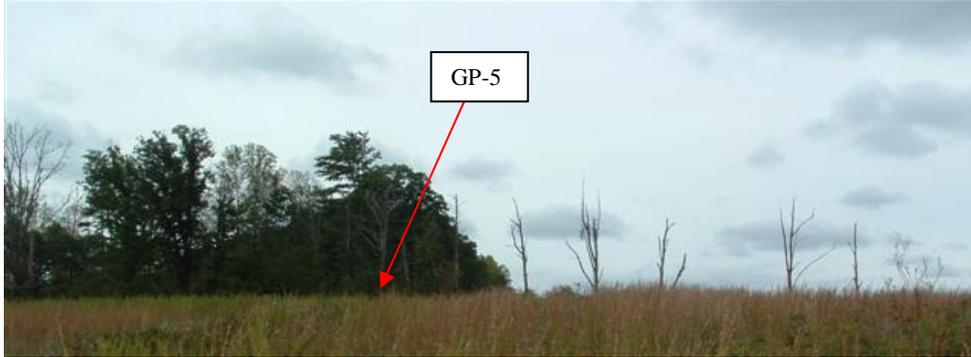
Note: the region between GP-5 and GP-6 has historically indicated potential methane gas presence (dead trees, noted in previous inspection dated 05/25/06).

6. The approved LFG Plan states that the County, within 60 days of detection, must *prepare and implement a remediation plan for the methane gas releases, place a copy of the plan in the operating record, and notify the Division of Solid Waste Management that the plan has been implemented. The plan will describe the nature and extent of the problem and the proposed remedy.* In order to achieve compliance, with the **15A NCAC 13B .0503 (2)(a)ii** Rule regarding exceedances of the LEL for the gases at the property boundary, the County must implement measures to addresses LFG exceedances. While these measures do not require approval from the **Section, notification of actions taken to address the potential health and safety risks should continue to be communicated in writing** (to A. Keller, and Jaclynne Drummond).

It is recommended that precautionary measures include increased site monitoring and/or supplementing monitoring of on site structures, and to conduct and document risk assessment of potential receptors to include any residences and other structures within 500-feet of the waste boundary. **Note that the 60-day period to prepare and implement a remediation plan sets a deadline of May 23, 2011.**
