**FACILITY COMPLIANCE AUDIT REPORT**  
**Division of Waste Management**  
**Solid Waste Section**

**Date of Audit:** 06/25/09

MADISON COUNTY SOLID WASTE FACILITY  
 271 Craig Rudisill Road  
 Marshall, NC 28753

Partial Audit

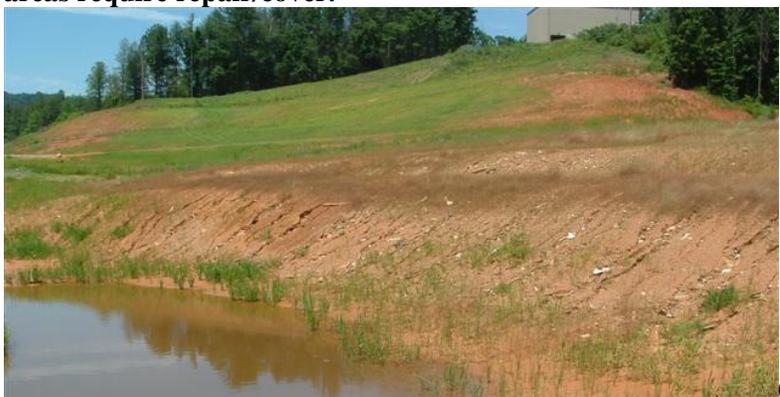
06/25/09

1. No issues with Wind Blown materials at the C&DLF.
2. The permitted edge-of-waste boundary stakes were maintained and visible.
3. The waste type in the C&D was reviewed and is according to permit. No unacceptable waste streams were noted.
4. The active working face of the C&DLF was kept to a controlled area, and the recently applied cover was adequate and in good condition. However, as seen in the picture below, the areas of the C&DLF which were less recently active (toward the sediment basin region) are eroding and waste has been uncovered. **These areas require repair/cover.**
