FACILITY COMPLIANCE AUDIT REPORT
Division of Waste Management
Solid Waste Section

Date of Audit: 05/03/11

MADISON COUNTY SOLID WASTE FACILITY
 271 Craig Rudisill Road
 Marshall, NC 28753

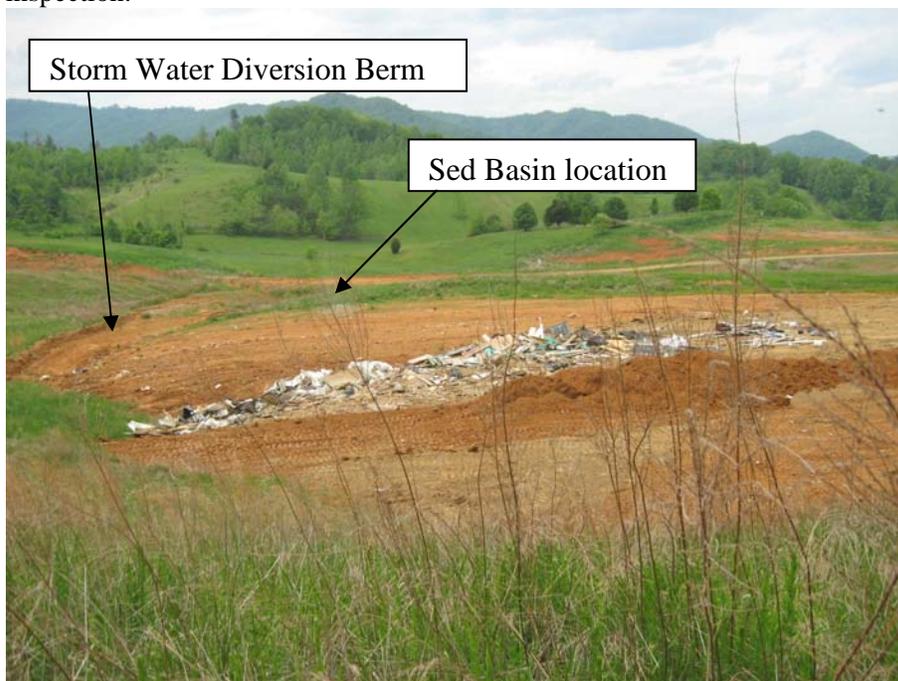
1. Minimal windblown noted at the working face during the inspection. The permitted edge-of-waste boundary stakes were maintained and visible. No unacceptable waste streams were noted.
2. The active working face of the C&DLF was kept to a controlled area, and the recently applied cover was adequate.
3. The Permit to Operate (PTO) submittal indicated that the fill sequence at the landfill matches the “Year 2 Waste Fill Area” from Sheet FILL-2. Note that this figure and fill sequence is an approved document (*CQA Report and Operations Plan, C&DLF Unit 2, Madison County, NC*, prepared by McGill Associates October 12, 2006) per the approved permit. The required storm water diversion berm was maintained at the time of the inspection.

The temporary sediment basin discharges outside the permitted waste fill area of Unit 2. Thus, the facility must ensure stormwater contacting C&D waste (leachate) and leachate seeps from the active fill area do not reach the sediment basin. (Discussed on site: A. Keller, J. Huff).
