FACILITY COMPLIANCE AUDIT REPORT
Division of Waste Management
Solid Waste Section

Date of Audit: 16 March 2010

Domtar Paper Company Landfill
 Ken Trowbridge Road
 Plymouth, North Carolina

Annual Comprehensive

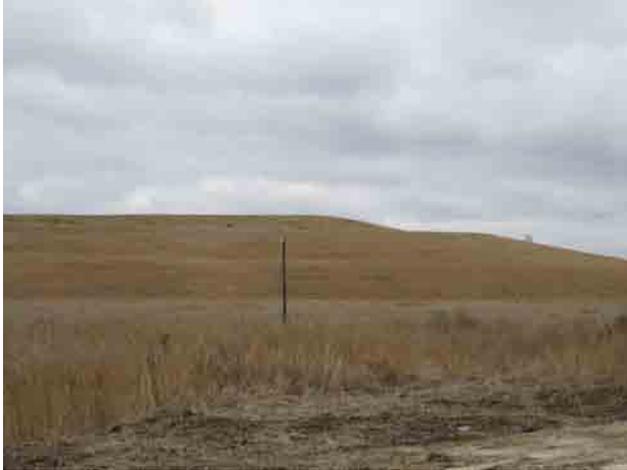
- 19) Some edge of liner markers have been installed in the active cell. *Please finish the installation of Edge of Liner markers in this cell.
- 20) Phase 1 has been closed and covered with a cover crop established suitable to prevent erosion. Edge of waste markers have not been installed. *Please install and maintain Edge of Waste markers in the closed area of the landfill.

Phase 1, excellent cover

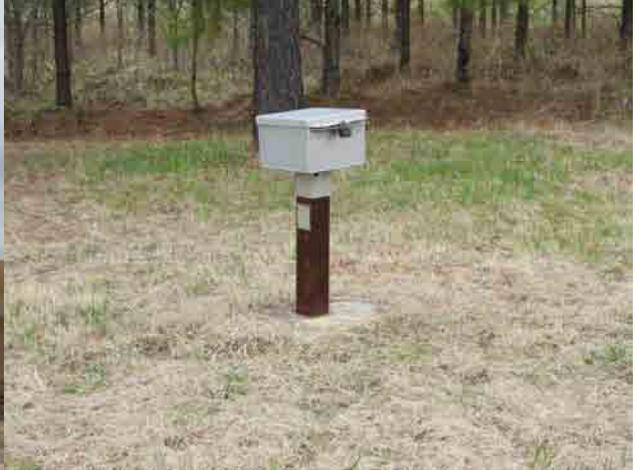
- 13) Proper signage is posted at the facility entrance in accordance with the facility permit requirements.
- 14) All monitoring wells are easily accessible, secured by locks, and properly labeled.

Groundwater monitoring well

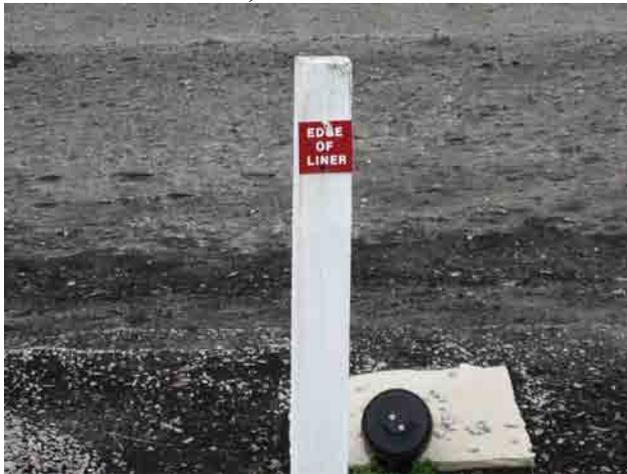
Edge of liner marker on Phase II

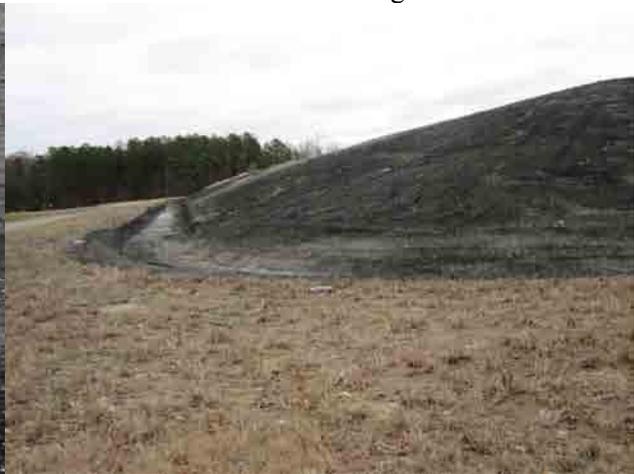
Cover and grading sideslope Phase II

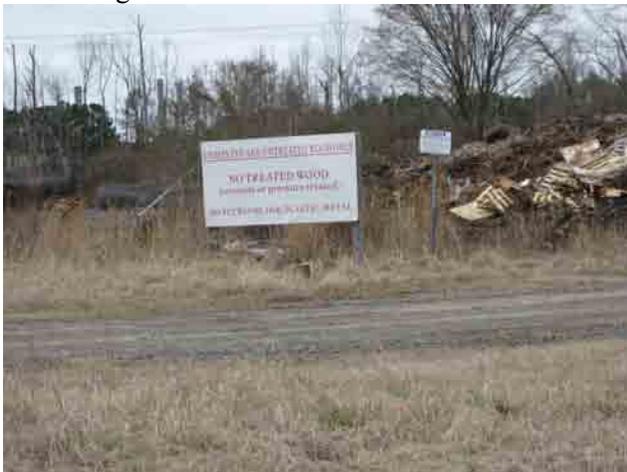
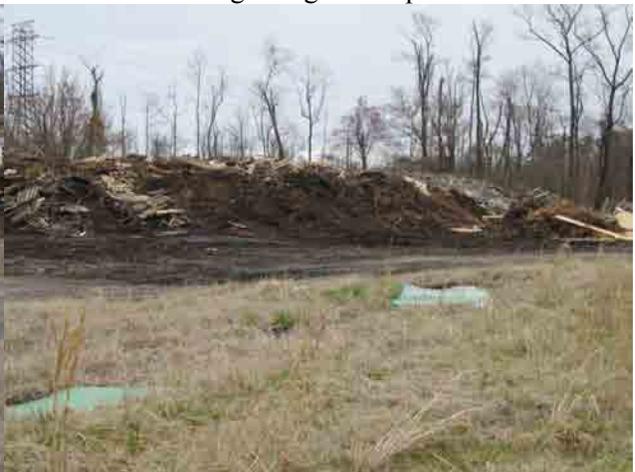
Wood grinding element, needs addition to operations plan

- 4) Facility is currently accepting +/-160 tons of waste per day, with approximately 90% of the waste disposed being ash from the paper mill.
- 5) The current facility permit and operations plan were presented and reviewed during this audit. The Operations Plan needs to include all operations at the landfill. *Please ensure that the wood storage/grinding area is recorded on your site plan and that all activities are listed in your facility operations plan.
