FACILITY COMPLIANCE AUDIT REPORT
Division of Waste Management
Solid Waste Section

Date of Audit: 8 December 2009

Washington County MSW Landfill
 718 Landfill Rd
 Mackeys, NC 27970

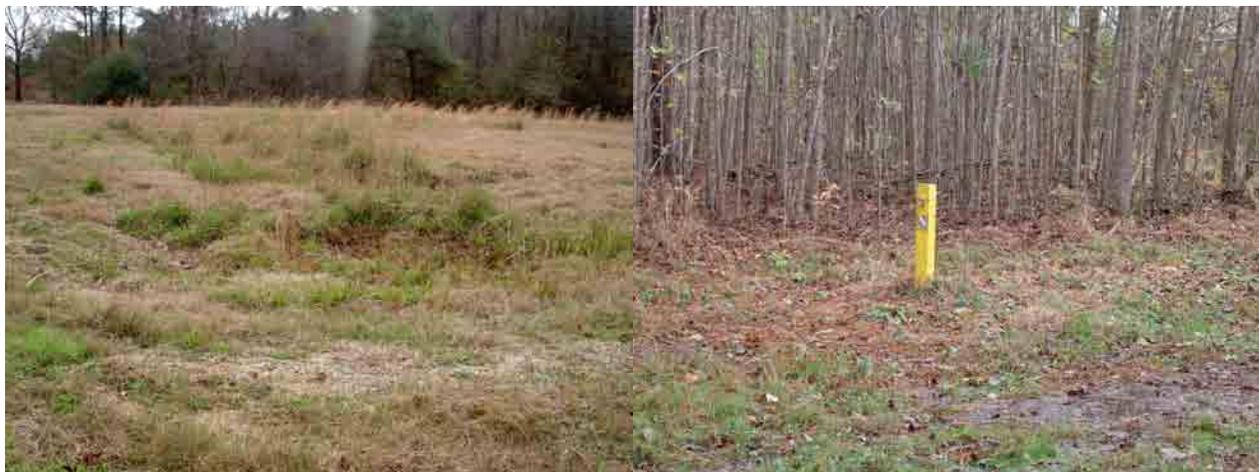
- 5) Vegetative cover is well established over the entire closed landfill and no areas of erosion were noted during this audit.
- 6) The groundwater monitoring wells were observed during this audit. All wells were readily accessible, painted with high visibility paint, properly labeled, and secured with functional locks.

- 7) Several areas of settlement across the surface of the landfill were noted as retaining water. *Please fill and grade these areas to ensure positive drainage of surface waters from the landfill.

Area of settlement with standing water

GW monitoring well-locked, labeled, and highly visible

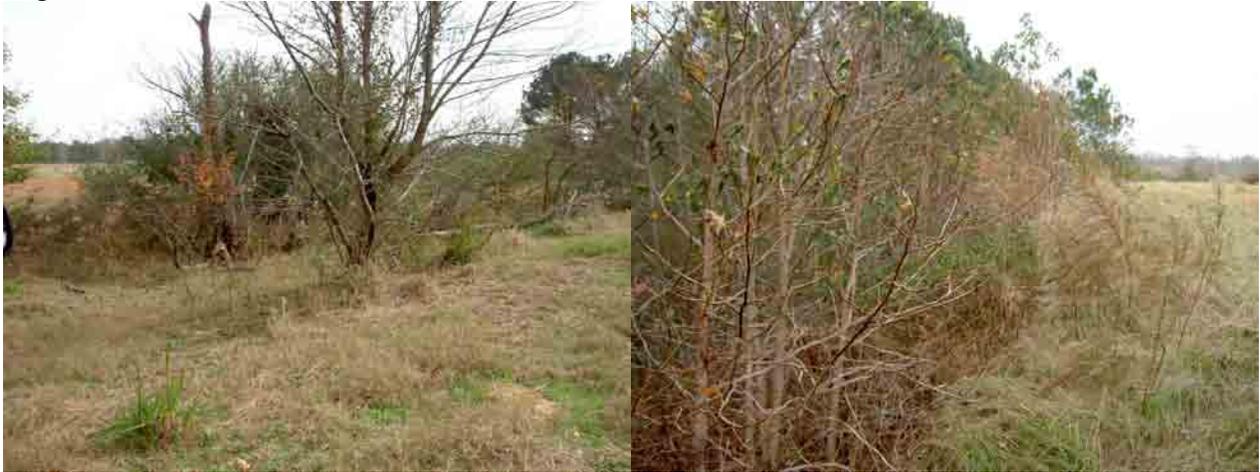
- 8) Trees were observed growing on several of the sideslopes of the landfill. *Please remove all trees growing on the landfill to preserve the integrity of the landfill cap system.

Trees growing along landfill sideslopes that need removal

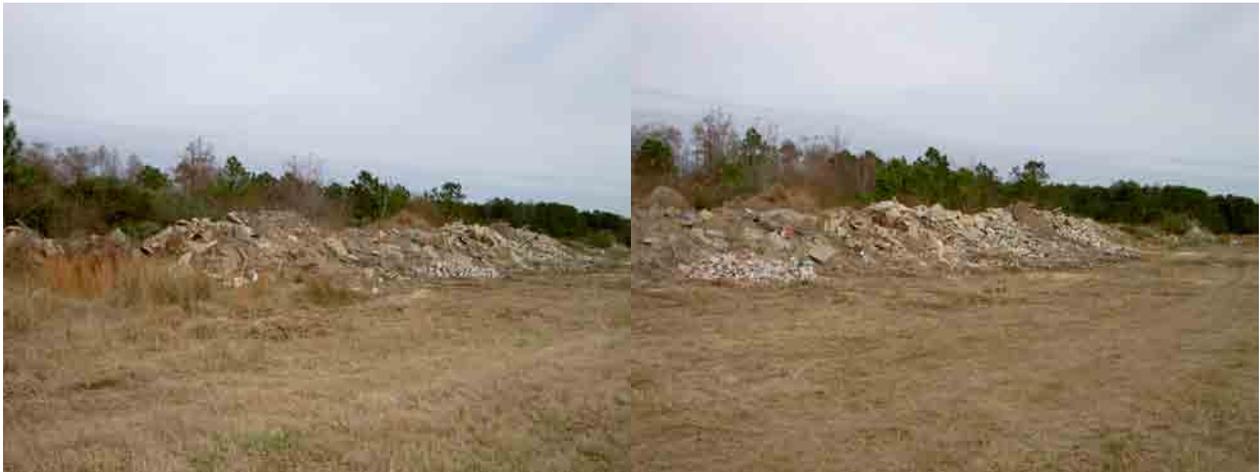
- 9) Edge of waste markers have been installed along the toe of the landfill sideslopes.
- 10) *The inert debris stored on-site needs to be compacted into one pile and processed/reused within twelve months of receipt. All waste not reused within twelve months of receipt needs to be disposed in the active C&D landfill unit.

Inert debris storage area Inert debris needs compacted pile and processing for re-use
