# FACILITY COMPLIANCE AUDIT REPORT

## Division of Waste Management Solid Waste Section

**Date of Audit:** 16 March 2010**Date of Last Audit:** 8 December 2009**FACILITY NAME AND ADDRESS:**

Washington County C&D Landfill  
 718 Landfill Rd  
 Mackeys, NC 27970

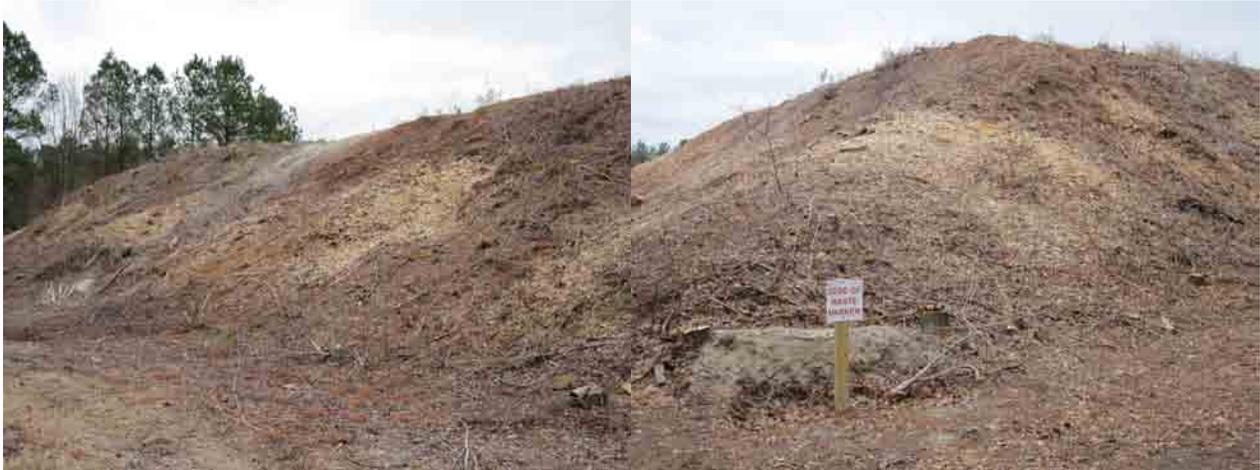
- 14) The landfill sideslopes have been cleared of all trees and woody vegetation.
- 15) The eroded areas on the landfill sideslopes have been repaired and the sideslopes have been mulched to prevent erosion of the landfill cap system. \*Please ensure that all sideslopes are graded and maintained at a slope not greater than 3:1.

Sideslopes-trees and brush removed

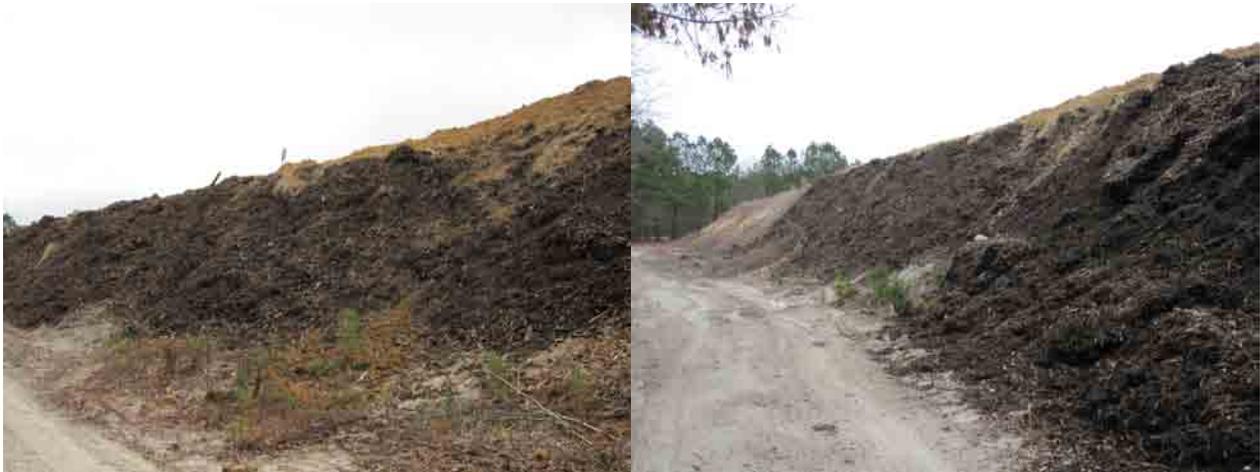
Sideslopes-eroded areas repaired and mulched

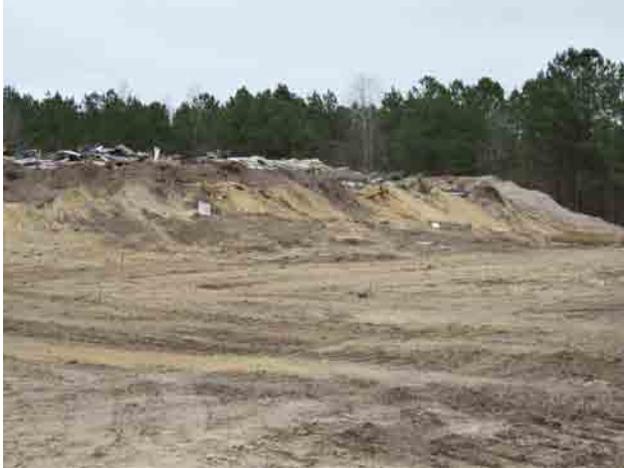
- 19) The area of standing water that was noted at the toe of the landfill working face in the previous audit has been filled and graded to provide for positive drainage of surface waters away from the toe of the slope and to prevent ponding.

Toe of sideslope filled and graded for drainage

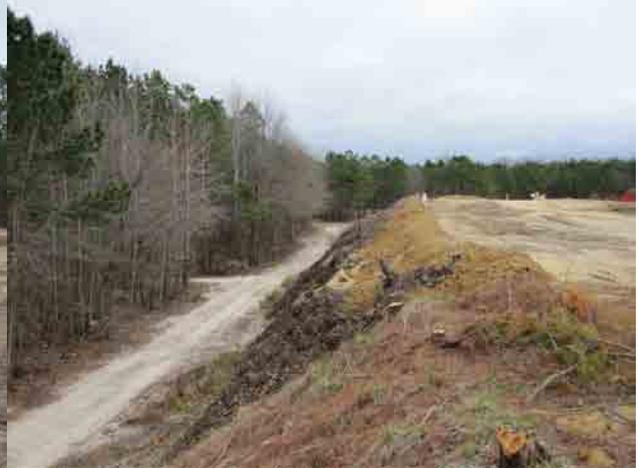
Sideslope-needing 3:1 grade
