FACILITY COMPLIANCE AUDIT REPORT
Division of Waste Management
Solid Waste Section

Date of Audit: 10 June 2011

Washington County C&D Landfill
 718 Landfill Rd
 Mackeys, NC 27970

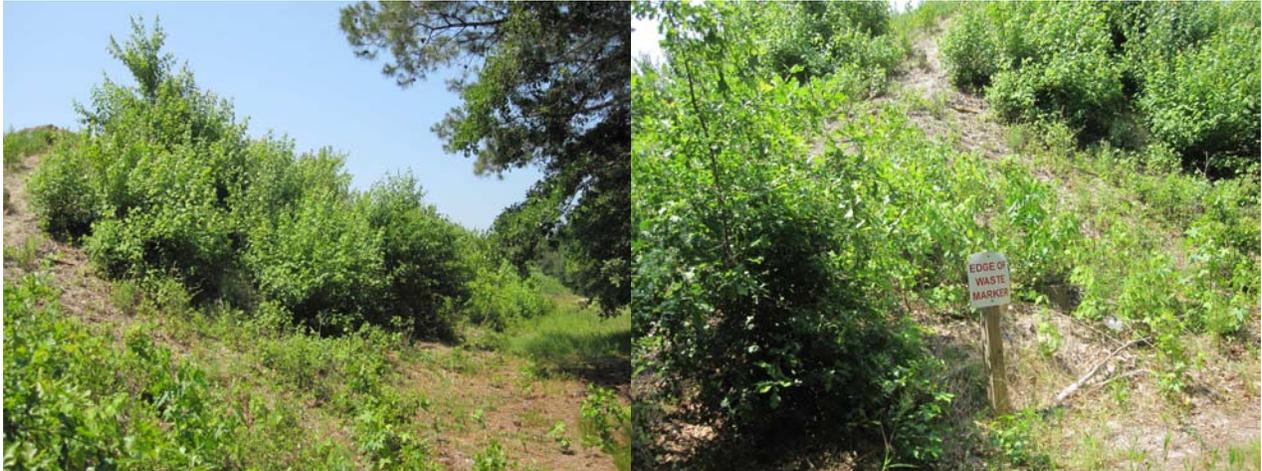
- 26) Brush and woody vegetation were noted on the landfill sideslopes. *Please remove all brush and woody vegetation and work establish a permanent groundcover suitable to preserve site stability and prevent erosion of your landfill cap system on all facility sideslopes.

Brush and woody vegetation needing removal from facility sideslopes

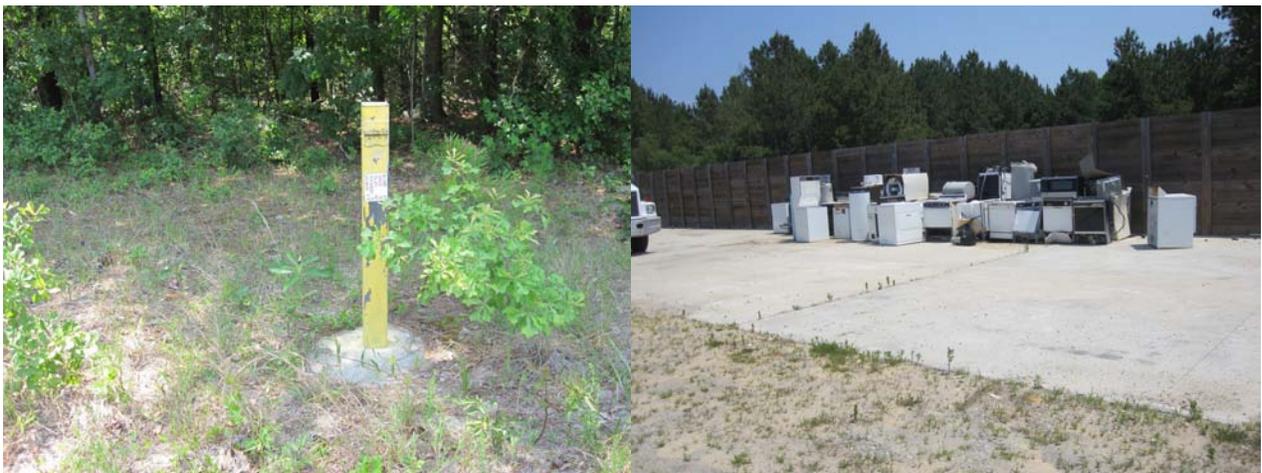
- 16) The facility groundwater monitoring wells were observed during this audit. All wells were readily accessible, painted with high visibility paint, secured by locks, and properly labeled.

- All metal containing materials collected for recycling are deposited on-site on the concrete pad and are maintained in an orderly fashion until collected by the metal salvage contractor.

- All Freon containing white goods are placed and maintained in an upright condition and are kept separate from non-Freon containing white goods/metals.

Groundwater Monitoring Well secured and labeled

Well managed white goods/recyclable metals area
