FACILITY COMPLIANCE AUDIT REPORT
Division of Waste Management
Solid Waste Section

Date of Audit: 9 November 2009

Larry Styron LCID Landfill
 Herring-Smith Road
 Newport, NC 28570

Comprehensive

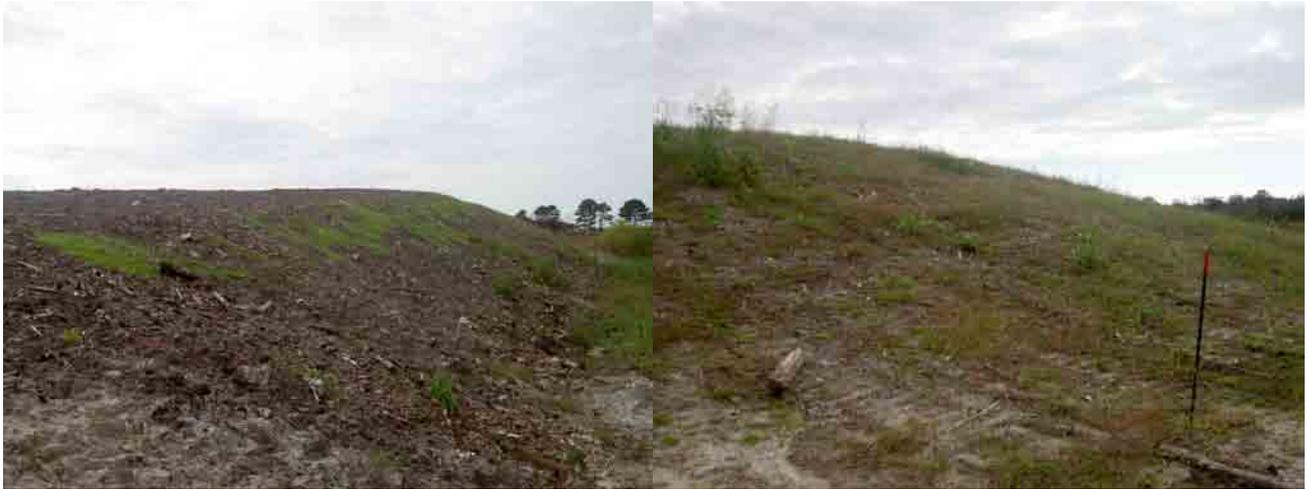
Sparse cover on sideslopes needing to be re-seeded. Waste boundary marker installed at toe of slope.

- 4) **15A NCAC 13B .0566 (6)** Adequate erosion control measures, structures, or devices shall be utilized to prevent silt from leaving the site and to prevent excessive on site erosion. **Resolved.** However, there are several areas where the cover crop failed to germinate allowing for minor erosion of the landfill cap. These areas need to be re-graded and seeded to prevent further damage to the cap system.

- 5) **15A NCAC 13B .0566 (7)** Provisions for a ground cover sufficient to restrain erosion must be accomplished within 30 working days or 120 calendar days upon completion of any phase of landfill development. **Resolved.** The facility has been seeded to establish a groundcover to prevent erosion. However, the seed has failed to germinate uniformly across the entire landfill. As per our conversation, please re-seed and cover with straw or mulch as soon as possible to prevent erosion of your cap system and to establish a consistent cover crop over the entire landfill.

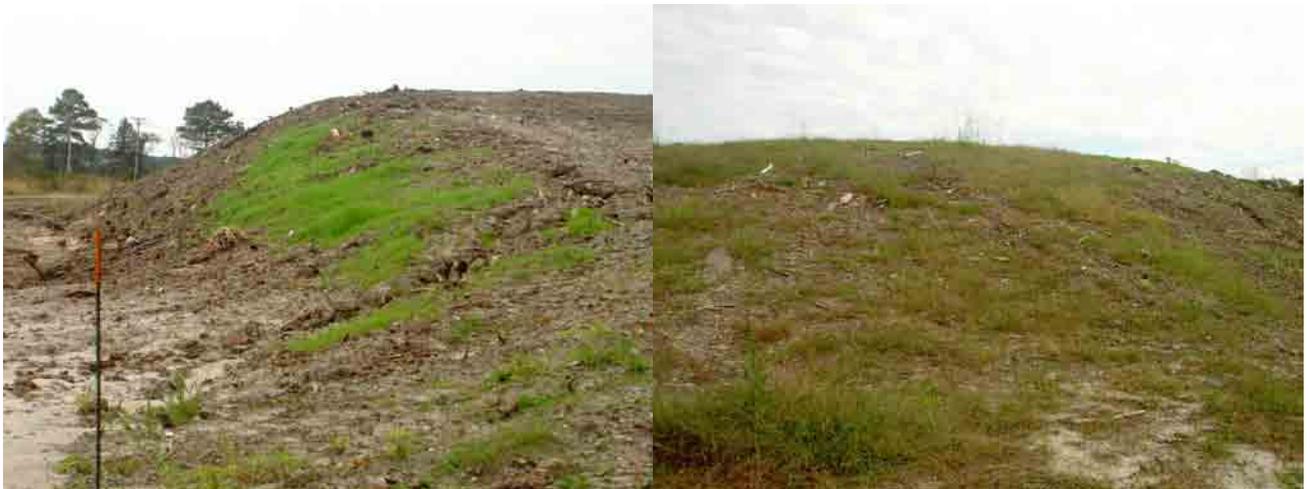
Sparse cover on sideslopes needing to be re-seeded. Washout areas in need of fill, re-grading, and re-seeding/mulching.
