FACILITY COMPLIANCE AUDIT REPORT
Division of Waste Management
Solid Waste Section

Date of Audit: 21 January 2011

R&R Farms LCID Landfill
 Sparrowhawk Lane
 Newport, NC 28570

Follow up audit

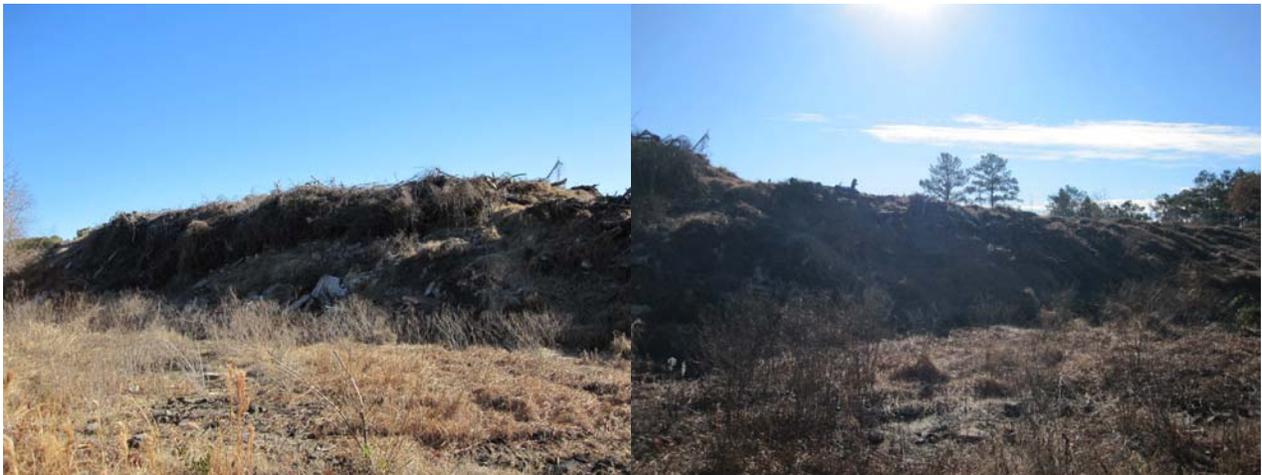
Areas on western sideslope needing continued attention: cover, grading, and seeding necessary

5. *The western sideslope needs continued attention. As per our conversation, please continue to work on the application of adequate soil cover and the grading of all facility sideslopes to a slope of not greater than 3:1 and the facility sideslopes are covered and graded, please seed and mulch to establish a groundcover suitable to prevent erosion of your landfill cap system.

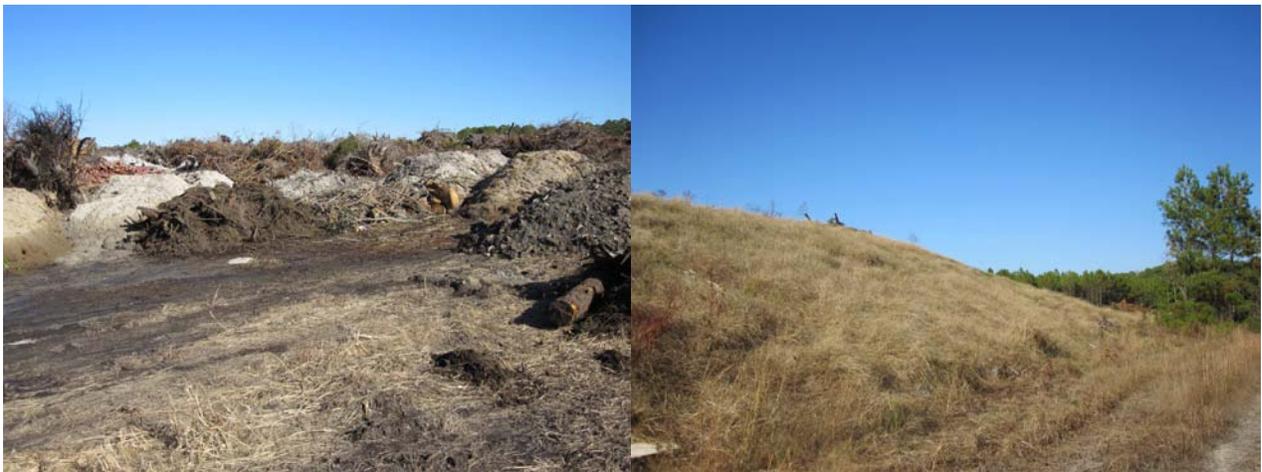
Working face needing compaction and cover

Eastern sideslope with good cover

8. The waste type being disposed is LCID waste only; no unacceptable waste streams were noted during this audit.
9. *The active working face has not been covered monthly as required. As per our conversation, please compact and cover the active working area.
