FACILITY COMPLIANCE AUDIT REPORT
Division of Waste Management
Solid Waste Section

Date of Audit: April 13, 2010

Wayne Smith
 d/b/a Stump & Stump Disposal
 Varsity Road
 Sylva, NC 28779

Comprehensive Audit of LCID Landfill

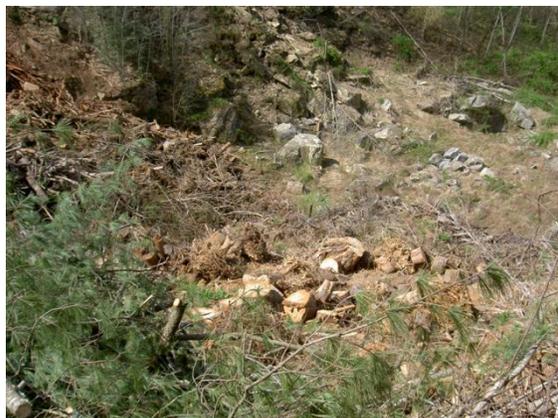
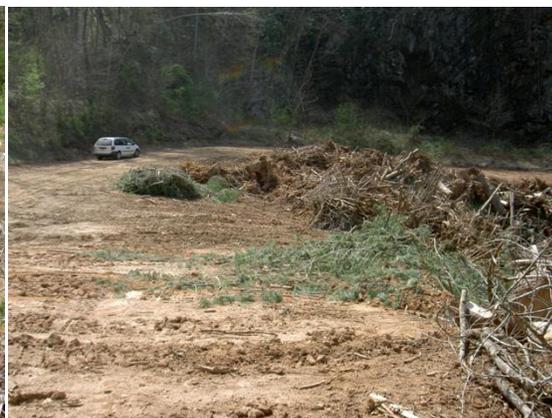
7. Mr. Harrison met with Mr. Smith during a separate investigation the same day. The results of the audit were relayed by Mr. Harrison.
7. The slope of the landfill was very steep with roughly 70 feet of vertical exposed waste. **This is a violation of 15A 13B .0566 (4) which states: Adequate soil cover shall be applied monthly, or when the active area reaches one acre in size, whichever comes first. As a general rule a 3:1 slope or less should be maintained on the landfill.**

Photo taken from top of landfill looking down by Troy Harrison. Photo taken showing top of landfill by Troy Harrison.

To achieve compliance, Wayne Smith d/b/a Stump & Stump Disposal must cover the face of the landfill with an adequate cover of soil and slope to prevent erosion within 60 days. Further action may be required by the Division.

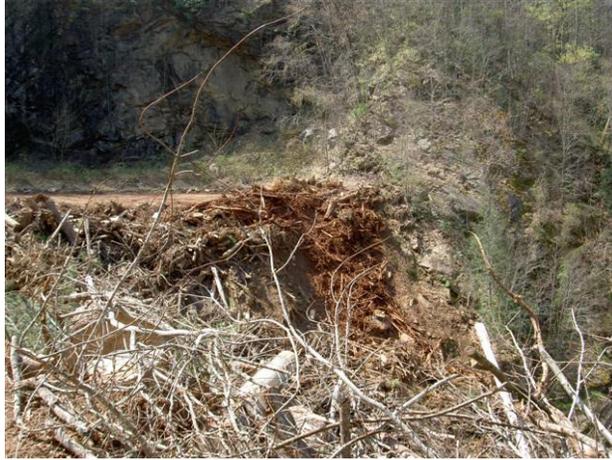
Wayne Smith d/b/a Stump & Stump Disposal is in violation of 15A 13B .0566 (4) on April 13, 2010 for failing to cover the disposal area with adequate soil cover.

Photo of exposed working face by Troy Harrison.

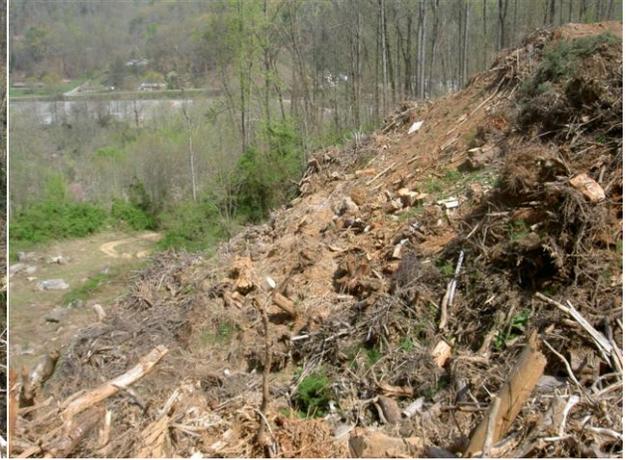
Photo of exposed working face by Troy Harrison.

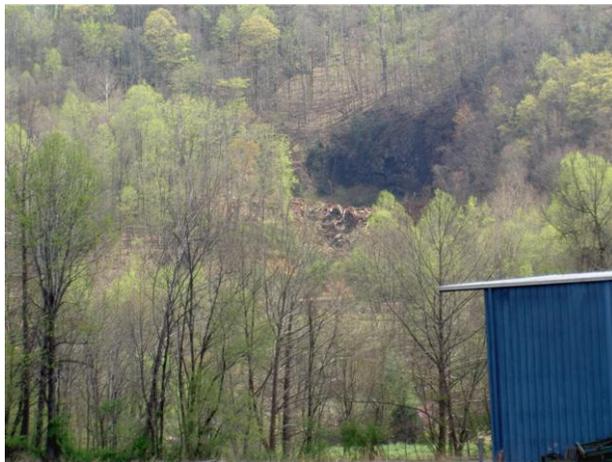
Zoom photo of landfill from railroad tracks.

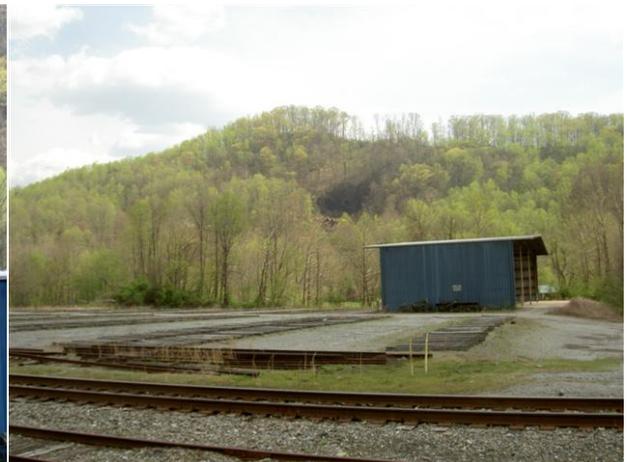
Photo of landfill from railroad tracks.

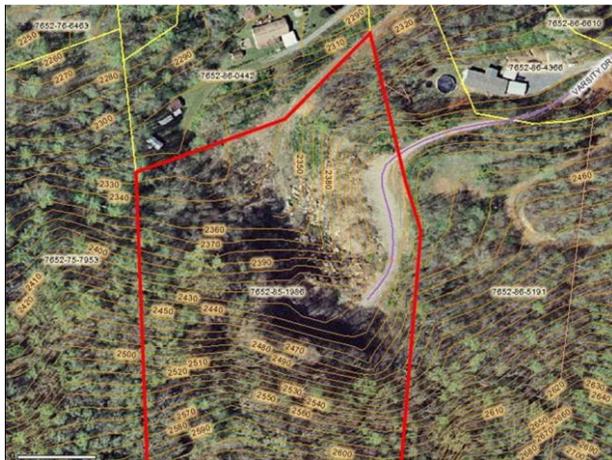
6. There was no one at the site during both audits, however; there had been recent activity at the site. Using the Jackson County GIS, it was roughly determined that the actual disposal area was 0.5 acre in size. The distances were approximate due to very steep terrain.

Aerial photo of landfill obtained from Jackson County GIS.
