# FACILITY COMPLIANCE AUDIT REPORT

## Division of Waste Management Solid Waste Section

Anna Wink LCID Landfill  
 Anna Wink Road  
 Newport, NC 28570

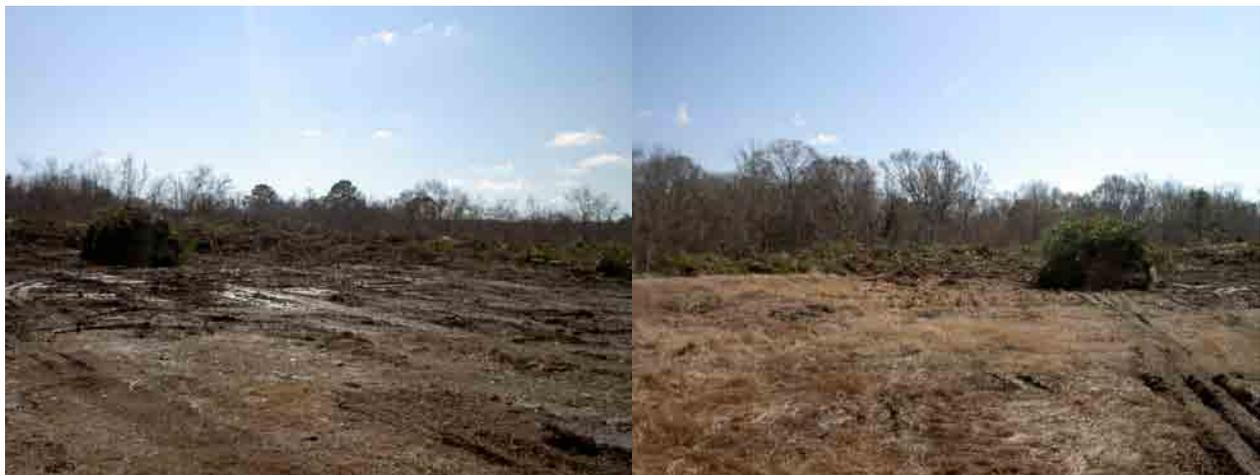
- 1) The access road to the facility is being managed properly at this time.
- 2) No off-site erosion was noted at this time.
- 3) The landfill working face was less than one acre and is being managed properly at this time.

Well managed working face

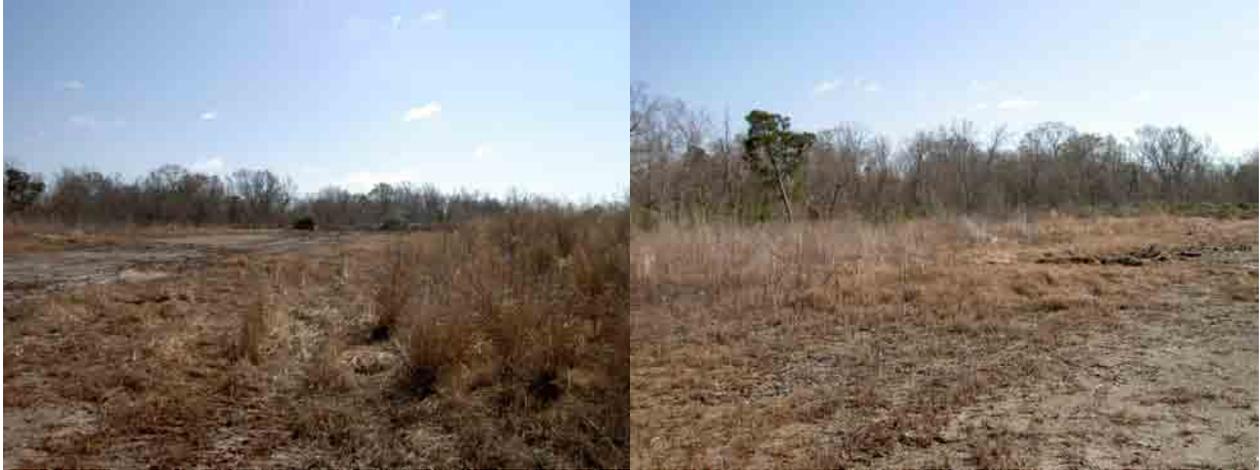
Sideslopes with good cover crop

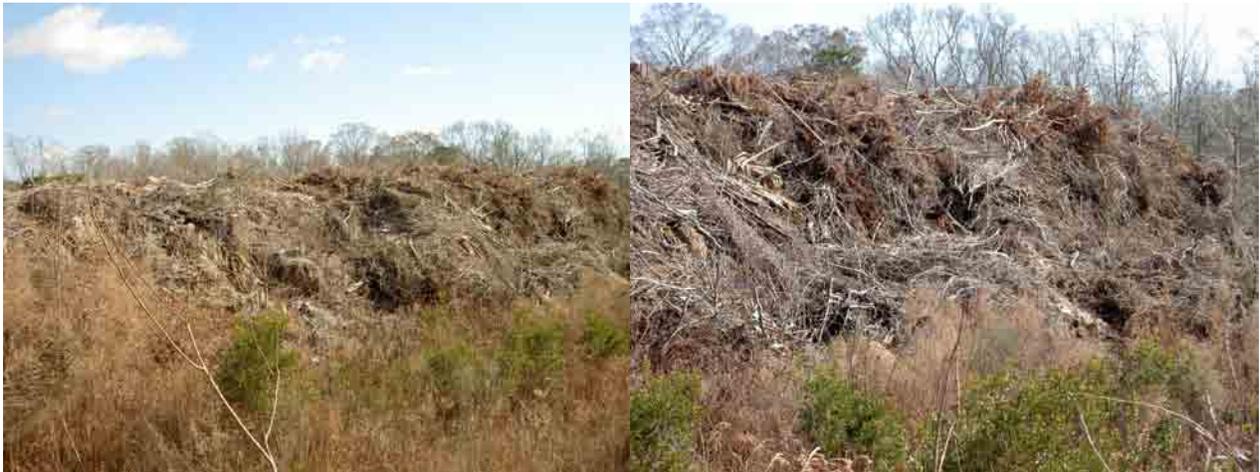
Sideslope needing cover and grading

- 4) There were some areas noted on the outside slopes that were lacking sufficient cover. \*Please cover and grade all the sideslopes at a 3:1 slope and establish a groundcover on them suitable to prevent erosion.
