FACILITY COMPLIANCE AUDIT REPORT
Division of Waste Management
Solid Waste Section

Date of Audit: 2 February 2010**Date of Last Audit:****FACILITY NAME AND ADDRESS:**

Coastal Dragline Services LCID Landfill
 175 Brown Farm Road
 Vanceboro, NC 28586

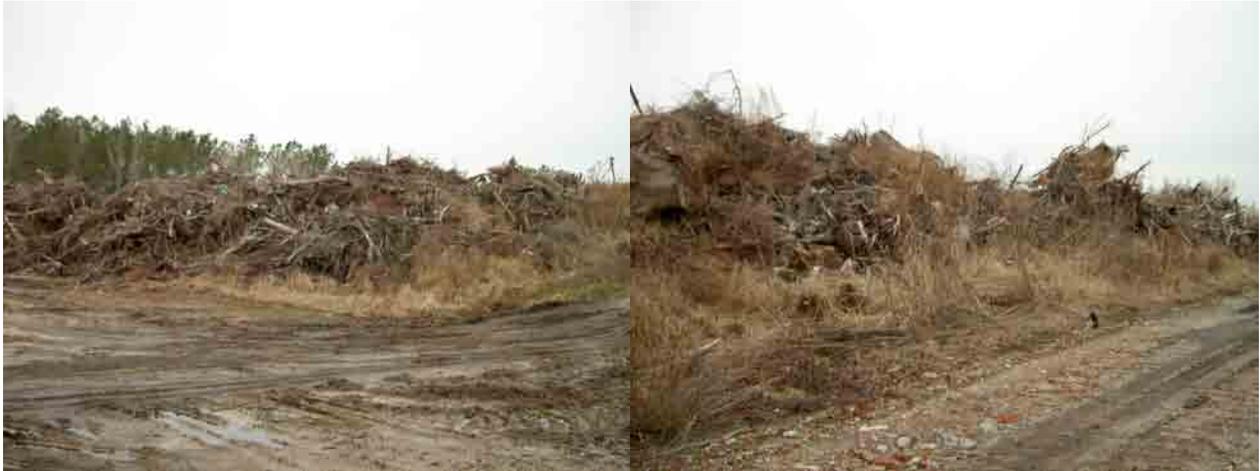
- The sideslopes of the landfill have not been graded, covered and maintained at a 3:1 slope with a groundcover established suitable to prevent erosion.
- The facility is not being covered monthly or when the active area reaches one acre in size.
- No attendant was on-site while the facility was operating.
- Property buffers and waste boundaries have not been marked.

Sideslopes needing cover and grading

- 1) Erect markers delineating the landfill waste footprint boundaries and all required buffers as listed in 15A NCAC 13B .0564 (9) on your LCID notification form.
- 2) Cover and grade all the sideslopes at a 3:1 slope and establish a groundcover suitable to prevent erosion.
- 3) Ensure the facility access gate is closed and locked whenever there is no attendant on-site.

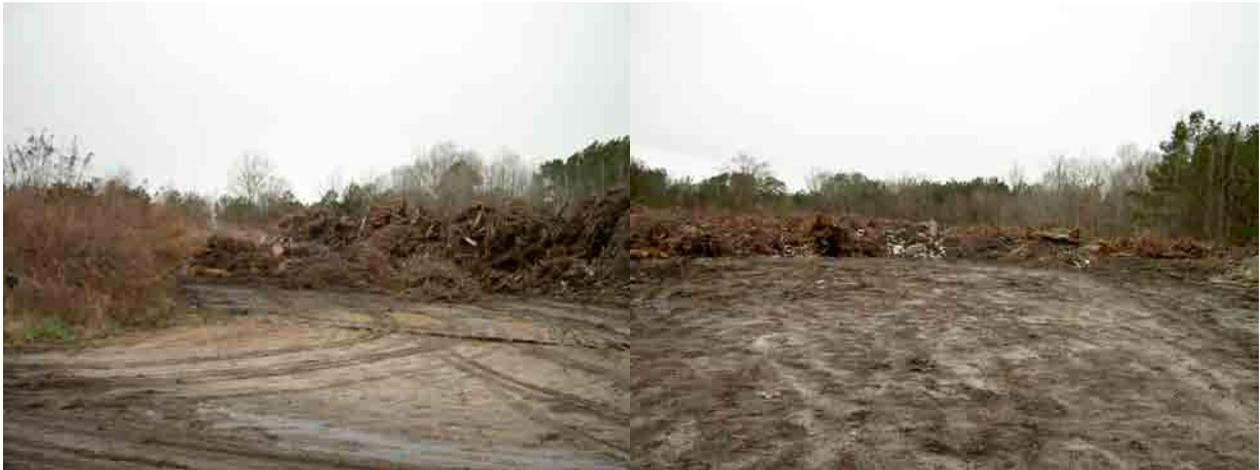
1. The facility should have only one active working face. The active working face needs to be maintained in the smallest feasible area.
2. The waste footprint of this facility appears to be approaching 2 acres in size. Please ensure that waste boundary markers are installed and maintained to ensure the facility footprint does not exceed its maximum allowable size.
3. The facility access road is of all weather construction and is being well maintained.
4. Please note that any incidental trash or any other wastes that this facility is not permitted to receive and are deposited should be removed immediately from the site to a facility permitted to receive such wastes.
5. This facility is recorded with the Craven County Register of Deeds at: Book 2336; Page 66.
6. Digital photographs were taken during this audit; see photographs attached below.

Two active working faces

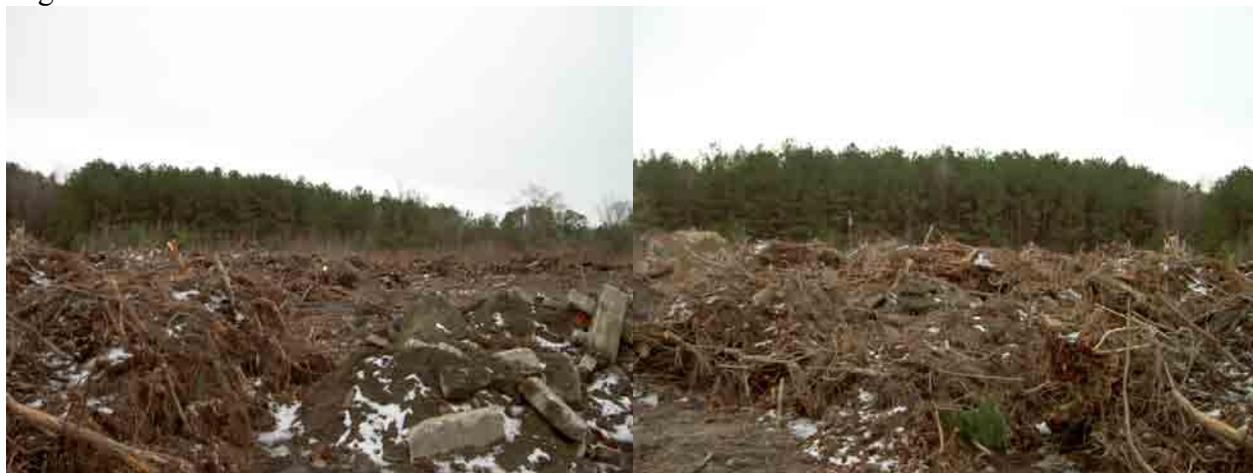
Working face too large and needing cover
