FACILITY COMPLIANCE AUDIT REPORT
Division of Waste Management
Solid Waste Section

Date of Audit: 25 June 2010

Coastal Dragline Services LCID Landfill
 175 Brown Farm Road
 Vanceboro, NC 28586

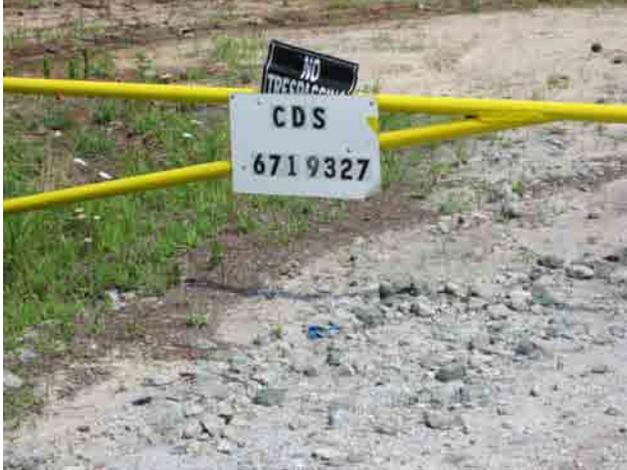
Sign posted Gate closed and locked

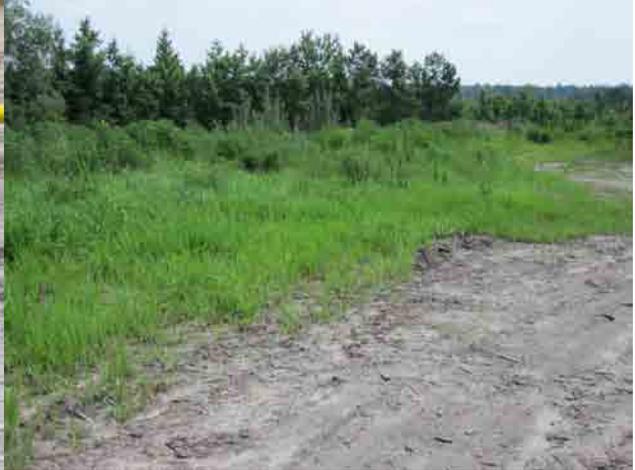
- 6) A groundcover has been well established on the northern and eastern sideslopes. *As per our conversation; please continue to work on the remaining sideslopes and ensure that a groundcover suitable to prevent erosion is established on all landfill sideslopes.

Cover crop

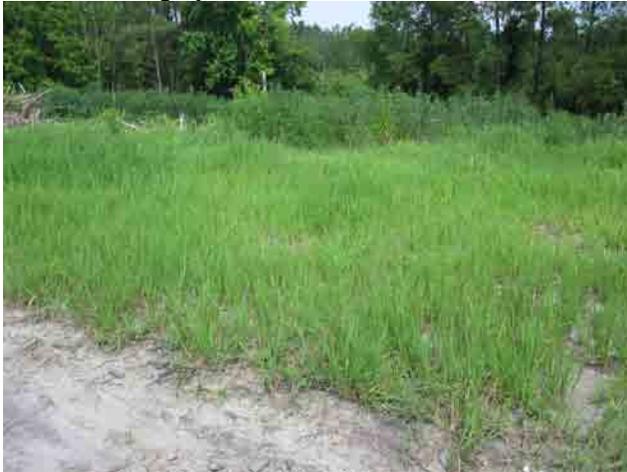
Cover crop

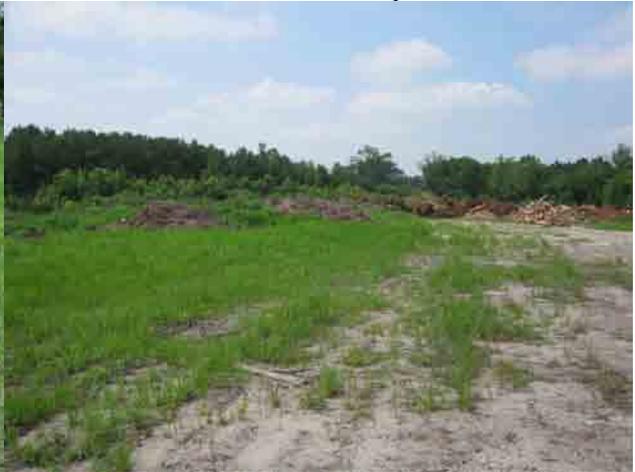
- 1) This facility is a Notified Land-clearing and Inert Debris Landfill.
- 2) The facility was closed and the gate locked during this audit.
- 3) The facility now has only one active working face. As per our conversation; please continue to ensure that the active working face is properly compacted and maintained in the smallest feasible area possible.

Working face

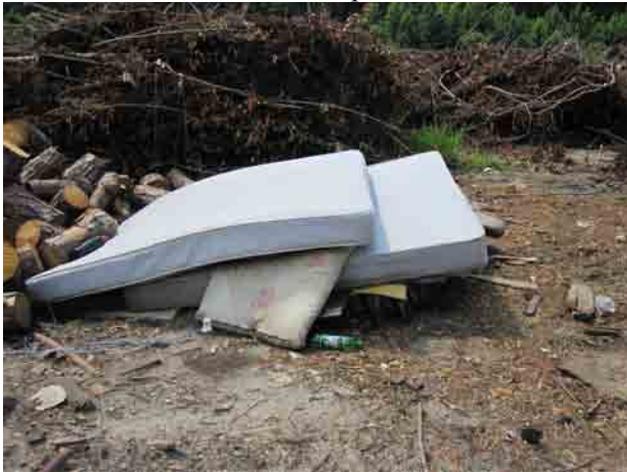
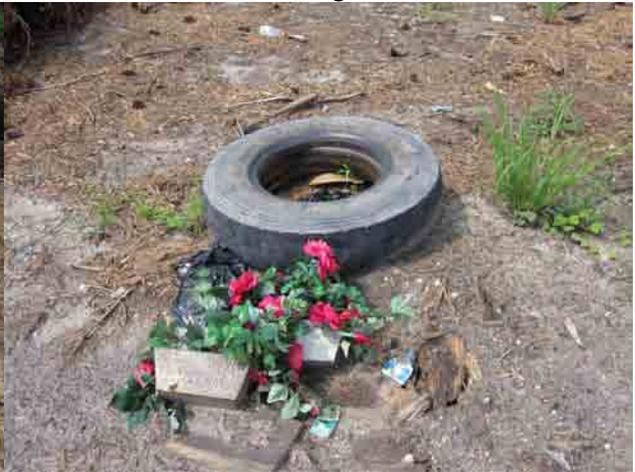
Unpermitted waste disposed at working face

- 5) Some unpermitted waste was noted at the working face (see photographs below). *As per our conversation, please remove all unpermitted waste from the facility and dispose at a facility permitted by the State to receive such wastes.
